HYDROLOGY RESULTS ON THE EU LIFE FUNDED “LIVING BOG PROJECT” 2017-2022

LIFE hydrology results
D01
14th July 2021

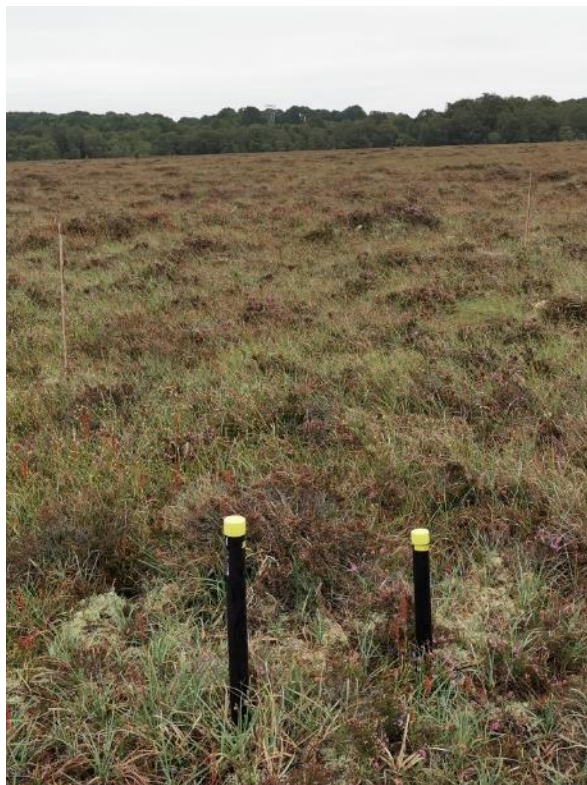
Figure 1-1: A Piezometric and Phreatic 'nest' installed near to, but not within, an ecological quadrat on Moyclare Bog SAC, Co. Offaly (000581).

and groundwater flow. Each piezometer pipe was placed approximately 0.5m away from the neighbouring phreatic pipe, forming a 'nest' such that the hydraulic gradient for each location could be calculated. Figure 1-1 illustrates a piezometer and phreatic pipe 'nest' installed on Moyclare Bog, the photograph also shows its close proximity to an ecological quadrat that was used to compare the hydrology and ecology data.

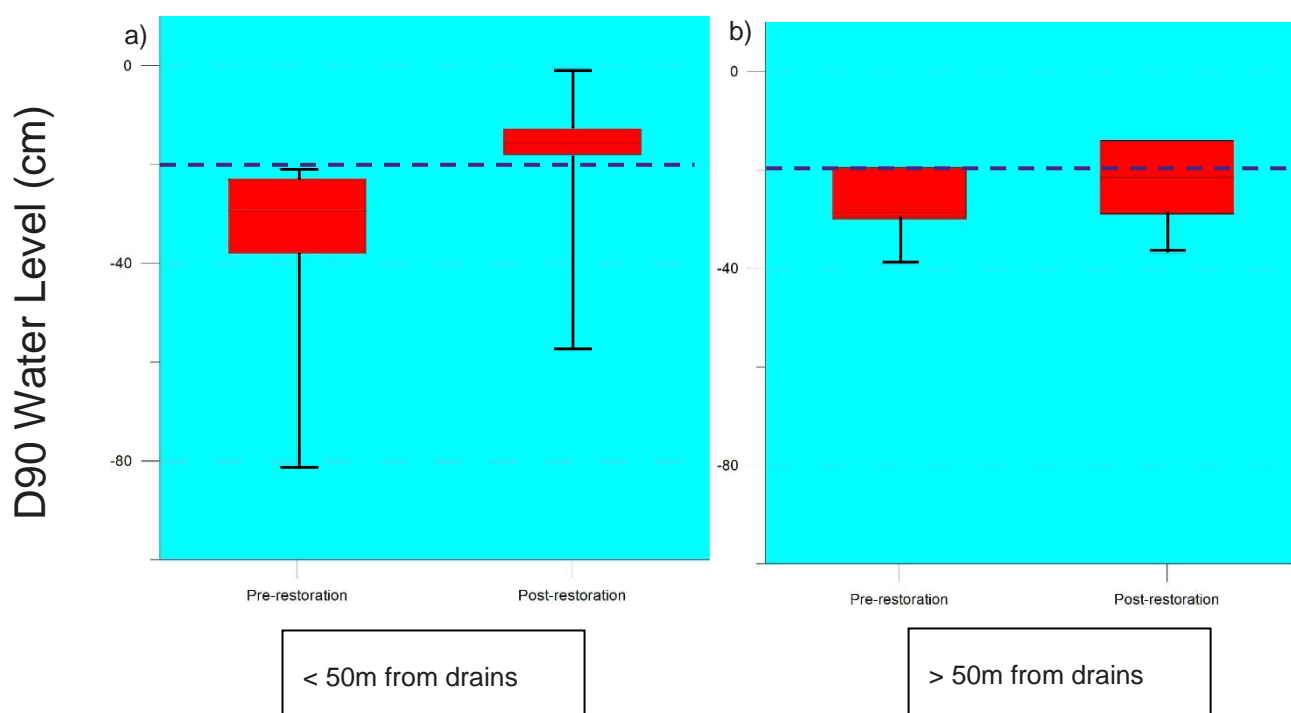
As shown, prior to restoration, in both areas, the interquartile ranges were located below the target level. However, post-restoration there was a noticeable improvement in the water levels in areas less than 50m from drains, with the interquartile range fully within the target zone. In monitoring wells located further than 50m from drains, there was a limited response noted, however as only 5 monitoring wells were located in this zone the results are not fully conclusive.

Figure 2-6: Box and whisker plot summarising the D-90 values for piezometers located in areas where PFH in cutover areas pre and post restoration

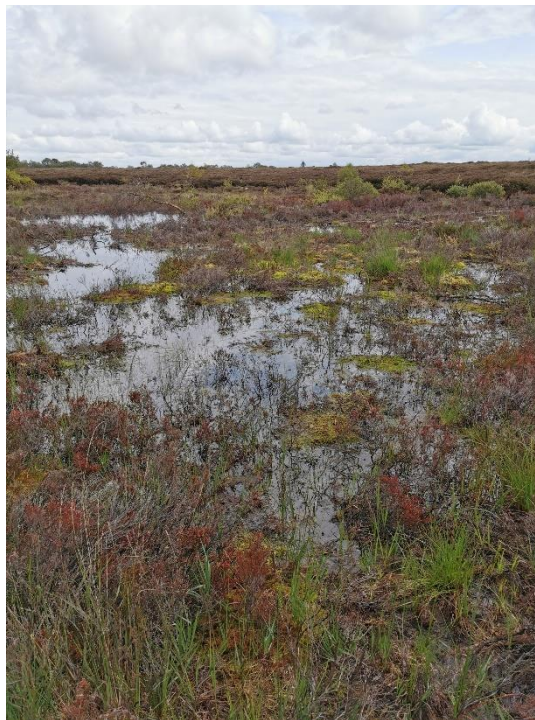
Figure 3-6 : Rewetting observed on Ardagullion Bog, where the water table came up to the surface throughout the year

Owing to regular site visits RPS survey teams are well placed to contribute anecdotal evidence based on conditions observed in the field. For instance, in the Eastern cutover in the vicinity of wells AR 1 and AR 2, the ground surface has become significantly wetter following restoration with pools forming close to the main drain in both areas with the local the topography contributing to the rapid changes in hydrology. On the western cutover, a similar impact was observed over a large area upstream of the weir-regulated bund, here the water table rose to the surface and remained there year-round. The design of the bund had been modified to alleviate concerns of landowners, as a result, the south-western corner of this cutover is currently outside the scope of the project in an area where restoration was not undertaken, therefore observations made in this area could be used as control monitoring to quantify the impact of restoration on the site.

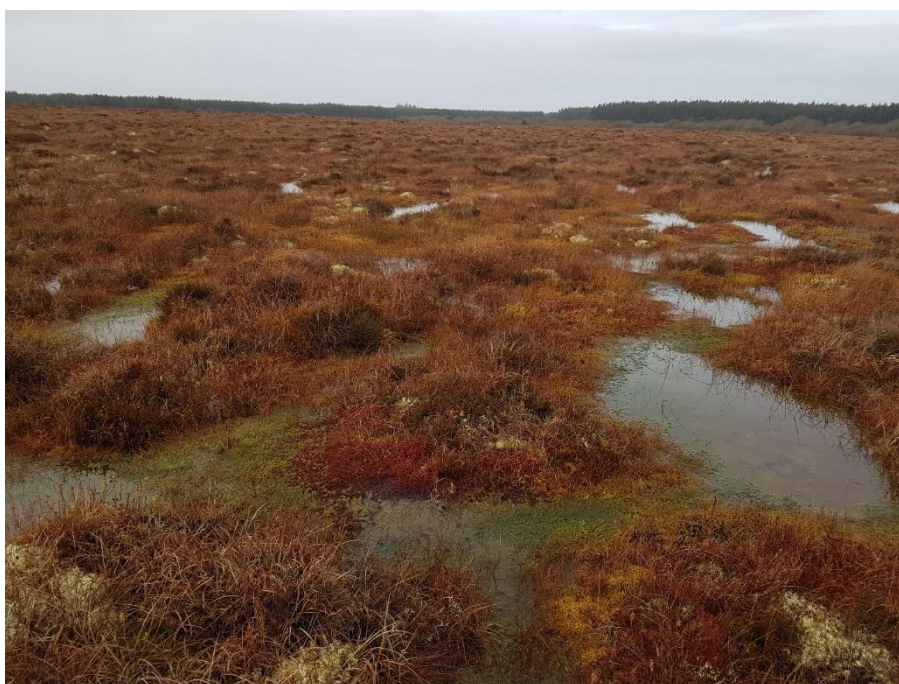
Figure 3-30: High bog at Carrowbehy. Large portions of the high bog were defined as ARB and remained wet throughout the year

A large proportion of the high bog was already defined as ARB and was considerably wet underfoot (Figure 3-30). given water table levels are generally closer to the ground surface in high bog areas anyway, hydrological changes are more difficult to observe visually than widespread rewetting of very dry cutover areas. Rewetting, in close proximity to drains, could be observed on the high bog near nests CB20 and CB18.

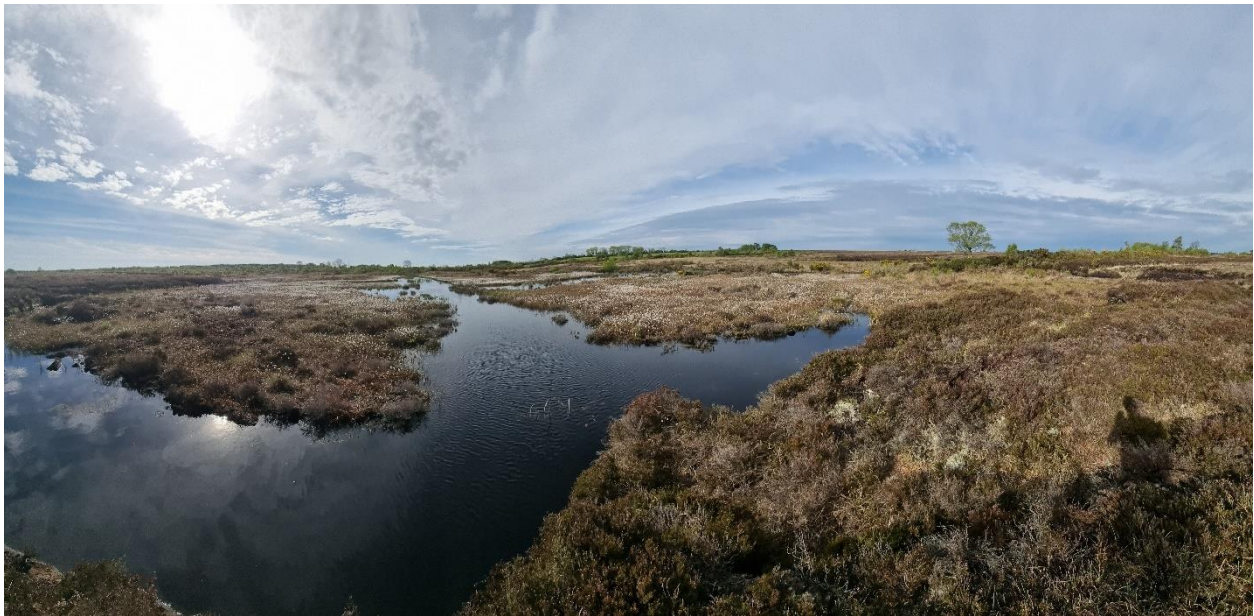
On account of regular periodic site visits, RPS survey teams are well placed to contribute anecdotal evidence based on conditions observed in the field. Carrownagappul was a large complex site, with a range of drain blocking methods trialled and differing results observed. In general, significant re-wetting was observed on cutover areas. Close to CG 5, where sandwich dams were used to effectively block large drains, with a large contributing catchment, significant re-wetting occurred (Figure 3-46). Noticeably the total area that re-wetted was significantly larger than that anticipated by the ecohydrological model.

Figure 3-46: Cutover at Carrownagappul Bog SAC where significant rewetting was observed

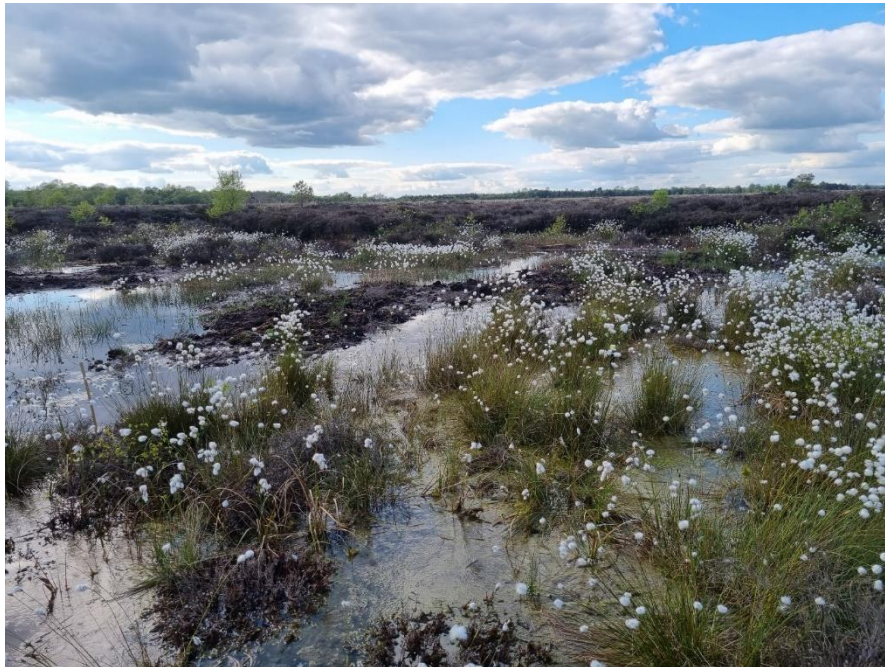
Figure 3-60: Cutover at Clara Bog where significant rewetting was observed

On account of regular periodic site visits, RPS survey teams are well placed to contribute anecdotal evidence based on conditions observed in the field. On Clara West, on the southern section of cutover, large-scale re-wetting was observed, with shallow pools of water forming that covered a large area throughout the year (Figure 3-60), even during the drier summer periods. Noticeably, this re-wetting area expanded over a larger area than anticipated by the ecohydrological model. Similar observations were noted on the southern cutover of Clara East, where re-wetting was noted in the vicinity of C4 and C8, however, this was more localised and confined to topographic low points. Some localised flooding of adjacent land was reported on Clara west, due to several drains flowing from farmland into cutover areas. Secondary works were completed in the area to lower the water levels in adjacent lands outside the SAC while maintaining the benefits obtained by the drain blocking within the site.

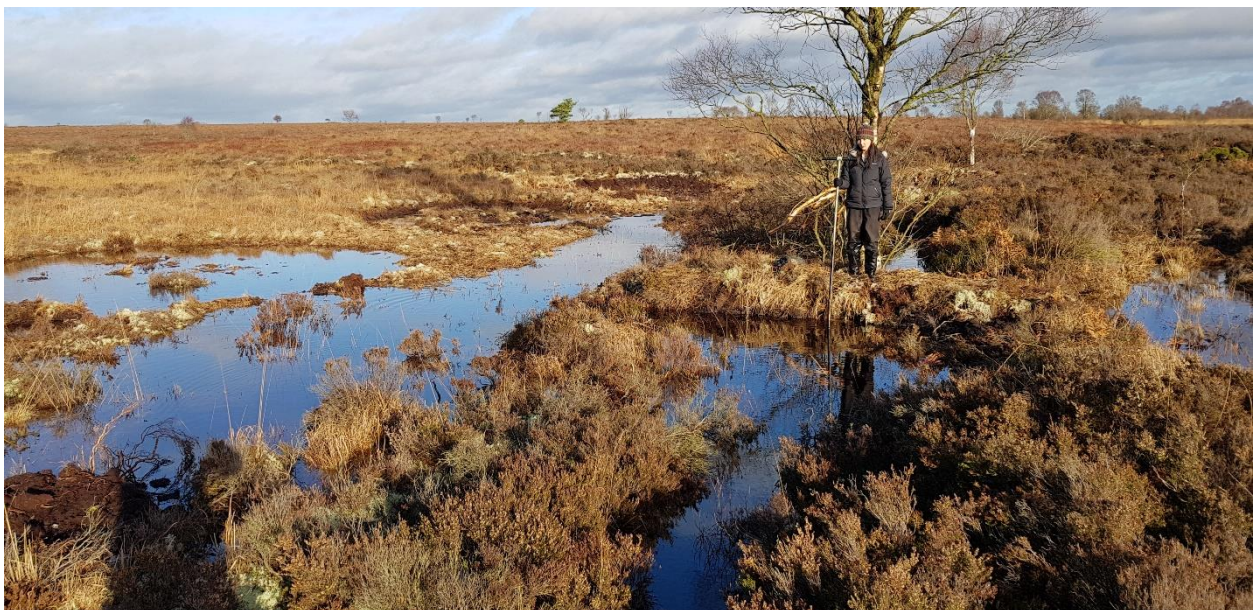
Figure 3-73: Cutover at Ferbane Bog SAC where significant rewetting was observed

Limited restoration measures were employed on the Eastern cutover due to the presence of mature forestry, however, partial blocking was completed by installing plastic dams at key locations, this significantly raised the water levels in drains within this area, however, ecological monitoring of the area will be required to determine the impact of this in the coming years as part of the AfterLIFE plan. On the Southern cutover, in the vicinity of well F1, the area has become inaccessible for measurements during wetter periods due to significant rewetting post-restoration. Observations from a distance have estimated the water table at 30cm or more above the ground surface. While F1 is accessible during the drier months the cutover surface typically remains submerged throughout the year (Figure 3-73).

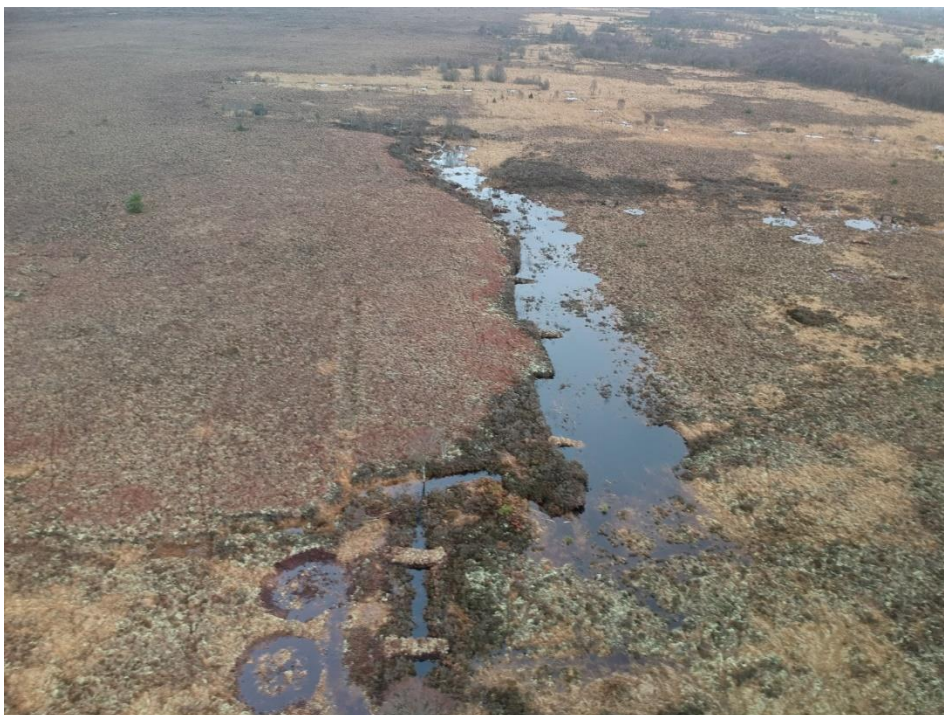
Figure 3-95: Cutover at Garriskil Bog SAC where significant rewetting was observed

On account of regular periodic site visits, RPS survey teams are well placed to contribute anecdotal evidence based on conditions observed in the field. The majority of cutover restoration took place on the Southern and Eastern cutovers, in both areas the ground surface has become significantly wetter following restoration with pools forming close to the main drains and across wider areas of cutover in both areas, with the local topography contributing to the rapid changes in hydrology. A large drain to the Southeast of the site, was a major outflow from the site, with a considerable contributing catchment. After restoration measures were completed, re-wetting could be observed to backup into the site that extended along the main facebank and surrounding drains. (Figure 3-95).

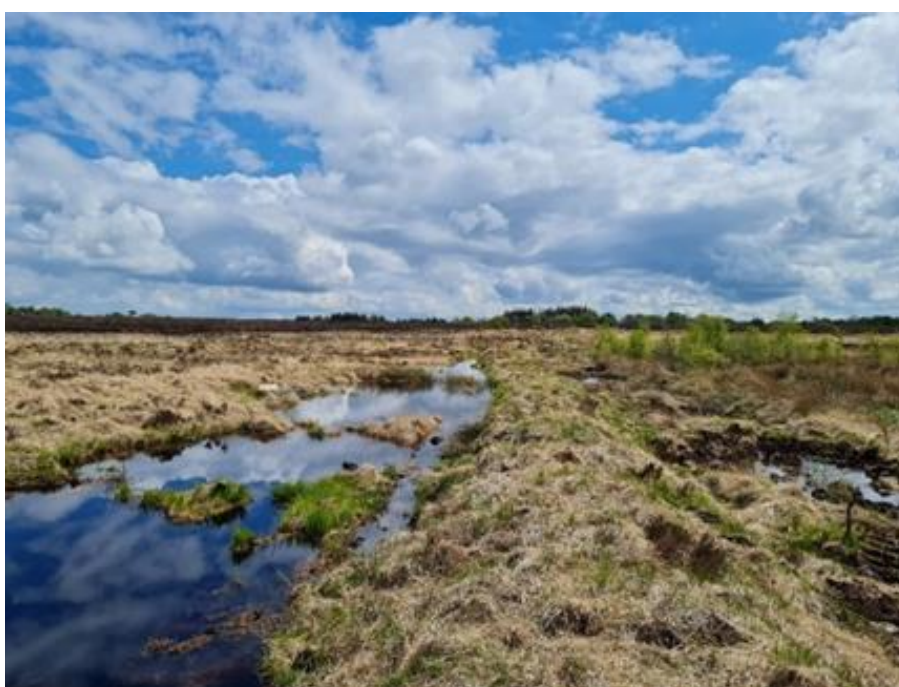
Figure 3-119: Rewetting observed on Killyconny Bog SAC, in cell bunds where the water table came up to the surface throughout the year

Owing to regular site visits, RPS survey teams are well placed to contribute anecdotal evidence based on conditions observed in the field. For instance, on the western cutover, significant re-wetting was evident from a barrier dam installed as part of an earlier restoration project. However, re-wetting was mainly confined to localised topographic low points, with higher areas remaining dry. To increase the effectiveness of measures in the area, cell bunding was trialled in three separate zones. Although no hydrological monitoring equipment was installed in the vicinity of these bunds, significant re-wetting was observed during site walkovers post-construction. Ecological monitoring should be conducted to report on the overall success of the measures as part of the AfterLIFE programme.

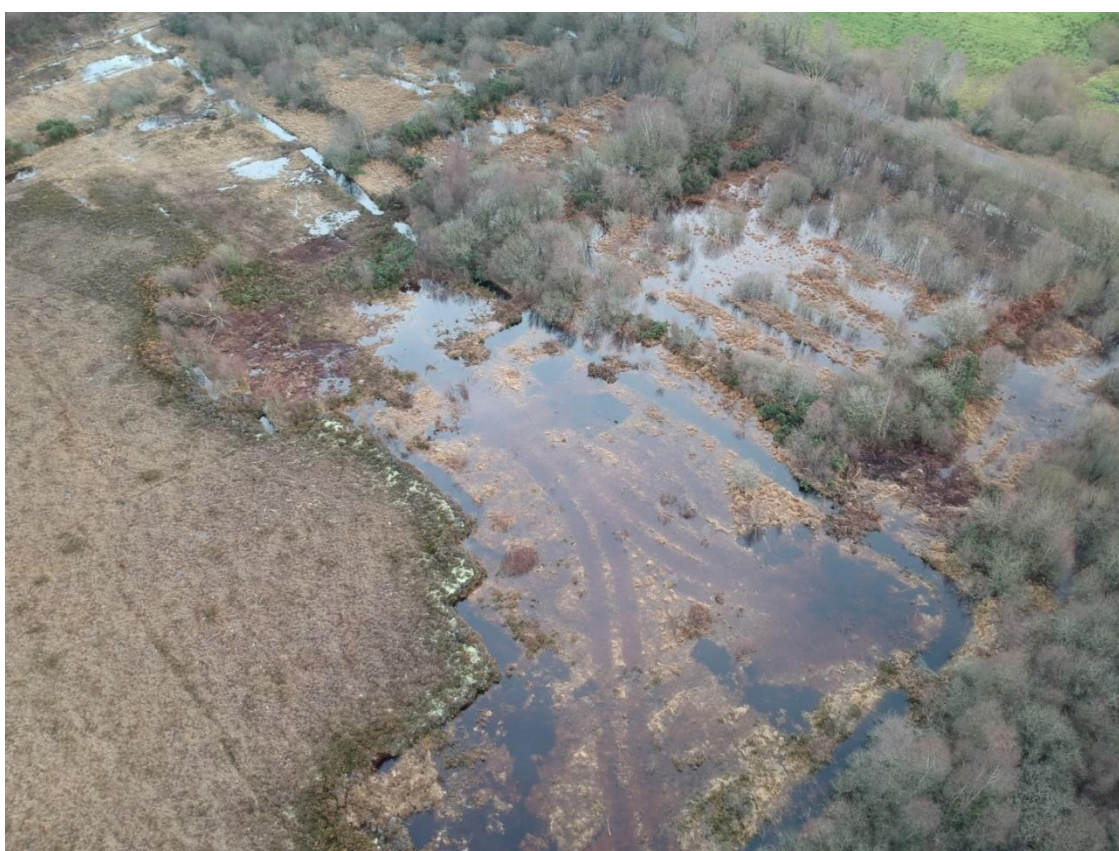
Figure 3-133: Rewetting observed on Mongan Bog SAC, where the water table came up to the surface throughout the year

Owing to regular site visits RPS survey teams are well placed to contribute anecdotal evidence based on conditions observed in the field. For instance, in the Southern cutover in the vicinity of all hydrological monitoring locations, the ground surface has become significantly wetter following restoration with pools forming close to the main drain in both areas with the local topography contributing to the rapid changes in hydrology (Figure 3-133). It was noted that excess water was pooling on this southern cutover, especially during the winter months. A report on this issue has been submitted to The Living Bog team, with ongoing discussion with stakeholders on the best approach to rectify the problem. On the Western cutover, a similar impact was observed over a large area where the water table rose to the surface and remained there year-round.

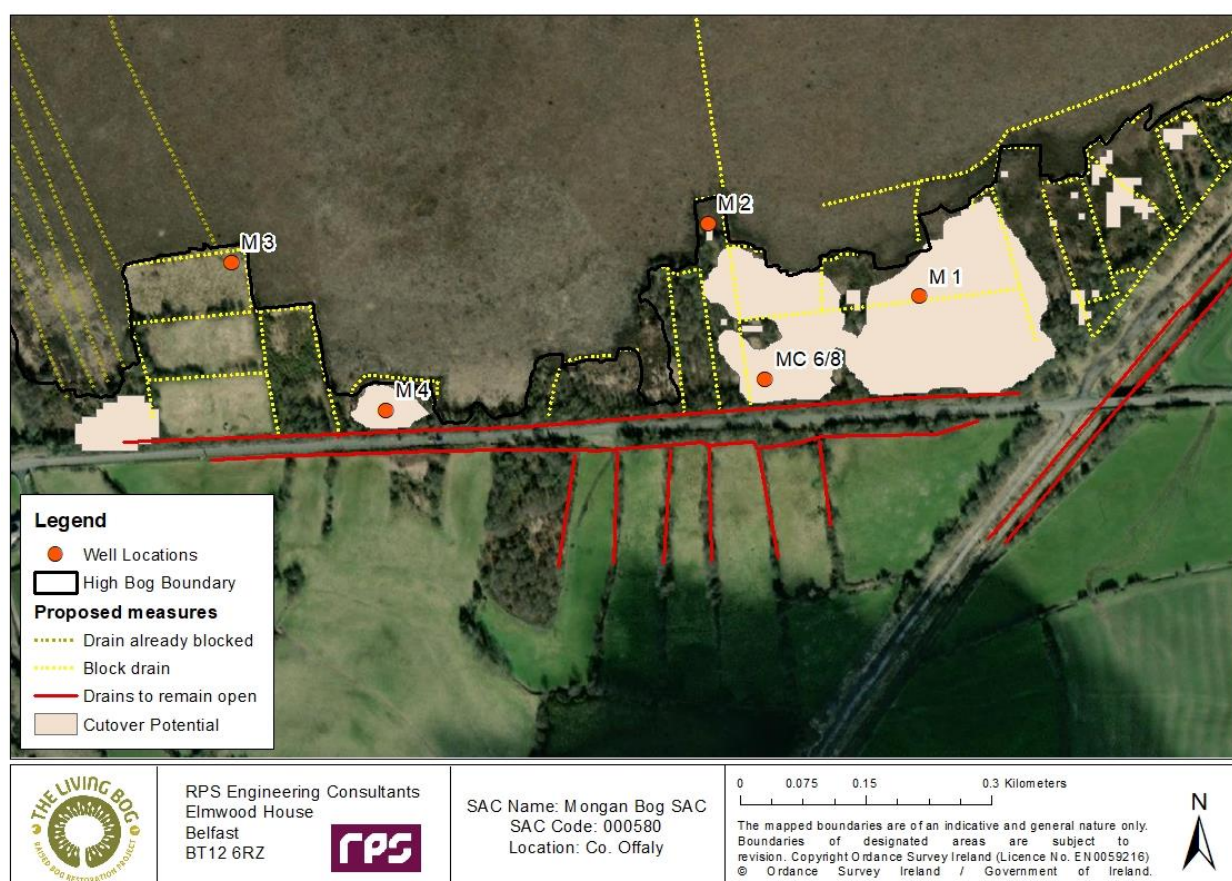
Figure 3-138: Location of wells M1, M2, M3, M4, M6 and M8 on the southern cutover at Mongan Bog SAC.

In a bid to evaluate and quantify the effects of restoration measures, M1, M2, M3, M4, M6 and M8 were placed in regions of high restoration potential in cutover bog (Figure 3-138), south of the high bog.

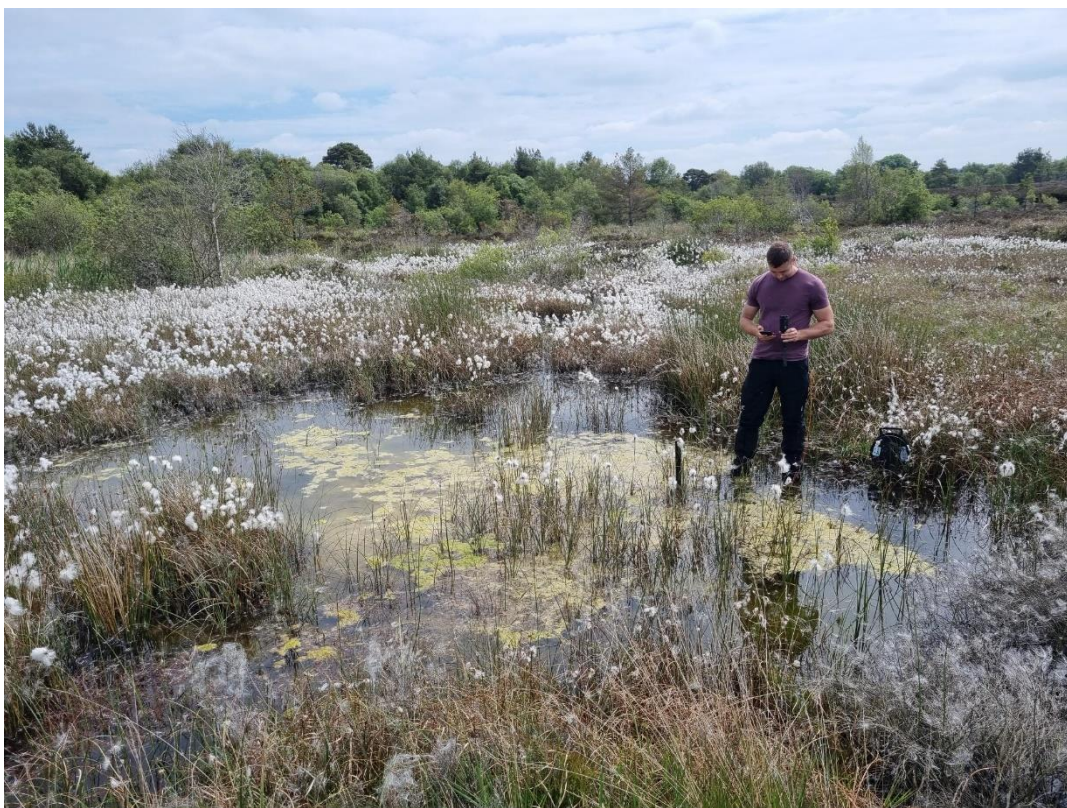
Figure 3-148: Cutover at Moyclare Bog SAC where significant rewetting was observed

Owing to regular site visits RPS survey teams are well placed to contribute anecdotal evidence based on conditions observed in the field. On the Northern cutover, large-scale re-wetting was observed when the drains were blocked, with a shallow pool of shallow water covering a large area throughout the year, even during the drier summer periods (Figure 3-148). This observation led to an amendment to the original restoration plan and the proposed barrier dam proposed on the northern cutover was deemed unnecessary as the natural topography of the area was considered sufficient to maintain water levels at the desired level close to the ground surface. Similar observations were noted on the southern cutover where re-wetting was noted, however, this was more localised and confined to topographic low points.

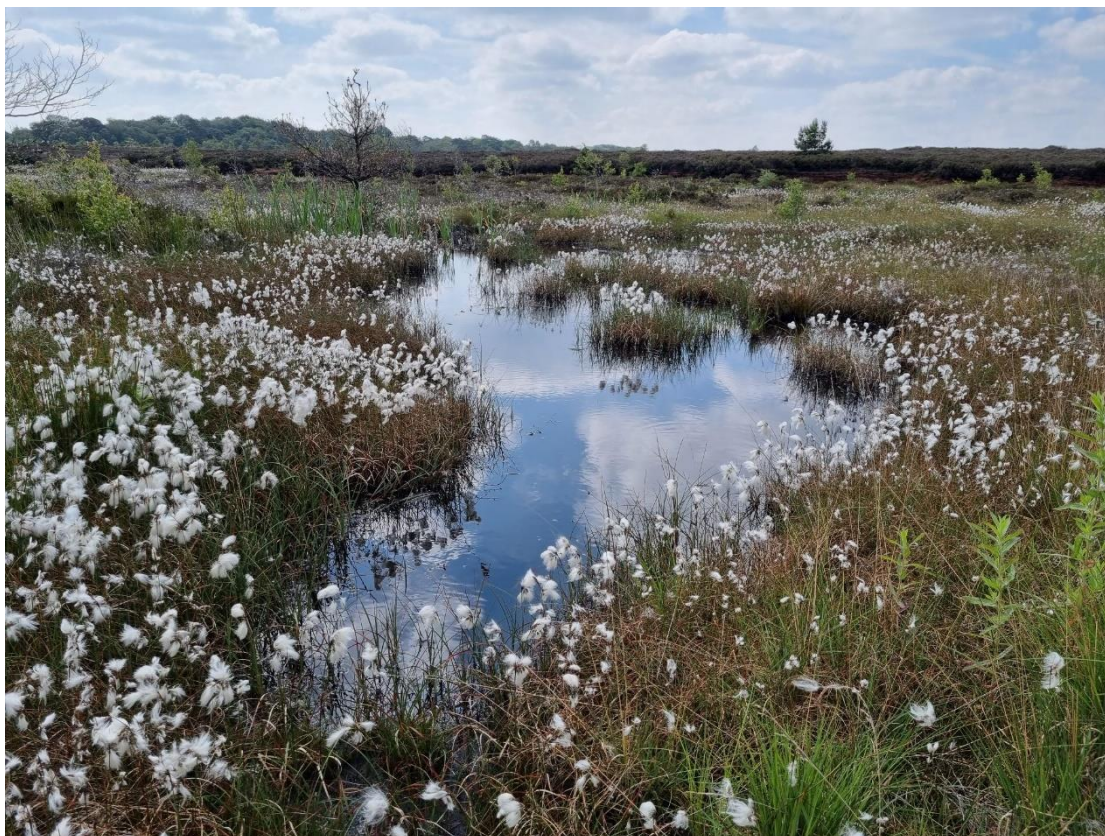
Figure 3-167: Cutover at Raheenmore Bog SAC where significant rewetting was observed

Owing to regular site visits RPS survey teams are well placed to contribute anecdotal evidence based on conditions observed in the field. For instance, in the Southern cutover, limited observations were made in the area surrounding R2 which was generally wet all year round, suggesting the conditions for PFH may already have been in existence. The area surrounding R5 re-wetted significantly (Figure 3-167), post-restoration with localised rewetting observed, which was indicative in general of pockets across the cutover on Raheenmore Bog SAC. A large drain along the Eastern boundary could not be blocked due to landowner issues, this drain is hypothesised to have ongoing impacts on the high bog as documented in the project

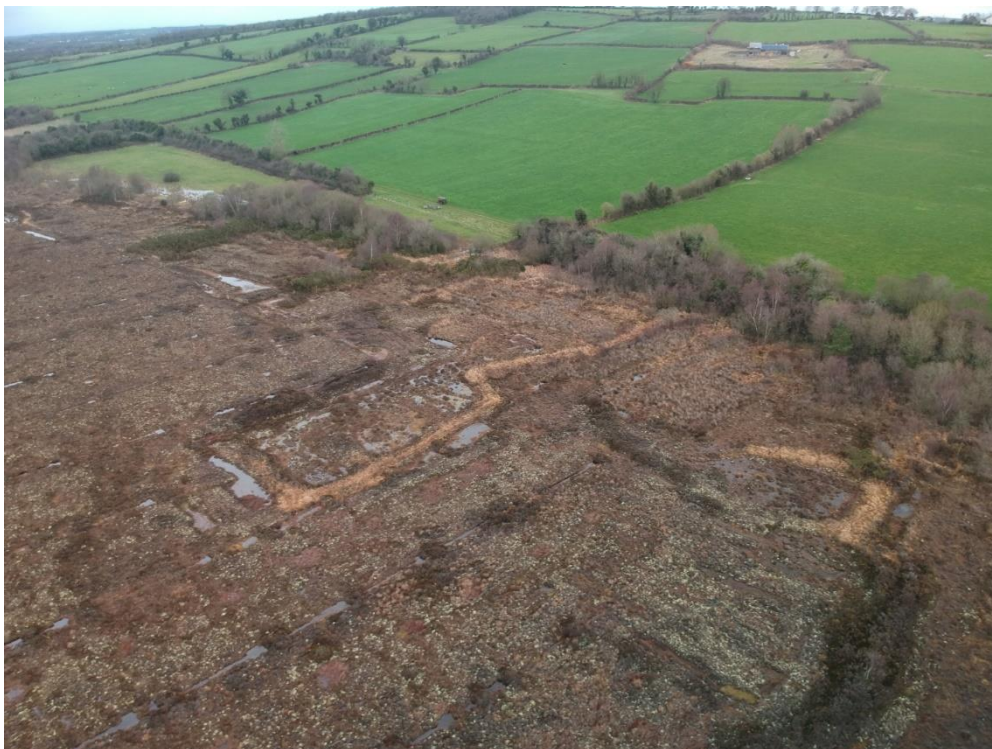
Figure 3-185: Rewetting observed on Sharavogue Bog SAC, where the water table came up to the surface throughout the year

Limited works were proposed for Sharavogue relative to the other sites, with the majority of high bog drains having been blocked as part of an earlier raised bog restoration programme. The eastern cutover is dominated by a well-developed lagg system and one of the aims of the restoration was to not cause further rewetting of this area as it may have a negative impact on the established ecological communities. Partial blockage was completed in the main drain to the North which was largely successful at raising the water level in the deep marginal drain, without having an impact on the adjacent land.
