National Parks & Wildlife Service

Carrowbehy/Caher Bog SAC (Site code 000597)

Raised Bog Restoration Plan (Report)

November 2022

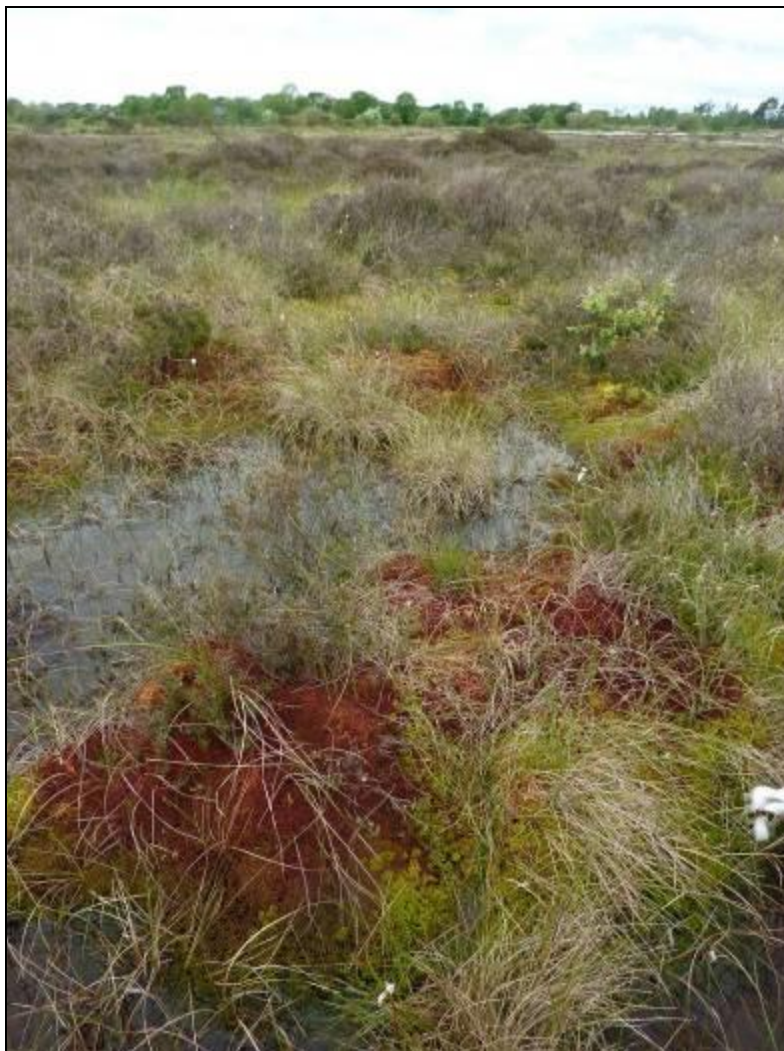
Figure 2.2 Water table at the surface of cutover bog following successful drain blocking resulting in *Sphagnum* development less than 10 years after drain blocking (this was previously an area of bare peat)

Blocking of cutover drains slows the flow of water off the cutover areas and increases the water table in the surrounding peat. This can help to reduce the rate of infiltration through the high bog and can lead to conditions that allow peat to form on the cutover (**Figure 2.2**).

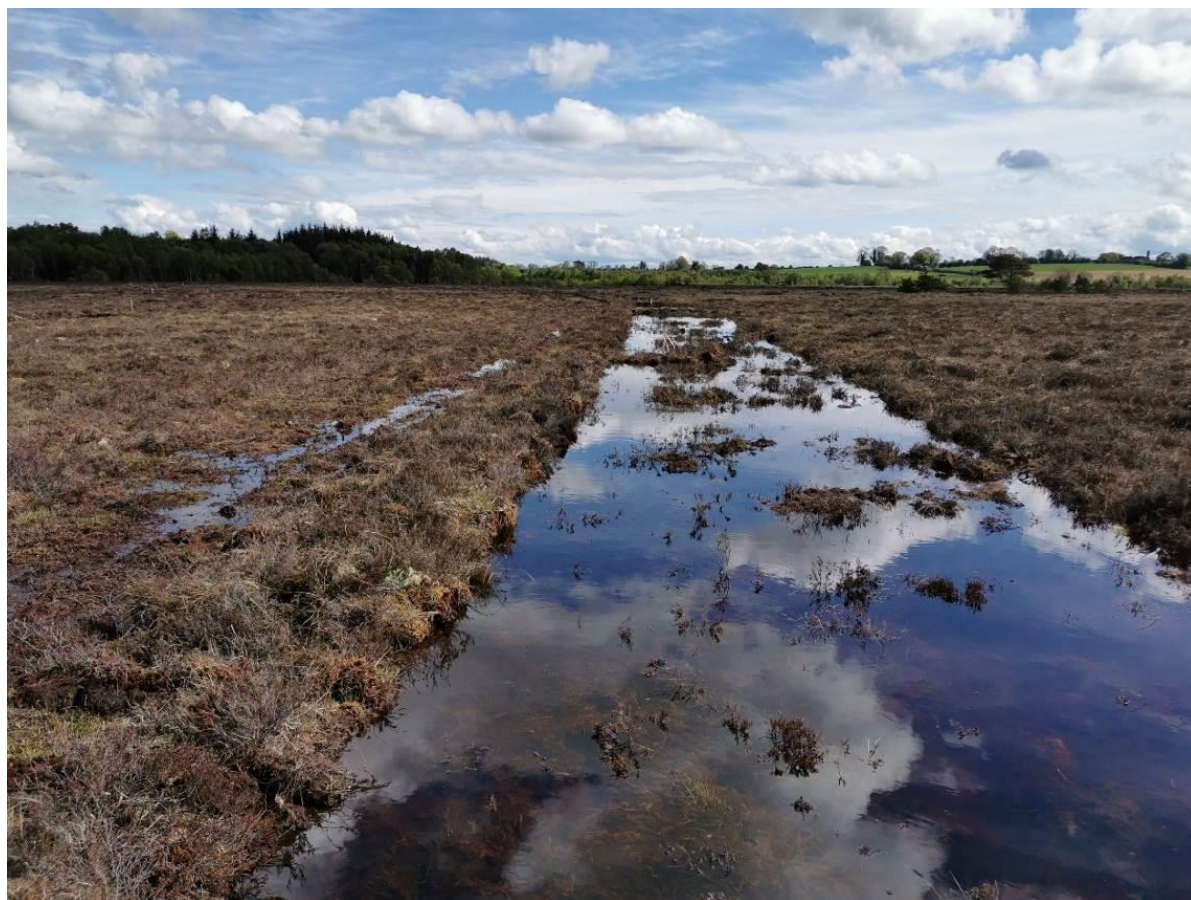
Figure 2.3 Contour bund constructed at Knockacoller Bog SAC, Co. Laois

Contour bunds on the high bog aims to reduce the rate of lateral flow through the upper layers of the peat. In contrast to some other bunding techniques, contour bunding is not intended as a means of impounding surface water. This method involves excavating a trench 1.5-2.0m deep, re-compacting peat into the trench and building a slightly raised bund 25-30cm above the current ground surface. In addition, these bunds have 5m long 'finger bunds' constructed using the same technique at approximately 25m spacing to prevent flow along the bund which may lead to erosion. After 1-2 years it is anticipated that the bund will have subsided close to current ground level and therefore will not appear as a prominent feature on the bog surface.

Contour bunds are most effective where there is cracking or slumping in the upper layers of the peat as the re-compacted trench assists in sealing up these cracks and slows the flow rate through the peat, supporting a higher water table behind the bund. The key issue with this technique is that the extent of the impact extending back into the bog depends on the hydraulic gradient (which is closely correlated to surface slope). As a result, the extent of impact from such bunds is likely to be extremely limited where the surface slope at the margins is steep. This method is best suited to sites with a relatively gentle slope towards the margins or as a means of effectively blocking a dense network of shallow surface drains on the high bog. Ground conditions will play an important factor in whether the bund can be constructed in such circumstances, therefore this method is most effective on drier sites where machines can operate safely and effectively.

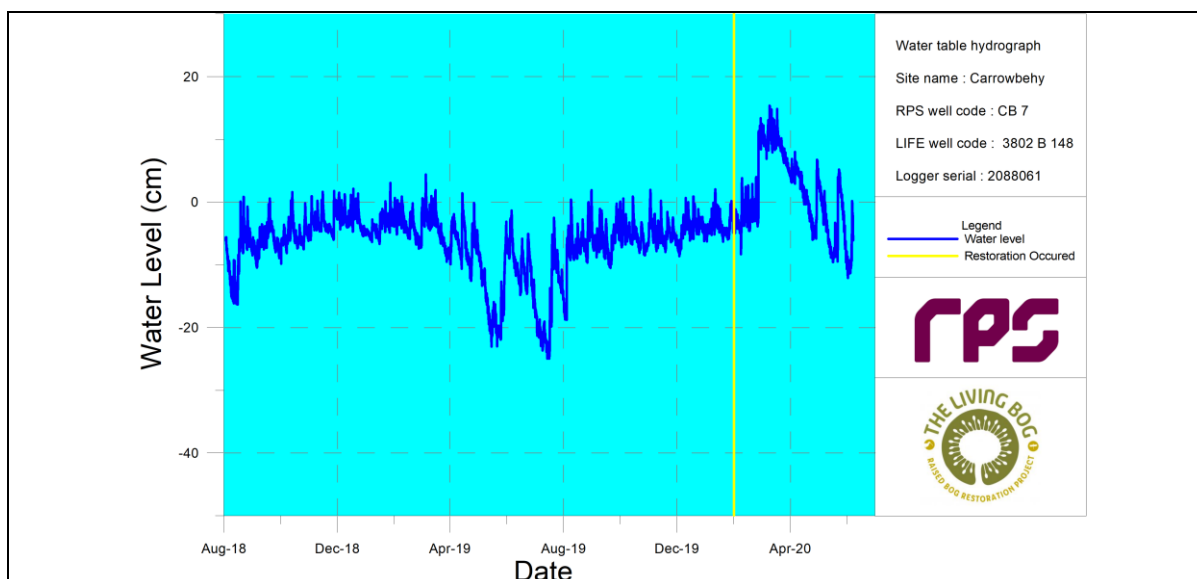
Figure 5.2 Example of hydrograph response at Carrowbehy/Caheer Bog SAC following drain blocking on the high bog

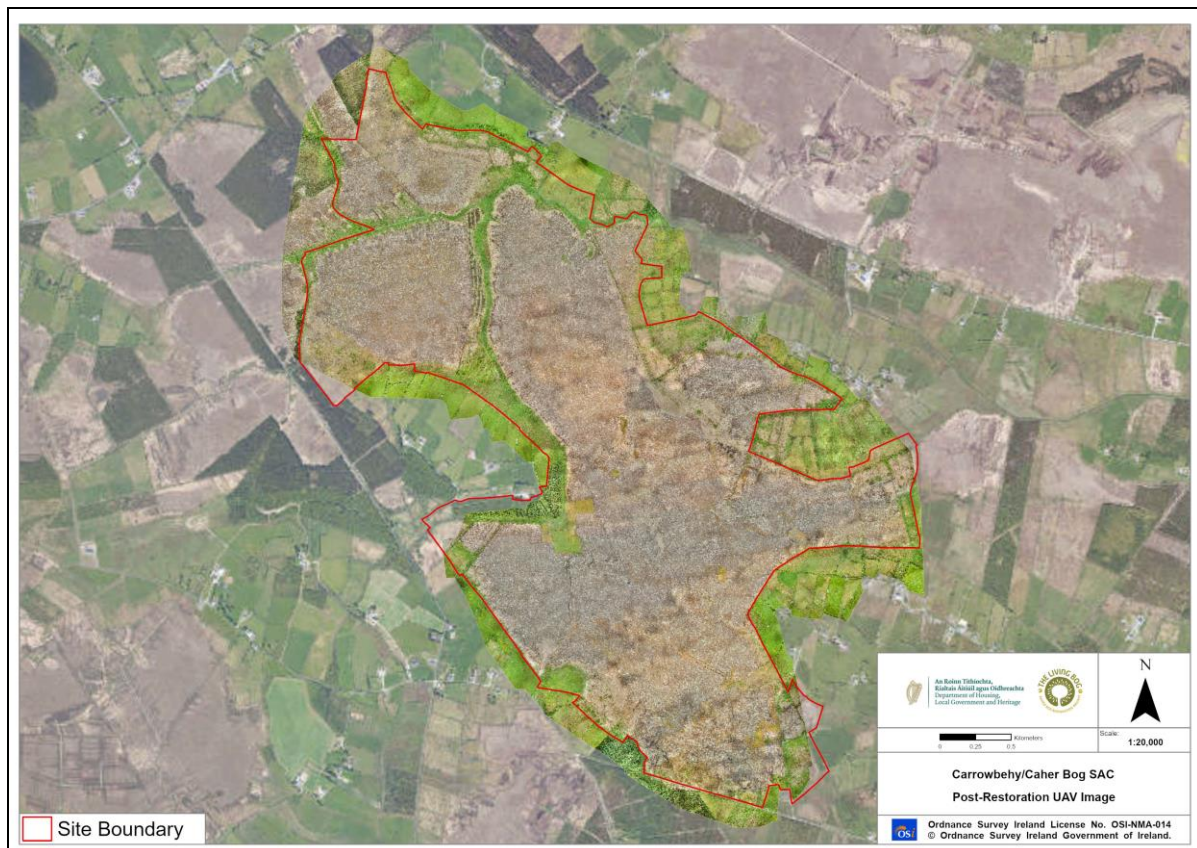
Figure 5.6 High resolution post-works ortho imagery from UAV survey]

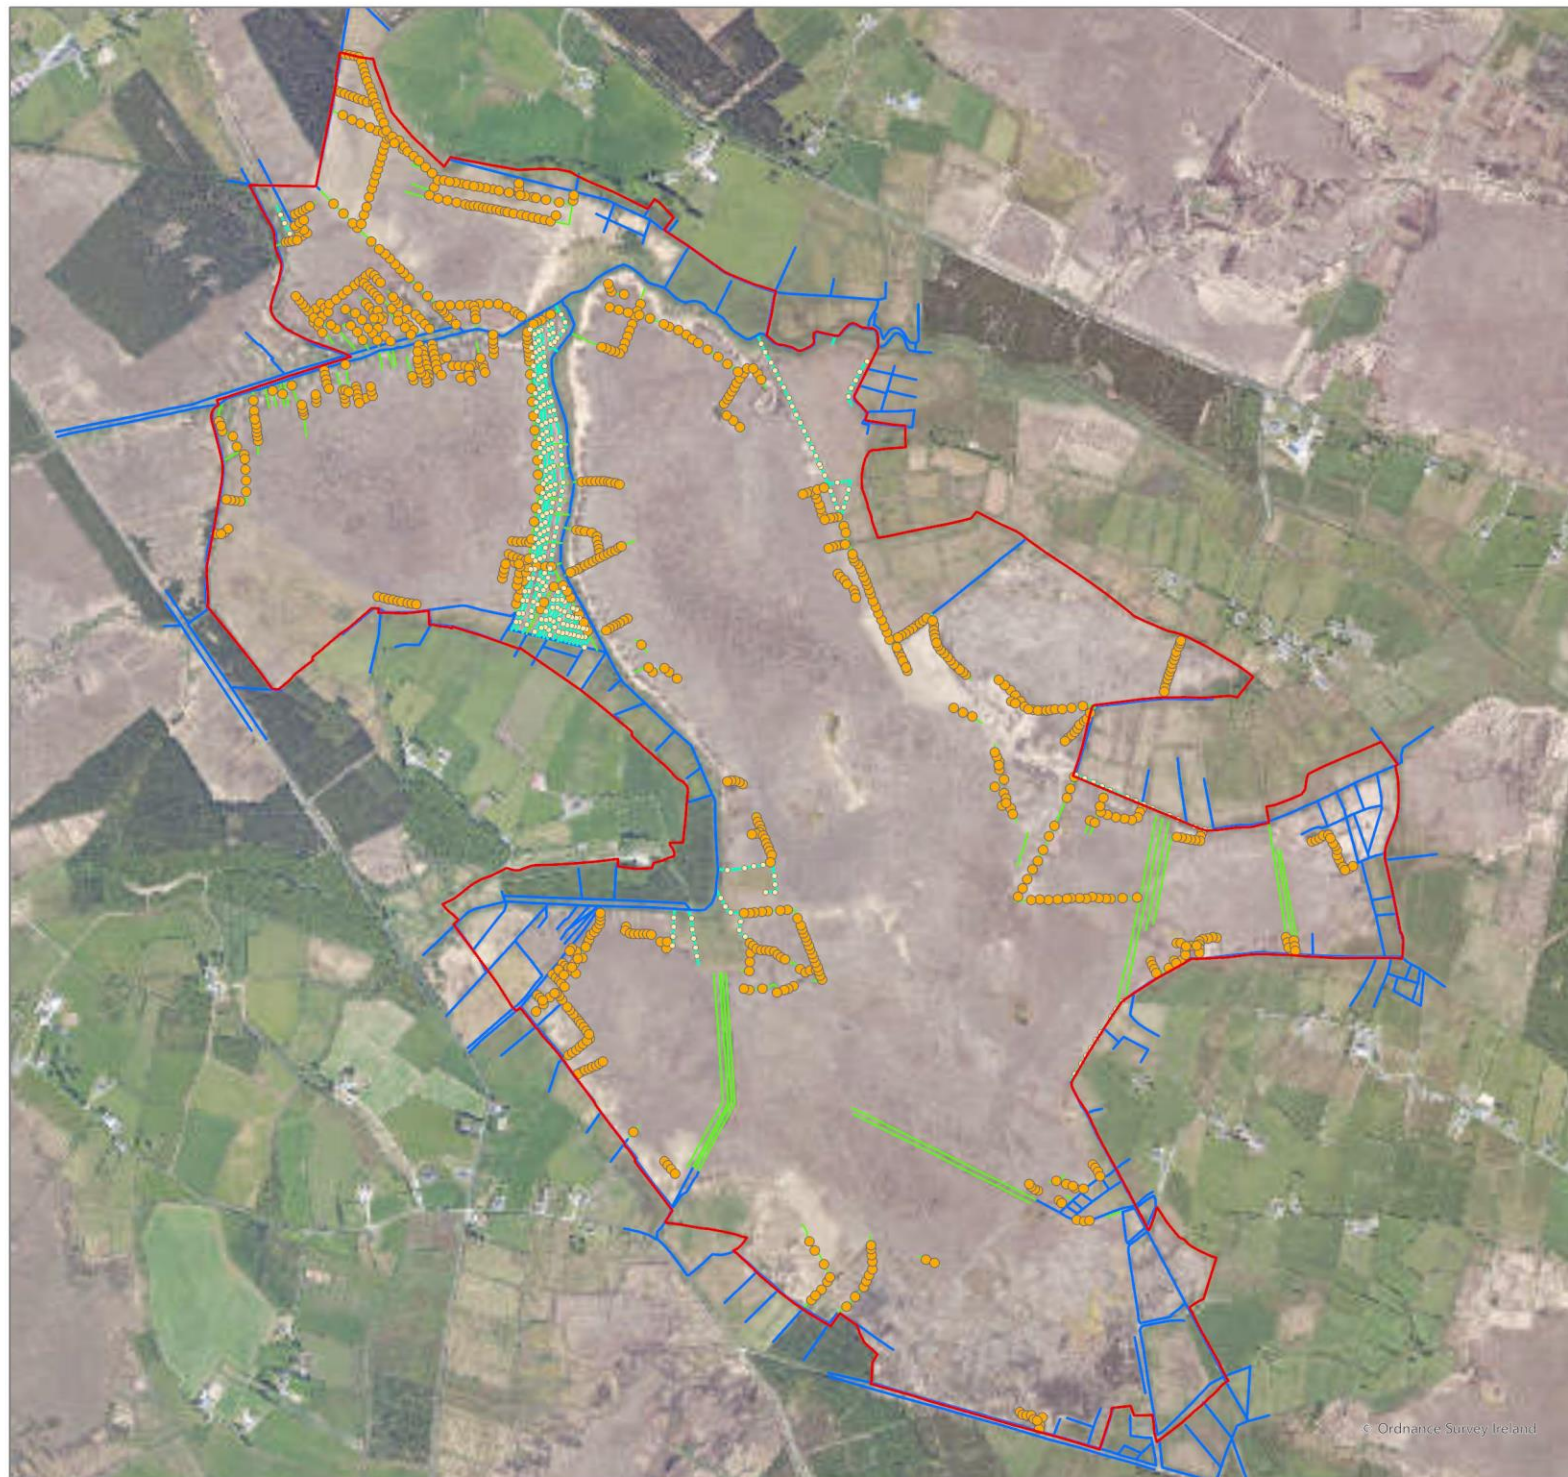
Map 1 outlines the location and extent of Carrowbehy/Caher Bog SAC and Map 2 illustrates the restoration measures that have been implemented to date as well as any proposed/outstanding restoration measures to be implemented at Carrowbehy/Caher Bog.
