National Parks & Wildlife Service

Carrownagappul Bog SAC (Site code 001242)

Raised Bog Restoration Plan (Report)

October 2022

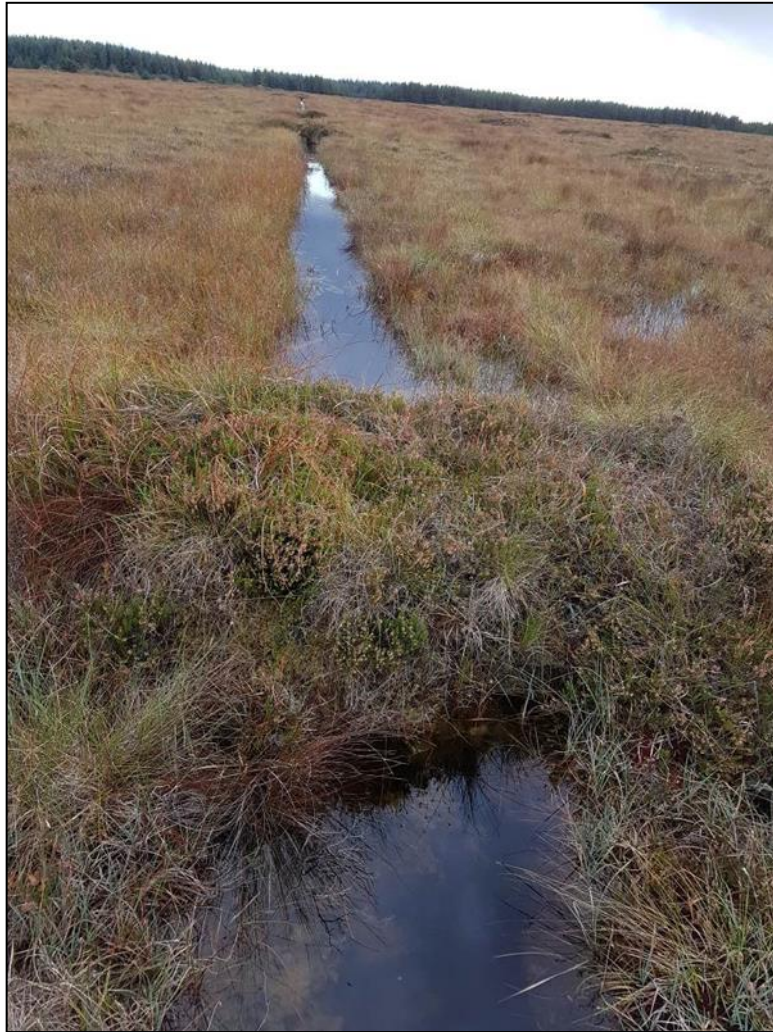
Figure 2.1 Example of a peat dam to block a typical high bog drain

Blocking high bog drains slows the flow of water off the surface of the bog and increases the water table in the peat. Drain blocking is a proven and effective restoration measure on Irish raised bogs with minimal maintenance requirements. The approach has been demonstrated at a number of raised bogs in Ireland with very positive results evident in less than 10 years (**Figure 2.1**) as outlined by Fernandez *et al.* (2014a).

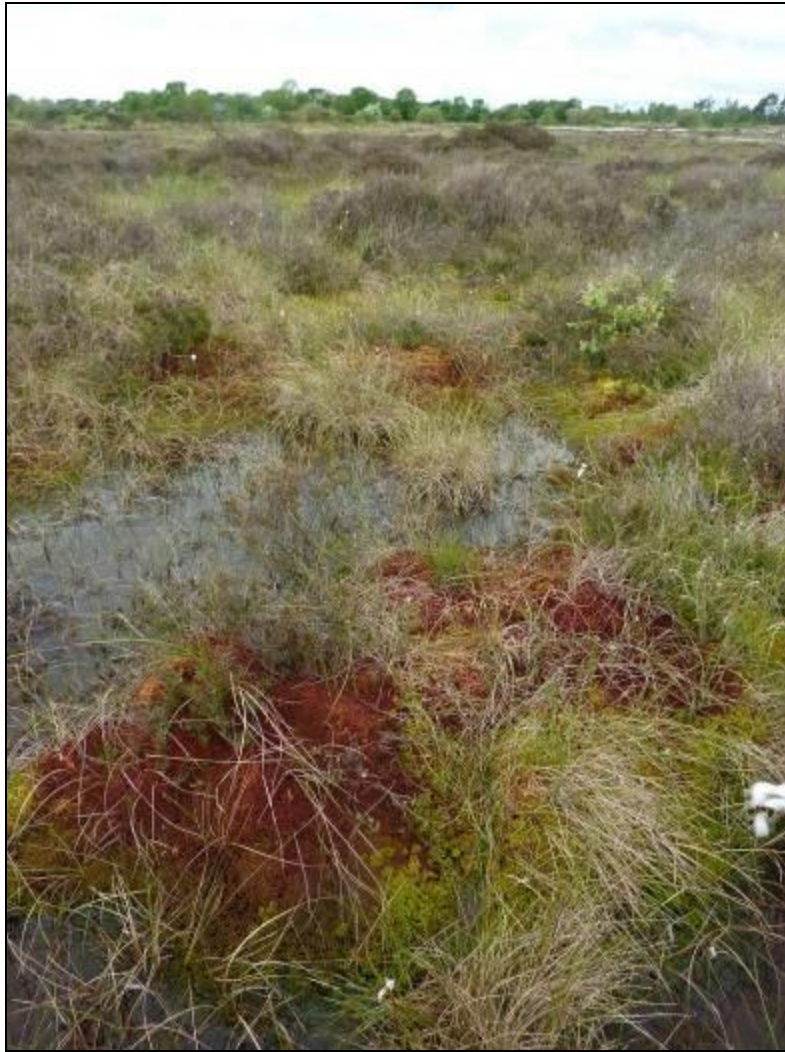
Figure 2.2 Water table at the surface of cutover bog following successful drain blocking resulting in *Sphagnum* development less than 10 years after drain blocking (this was previously an area of bare peat)

Blocking of cutover drains slows the flow of water off the cutover areas and increases the water table in the surrounding peat. This can help to reduce the rate of infiltration through the high bog and can lead to conditions that allow peat to form on the cutover (**Figure 2.2**).

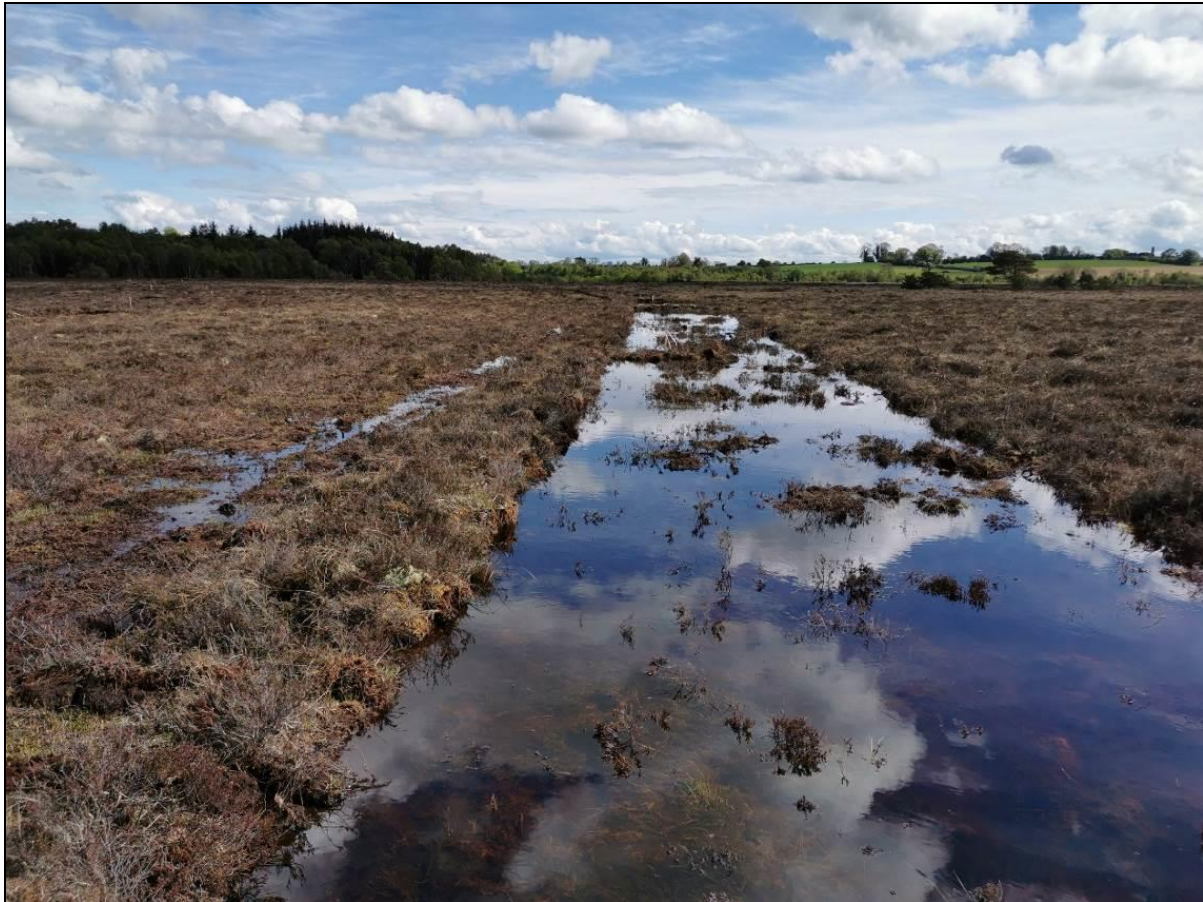
Figure 2.3 Contour bund constructed at Knockacoller Bog SAC, Co Laois

Contour bunds on the high bog aims to reduce the rate of lateral flow through the upper layers of the peat. In contrast to some other bunding techniques, contour bunding is not intended as a means of impounding surface water. This method involves excavating a trench 1.5-2.0m deep, re-compacting peat into the trench and building a slightly raised bund 25-30cm above the current

ground surface. In addition, these bunds have 5m long ‘finger bunds’ constructed using the same technique at approximately 25m spacing to prevent flow along the bund which may lead to erosion. After 1-2 years it is anticipated that the bund will have subsided close to current ground level and therefore will not appear as a prominent feature on the bog surface.

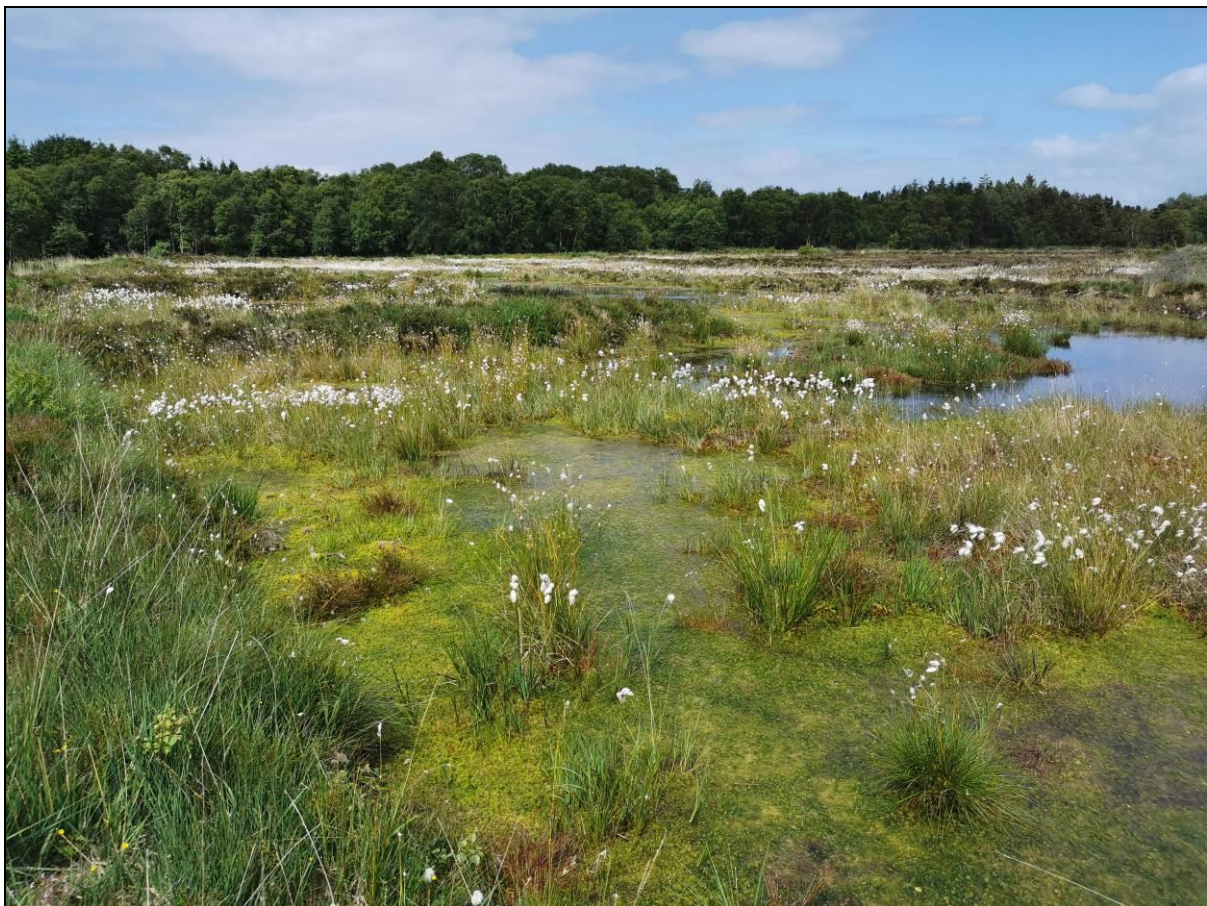
Figure 2.4 Example of existing cell bund constructed at Cloncrow Bog NHA (The vegetation in this photo has developed in the 2 years since cell construction)

Cell bunds are typically constructed by excavating a trench 1.0-1.5m deep, recompacting the excavated peat into the trench and constructing a bund 0.5-0.6m high above the ground surface (Figure 2.3). Water level control structures (pipes or overflow weirs) are incorporated into these cells as a means to regulate water levels and evenly distribute water across the site.

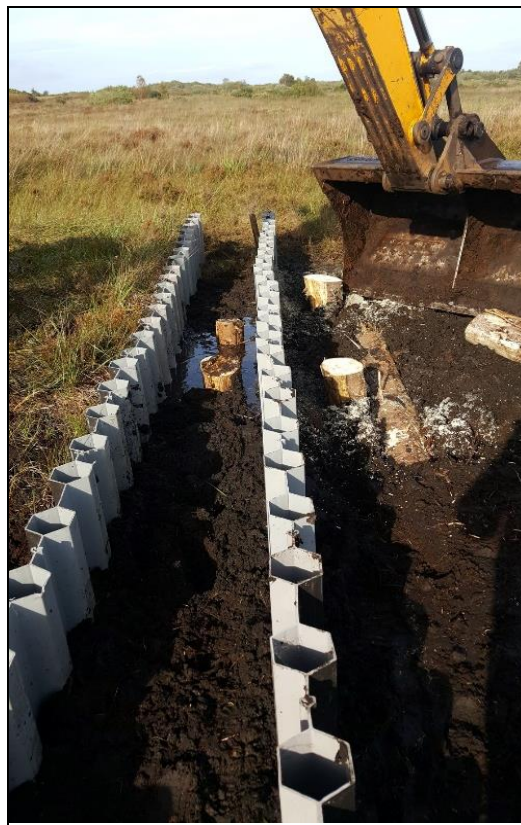
Figure 5.4 Example of large sandwich dam trialled on Carrownagappul

All of the proposed as part of the Living Bog Project were completed as required at Carrowngappul Bog SAC. This includes construction of 2,820 dams, which were primarily constructed from peat but also included some plastic dams. In addition, a number of trial measures were completed at Carrownagappul including the construction of large sandwich dams constructed of a peat core and large reinforced plastic dams. Cell bunding and bunding across areas cut with a Liliput machine was completed on some areas of cutover bog. There was also a trial of enhanced forest to bog restoration measures which involved felling of conifers on high bog, stump flipping and ground smoothing. A techniques manual which details each of these methods including the methods developed through the Living Bog Project was produced as part of the project (Cushnan et al., 2022).

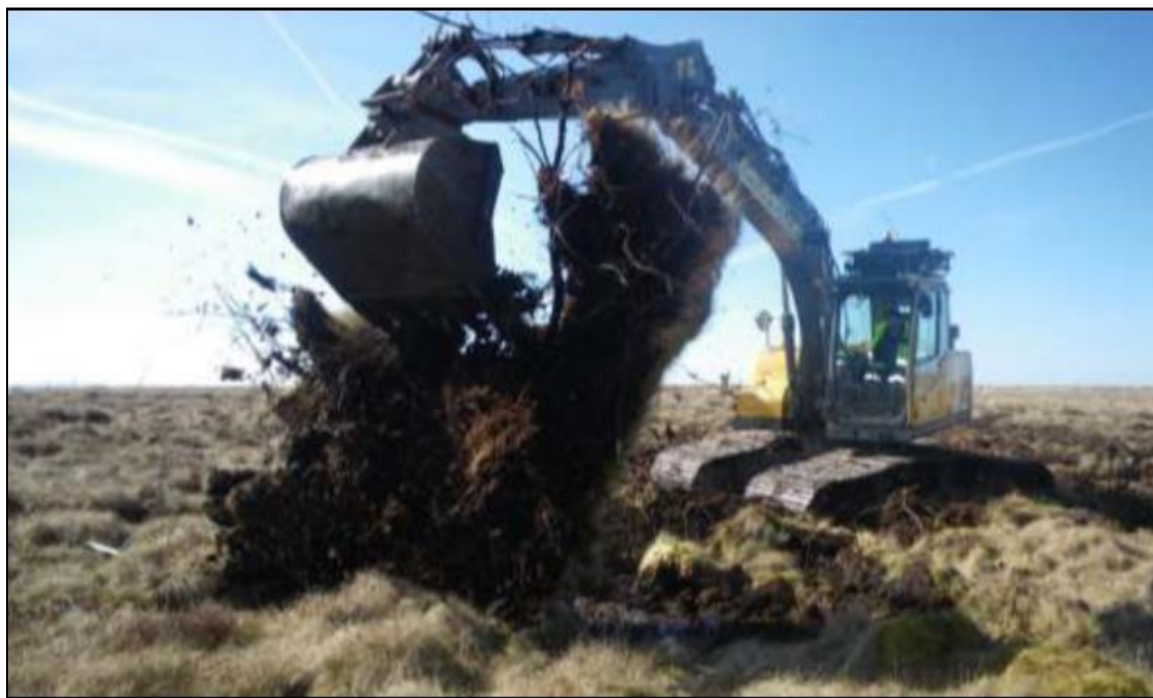
Figure 5.5 Example of stump flipping
