National Parks & Wildlife Service

# Drumalough Bog SAC (Site code 002338)

## **Raised Bog Restoration (Report)**

October 2022

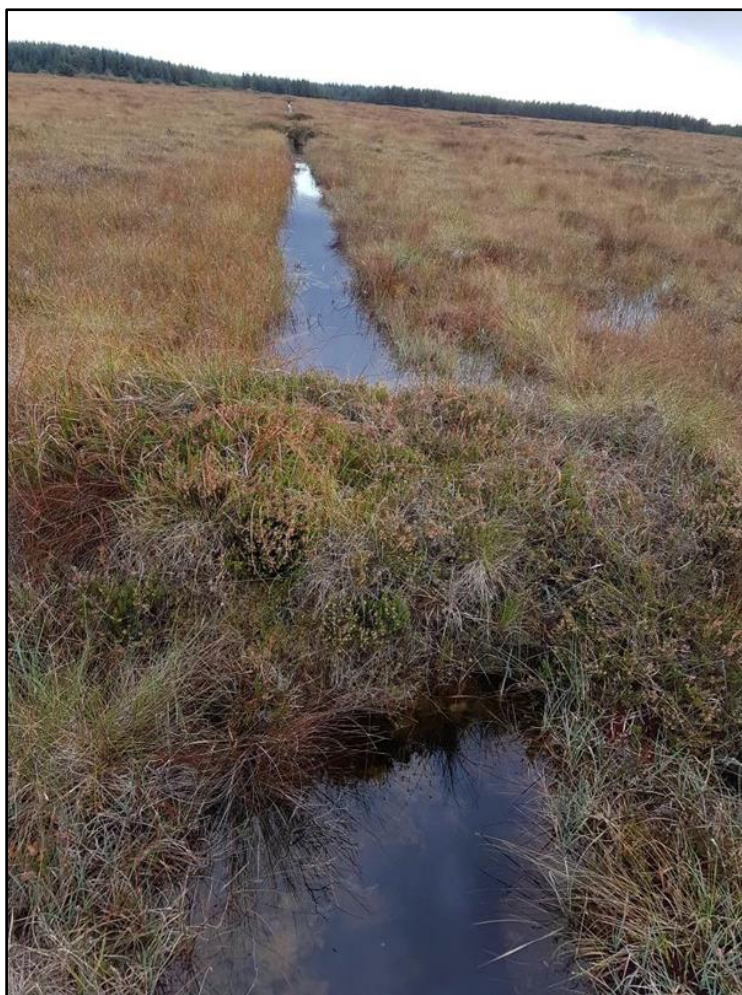
**Figure 2.1** Example of a peat dam used to block a typical high bog drain.

Blocking high bog drains slows the flow of water off the surface of the bog and increases the water table in the peat. Drain blocking is a proven and effective restoration measure on Irish raised bogs with minimal maintenance requirements. The approach has been demonstrated at a number of raised bogs in Ireland with very positive results evident in less than 10 years (**Figure 2.1**) as outlined by Fernandez *et al.* (2014a).

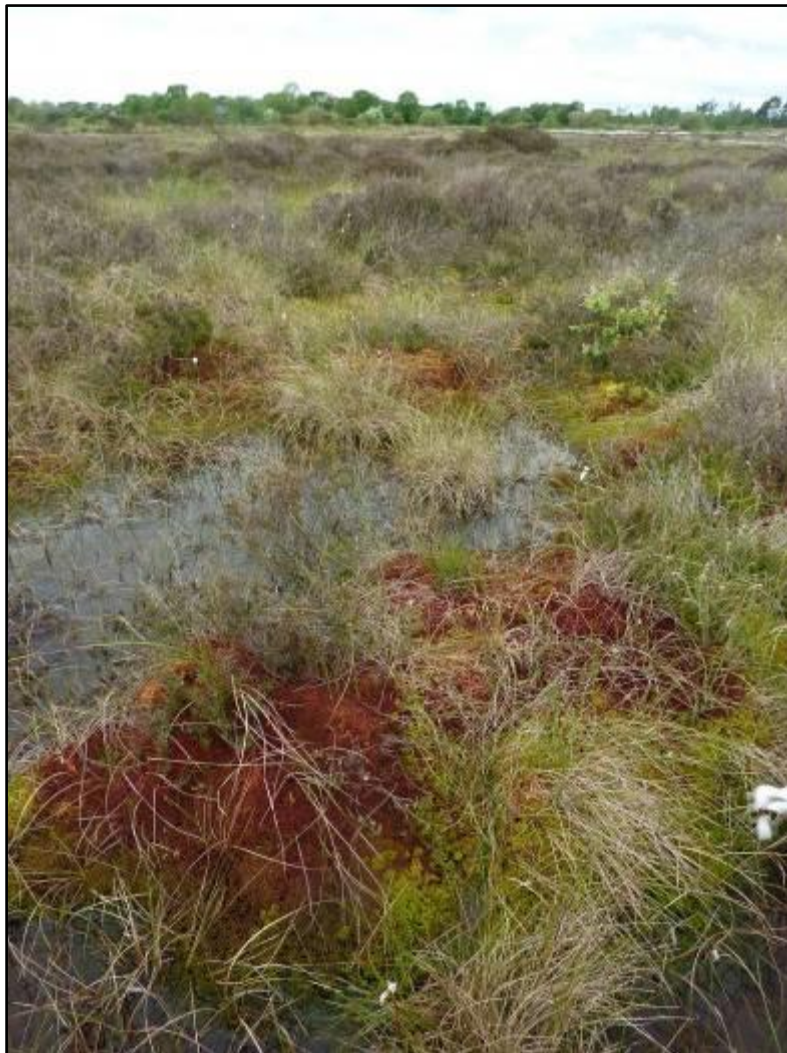
**Figure 2.2** Water table at the surface of cutover bog following successful drain blocking resulting in *Sphagnum* development less than 10 years after drain blocking (this was previously an area of bare peat)

Blocking of cutover drains slows the flow of water off the cutover areas and increases the water table in the surrounding peat. This can help to reduce the rate of infiltration through the high bog and can lead to conditions that allow peat to form on the cutover (**Figure 2.2**).

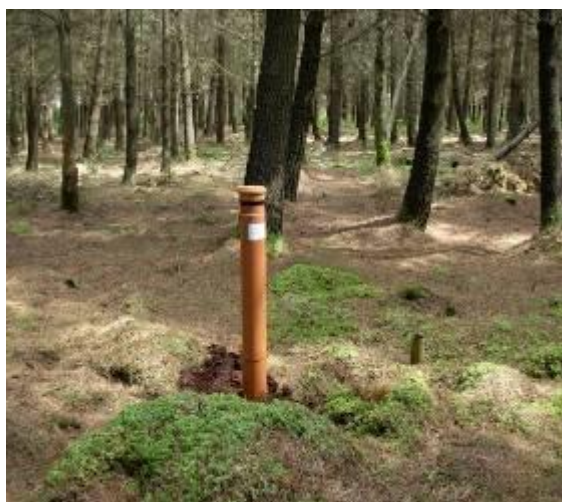
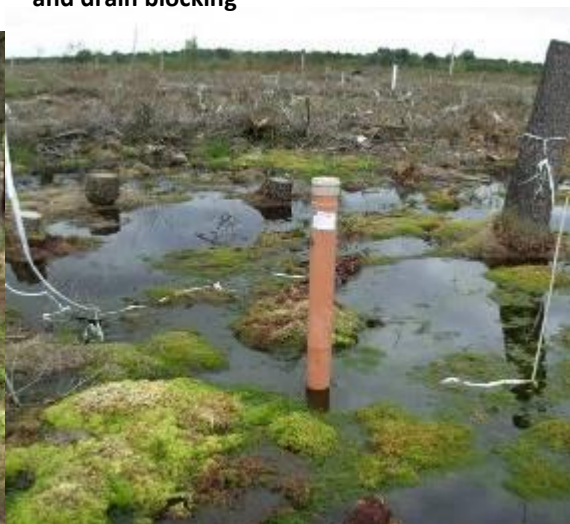
**a) Bog surface prior to forestry removal and drain blocking**

**b) Bog surface after forestry removal and drain blocking**

**Figure 2.3 Example of the impact of felling forestry on a raised bog to restore more natural hydrological conditions**

Felling of forestry as well as removal of trees growing sporadically is a proven restoration measure and has been used by Coillte at numerous raised bogs both on high bog and cutover, particularly as part of a number of LIFE funded restoration projects (**Figure 2.3**).

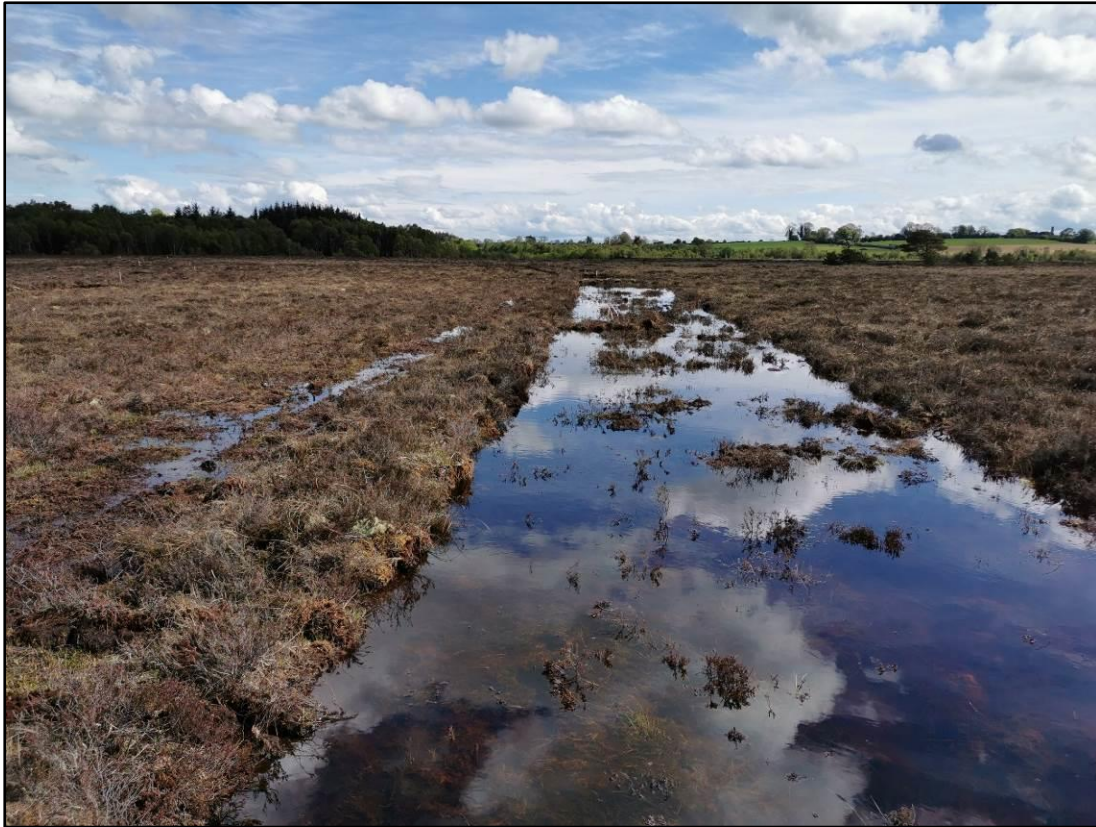
**Figure 2.4 Example of contour bund constructed at Knockacoller Bog SAC, Co. Laois**

Contour bunds on the high bog aims to reduce the rate of lateral flow through the upper layers of the peat. In contrast to some other bunding techniques, contour bunding is not intended as a means of impounding surface water. This method involves excavating a trench 1.5-2.0m deep, re-compacting peat into the trench and building a slightly raised bund 25-30cm above the current ground surface. In addition, these bunds have 5m long 'finger bunds' constructed using the same technique at approximately 25m spacing to prevent flow along the bund which may lead to erosion. After 1-2 years it is anticipated that the bund will have subsided close to current ground level and therefore will not appear as a prominent feature on the bog surface.

Contour bunds are most effective where there is cracking or slumping in the upper layers of the peat as the re-compacted trench assists in sealing up these cracks and slows the flow rate through the peat, supporting a higher water table behind the bund. The key issue with this technique is that the extent of the impact extending back into the bog depends on the hydraulic gradient (which is closely correlated to surface slope). As a result, the extent of impact from such bunds is likely to be extremely limited where the surface slope at the margins is steep. This method is best suited to sites with a relatively gentle slope towards the margins or as a means of effectively blocking a dense network of shallow surface drains on the high bog. Ground conditions will play an important factor in whether the bund can be constructed in such circumstances, therefore this method is most effective on drier sites where machines can operate safely and effectively.

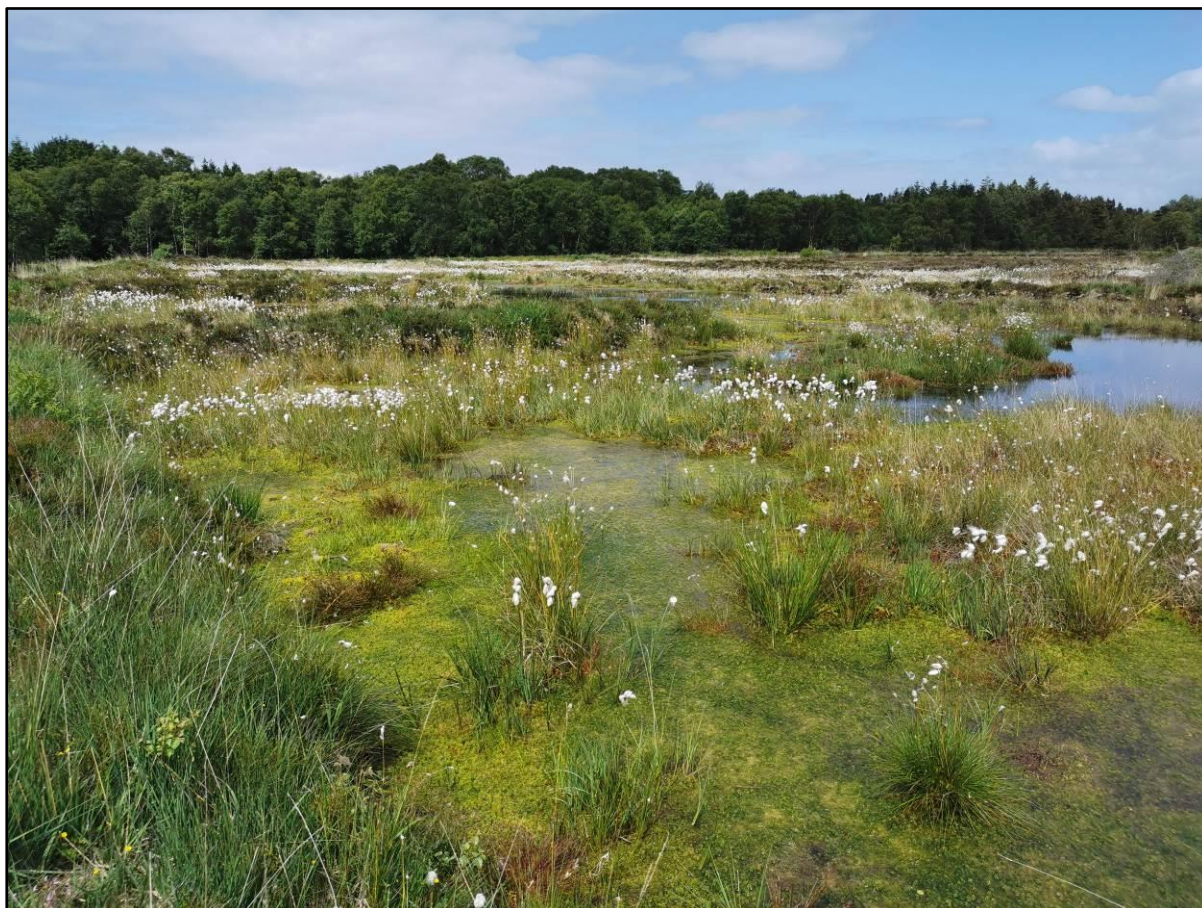
**Figure 2.5 Example of existing cell bund constructed at Cloncrow Bog NHA (the vegetation in this photo has developed in the 2 years since cell construction)**

Cell bunds are typically constructed by excavating a trench 1.0-1.5m deep, recompacting the excavated peat into the trench and constructing a bund 0.5-0.6m high above the ground surface (Figure 2.3). Water level control structures (pipes or overflow weirs) are incorporated into these cells as a means to regulate water levels and evenly distribute water across the site.

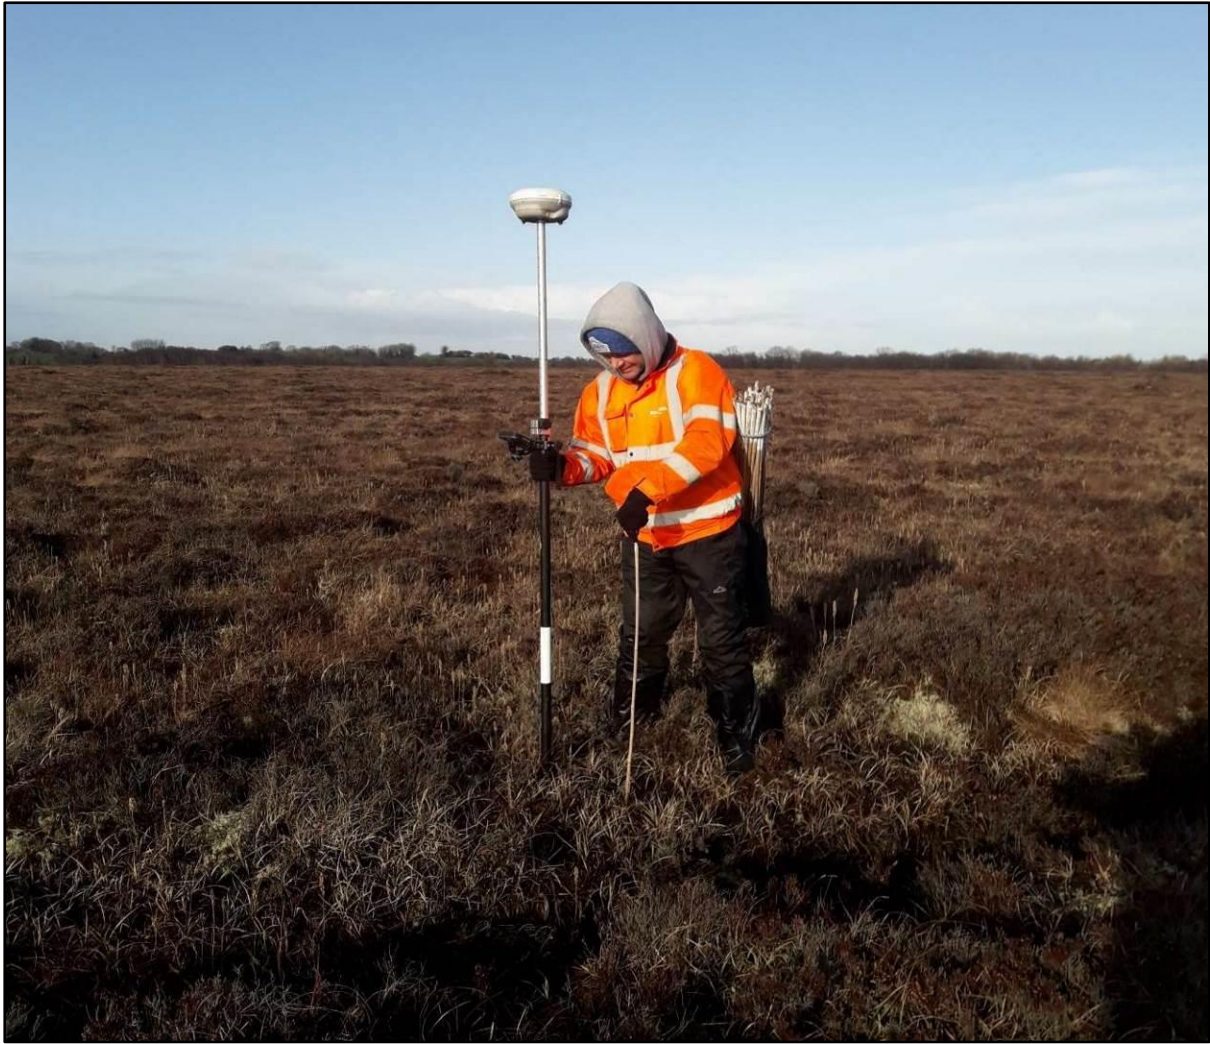
**Figure 5.1 Example of setting out dams on an area of high bog**

The surveying and staking out of drains and dams can be difficult due to the nature of the bog environment. Vegetation and soft ground conditions can make identification of some features and surveying difficult and potentially dangerous. The setting out of the Works is generally done using bamboo stakes to mark the locations of the restoration measures that are to be constructed such as the dams or bunds. All Works proposed during phase 1 of the restoration plan were set out as required. This activity provides an additional opportunity to review the restoration measures in detail on the ground and where necessary minor modifications can be made (e.g., adjusting the placement of particular dams due to dense vegetation coverage or alignment of bunds due to ground conditions). This ensure that the risk of damage to the raised bog is minimized as inadequate planning can increase the risk of machines entering unsuitable areas.

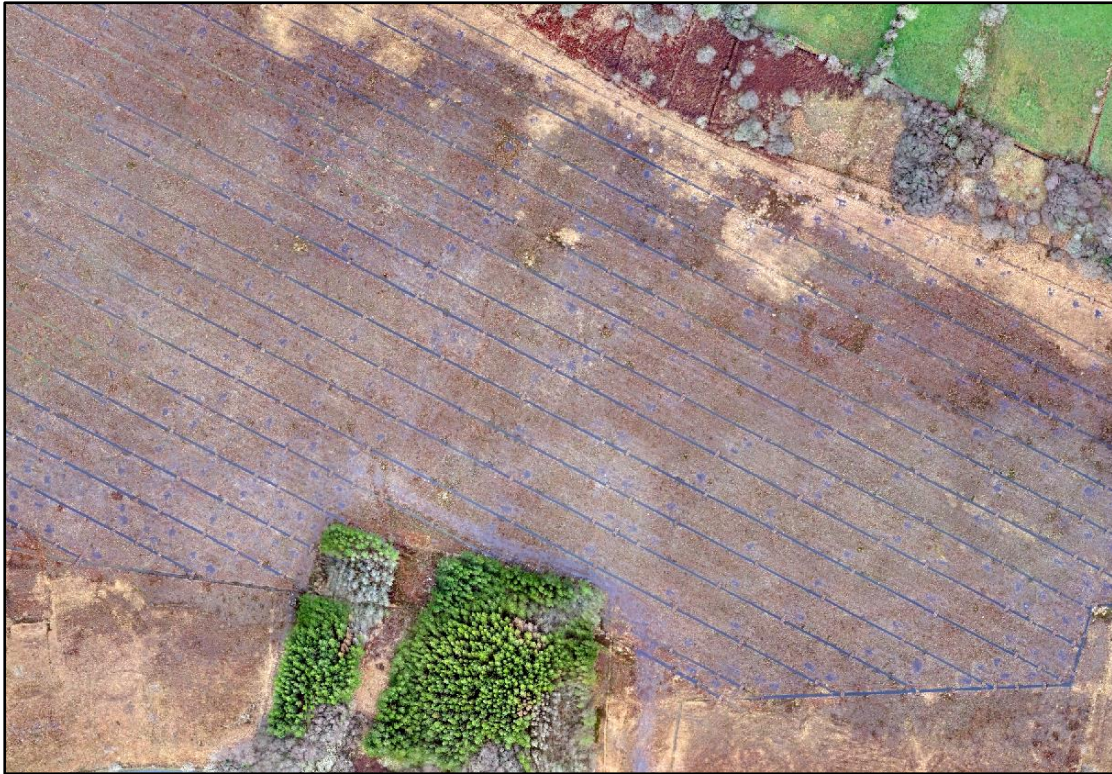
**Figure 5.3 Example of high-resolution ortho-imagery illustrating dams at Drumalough Bog**

Post-Works inspections have been completed and an as-built drawing prepared (summarised in Figure 5.2). This has included detailed aerial surveys of the bog to collect high-resolution ortho-imagery to ensure a detailed as-built drawing could be prepared.

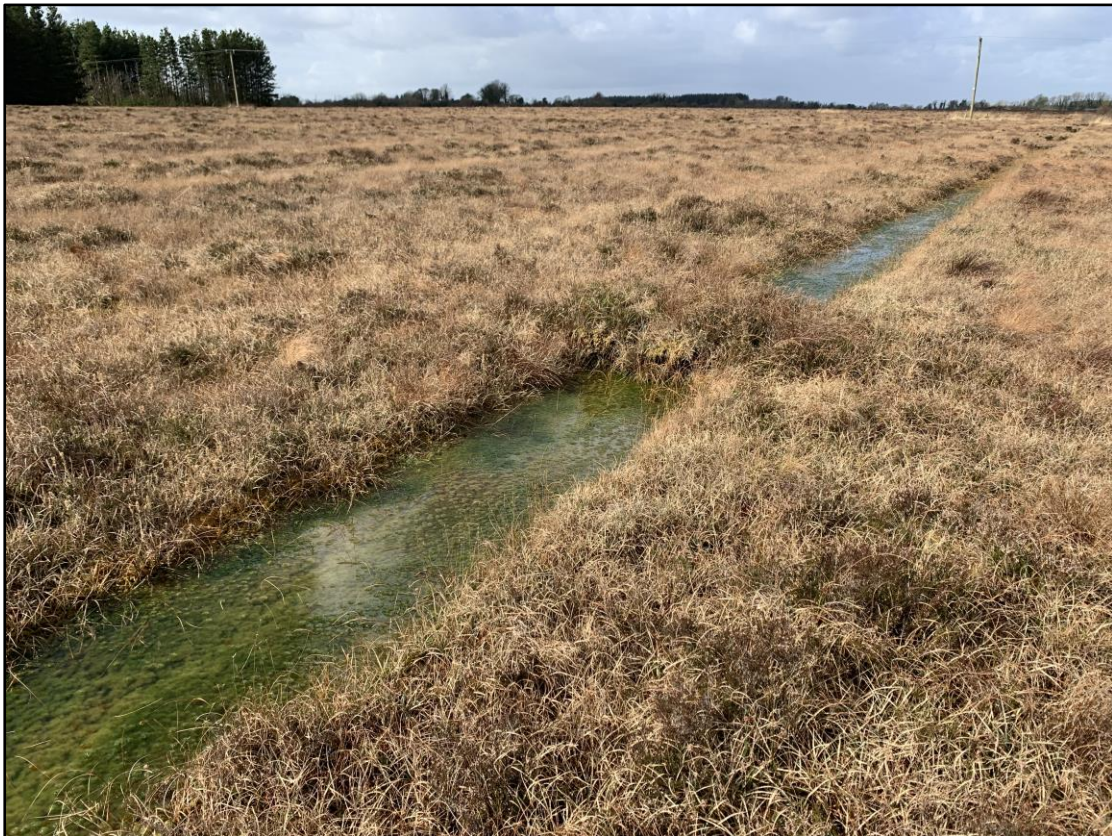
**Figure 5.4 Example of peat dam at Drumalough Bog**

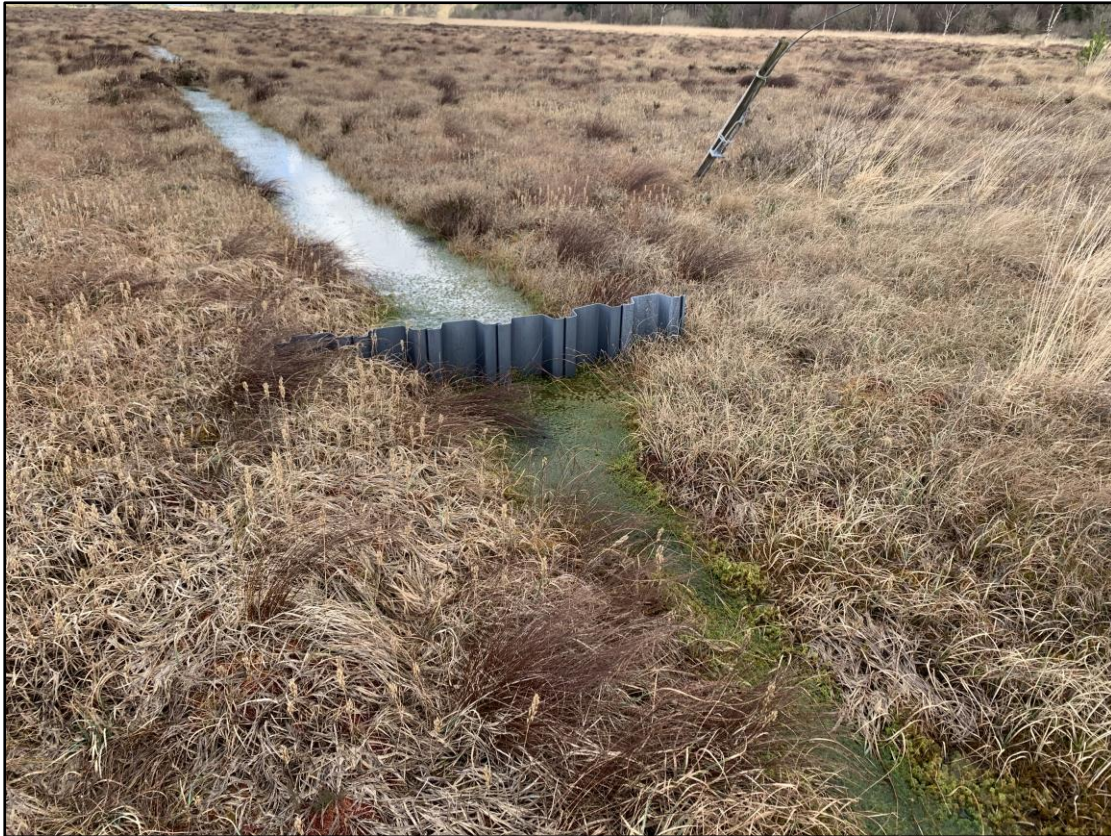
**Figure 5.5 Example of plastic dam at Drumalough Bog**
