# Garriskil Bog SAC (Site code 000679)

## **Raised Bog Restoration Plan (Report)**

Version 2

October 2022

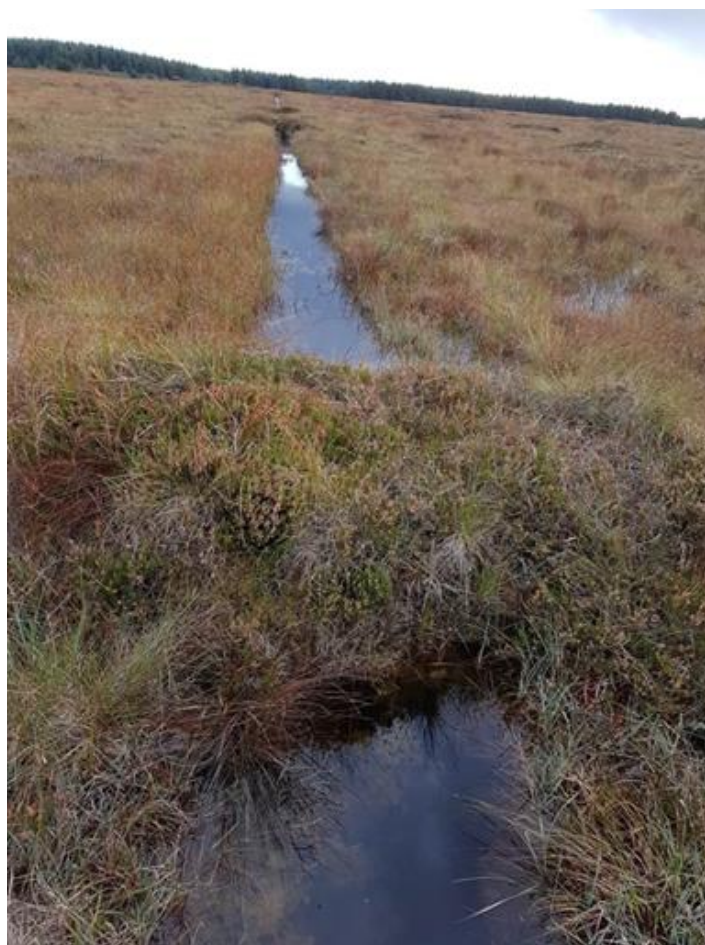
**Figure 2.1 Example of a peat dam used to block a typical high bog drain**

Blocking high bog drains slows the flow of water off the surface of the bog and increases the water table in the peat. Drain blocking is a proven and effective restoration measure on Irish raised bogs with minimal maintenance requirements. The approach has been demonstrated at a number of raised bogs in Ireland with very positive results evident in less than 10 years (**Figure 2.1**) as outlined by Fernandez *et al.* (2014a).

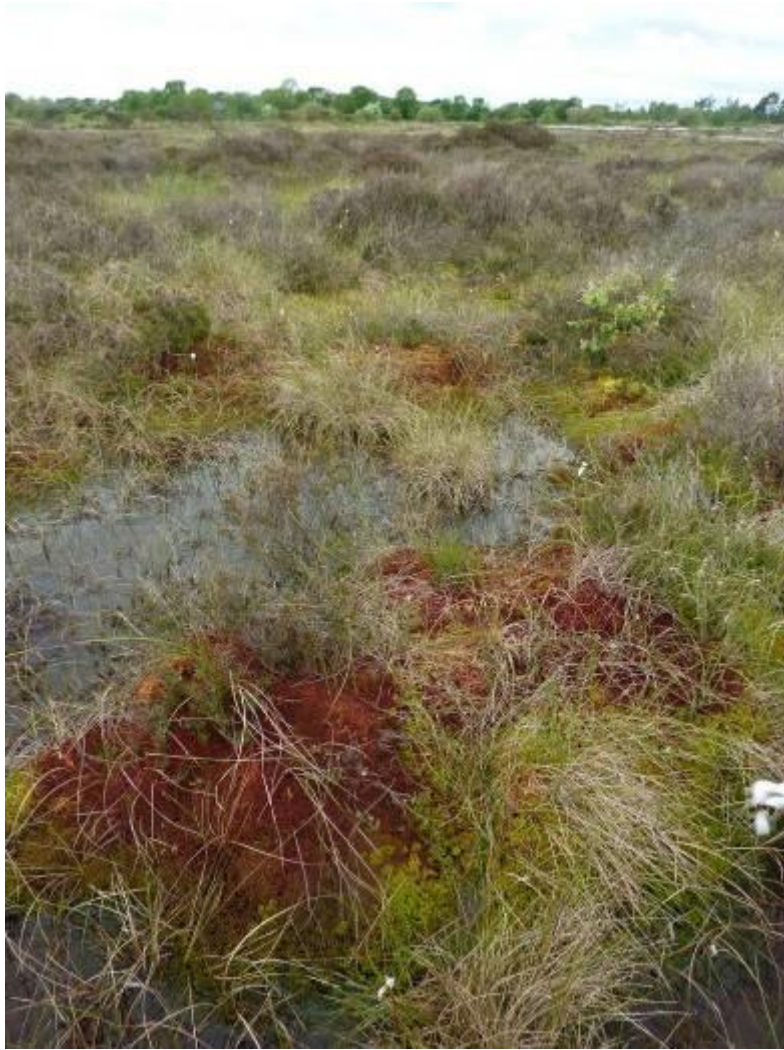
**Figure 2.2** Water table at the surface of cutover bog following successful drain blocking resulting in *Sphagnum* development less than 10 years after drain blocking (this was previously an area of bare peat)

Blocking of cutover drains slows the flow of water off the cutover areas and increases the water table in the surrounding peat. This can help to reduce the rate of infiltration through the high bog and can lead to conditions that allow peat to form on the cutover (**Figure 2.2**).

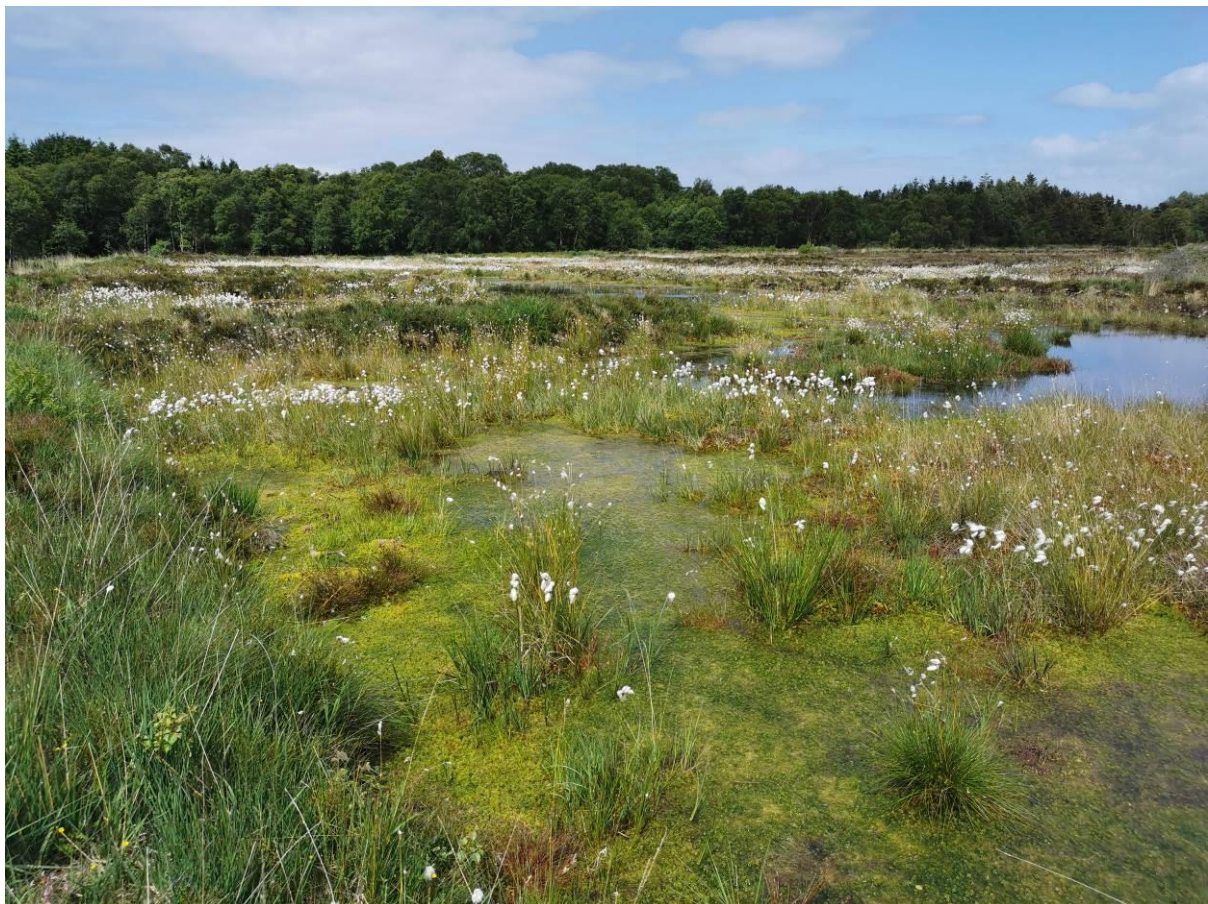
**Figure 2.4 Example of existing cell bund constructed at Cloncrow Bog NHA (The vegetation in this photo has developed in the 2 years since cell construction)**

Cell bunds are typically constructed by excavating a trench 1.0-1.5m deep, recompacting the excavated peat into the trench and constructing a bund 0.5-0.6m high above the ground surface (Figure 2.4). Water level control structures (pipes or overflow weirs) are incorporated into these cells as a means to regulate water levels and evenly distribute water across the site.

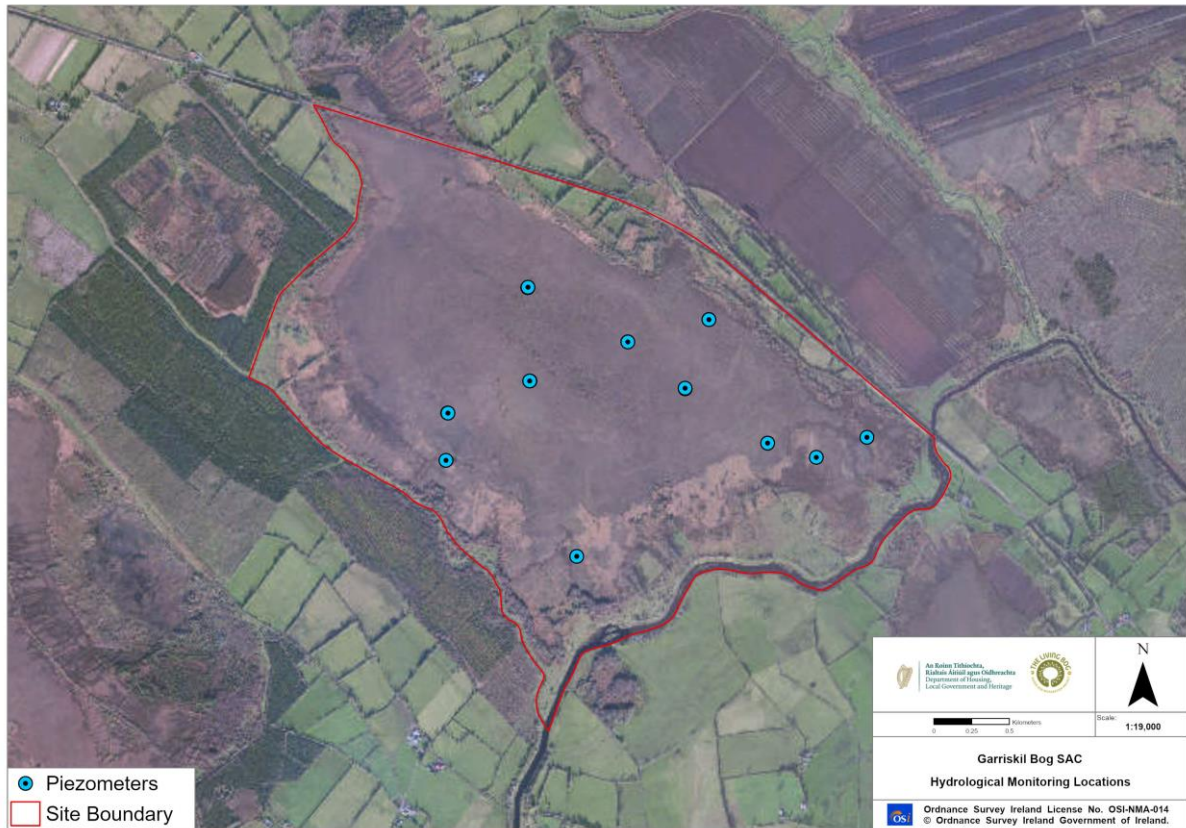
Figure 5.1 Location of hydrological monitoring network at Garriskil Bog SAC

Detailed hydrological characterisation of Garriskil Bog SAC was carried out in 2018 as part of the Living Bog Project. This comprised of detailed surveys of the high bog and cutover to collect data to enable the restoration plan to be refined. A detailed hydrological monitoring network was established in 2018, comprising eleven phreatic monitoring wells and seven deep piezometers to monitor vertical hydraulic gradients across the bog (high bog and cutover). These were monitored manually at monthly intervals, with a subset of three monitoring wells instrumented with automated data logging equipment. This enabled the collection of baseline data to inform restoration plan design as well as assess the hydrological impact of restoration measures. This information was used as a feedback mechanism in reviewing the restoration plan.

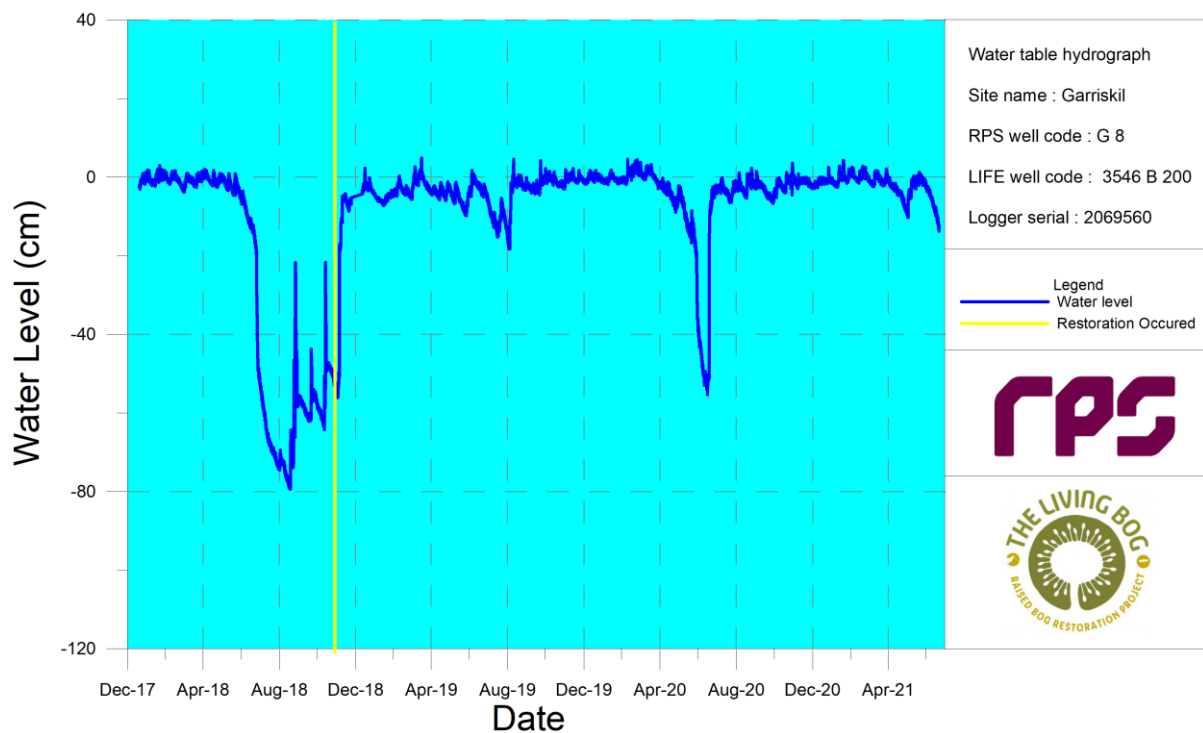
Figure 5.2 Example hydrological results from monitoring during the Living Bog Project at Garriskil Bog SAC, illustrating the positive response to the water table from drain blocking on the cutover

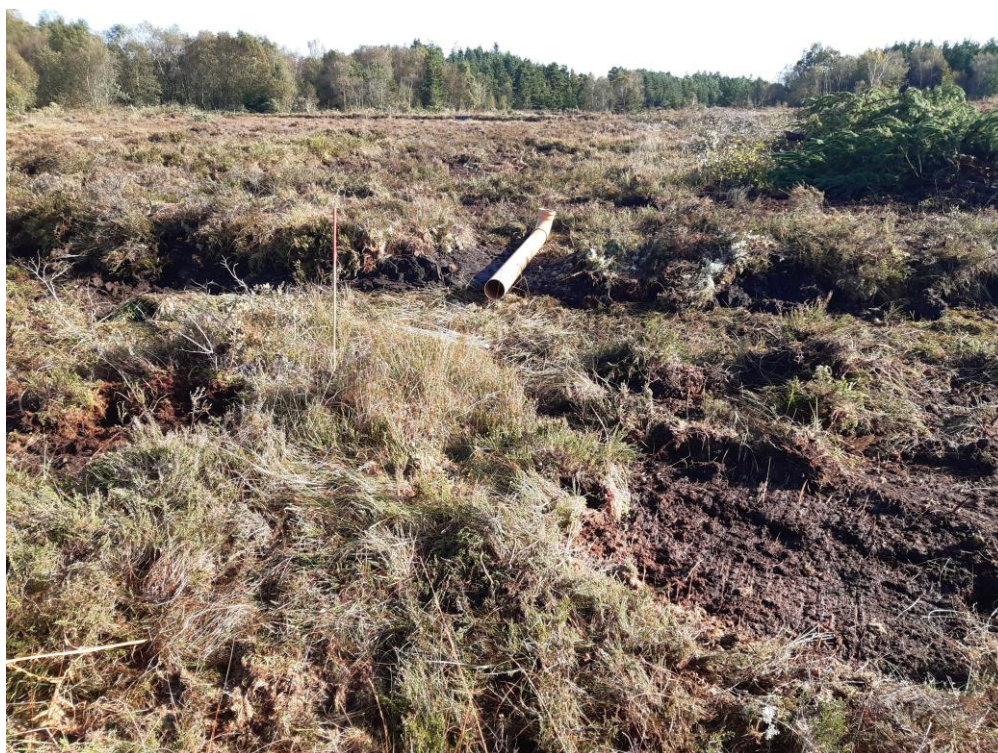
**Figure 5.5** Example of setting out for piped weirs in a trench bund on the cutover. The bamboo is sprayed red

The surveying and staking out of drains and dams can be difficult due to the nature of the bog environment. Vegetation and soft ground conditions can make identification of features and surveying of same difficult and potentially dangerous. The setting out of the Works is generally done using bamboo stakes to mark the locations of the restoration measures that are to be constructed such as the dams or bunds. All Works carried out as part of the Living Bog Project of the restoration plan were set out as required which facilitated work being completed. This activity provides an additional opportunity to review the restoration measures in detail on the ground and where necessary minor modifications can be made (e.g., adjusting the placement of particular dams due to dense vegetation coverage or alignment of bunds due to ground conditions). This ensure that the risk of damage to the raised bog is minimized as inadequate planning can increase the risk of machines entering unsuitable areas.

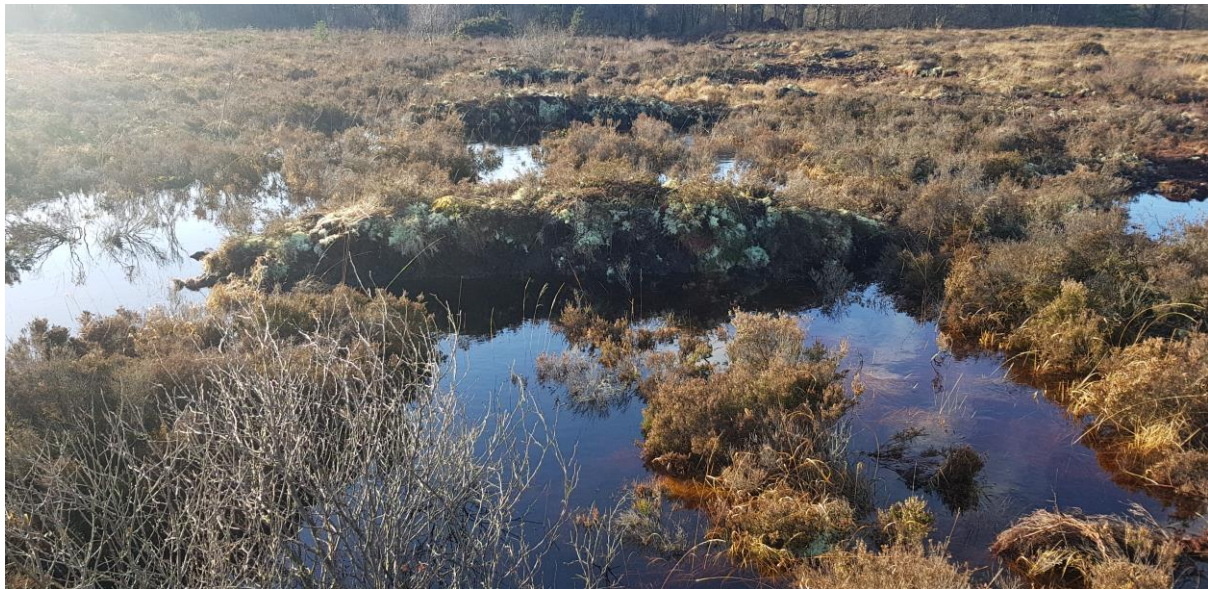
**Figure 5.6 Example of peat dam installed on the cutover of Garriskil Bog**

The majority of the proposed restoration measures as part of the Living Bog Project were completed as required at Garriskil Bog SAC. This includes construction of 903 dams, which were primarily constructed from peat. A techniques manual which details methodologies of restoration techniques including the methods developed through the Living Bog Project was produced as part of the project (Cushnan et al., 2022).

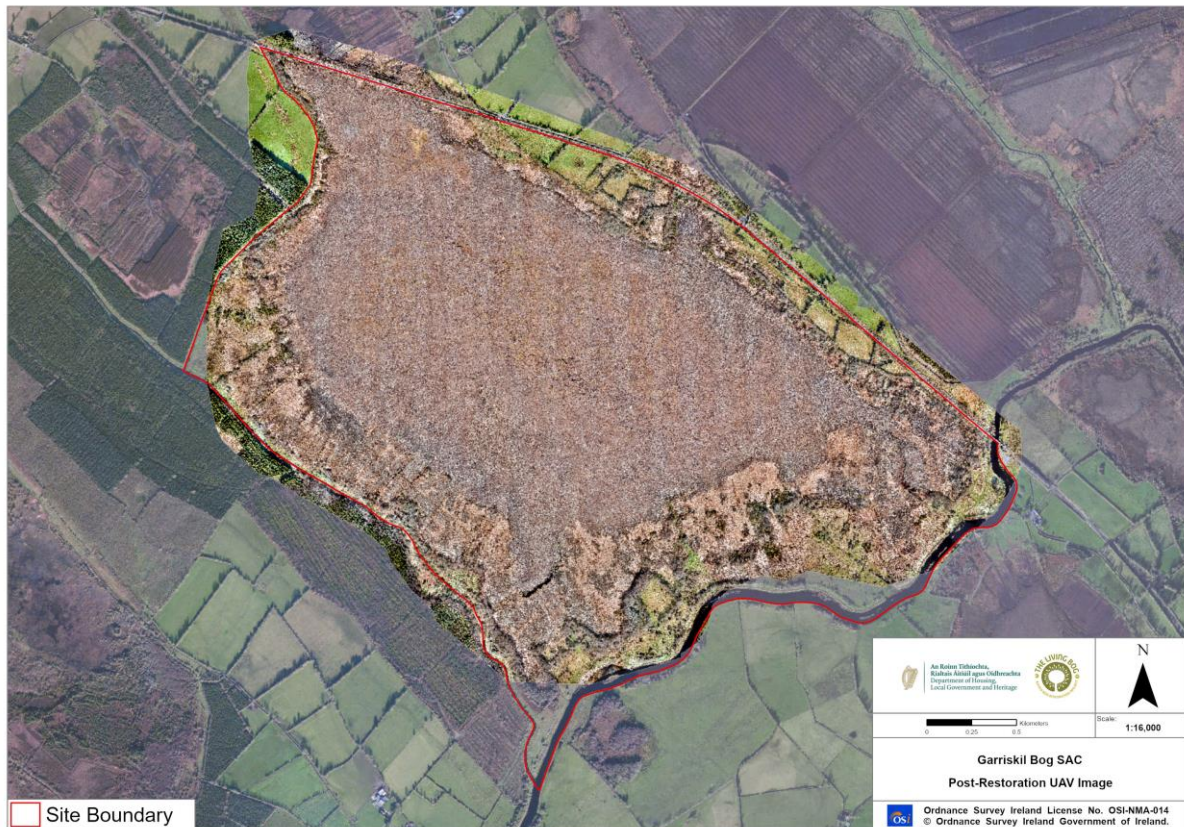
Figure 5.7 High resolution post-Works ortho imagery from UAV survey

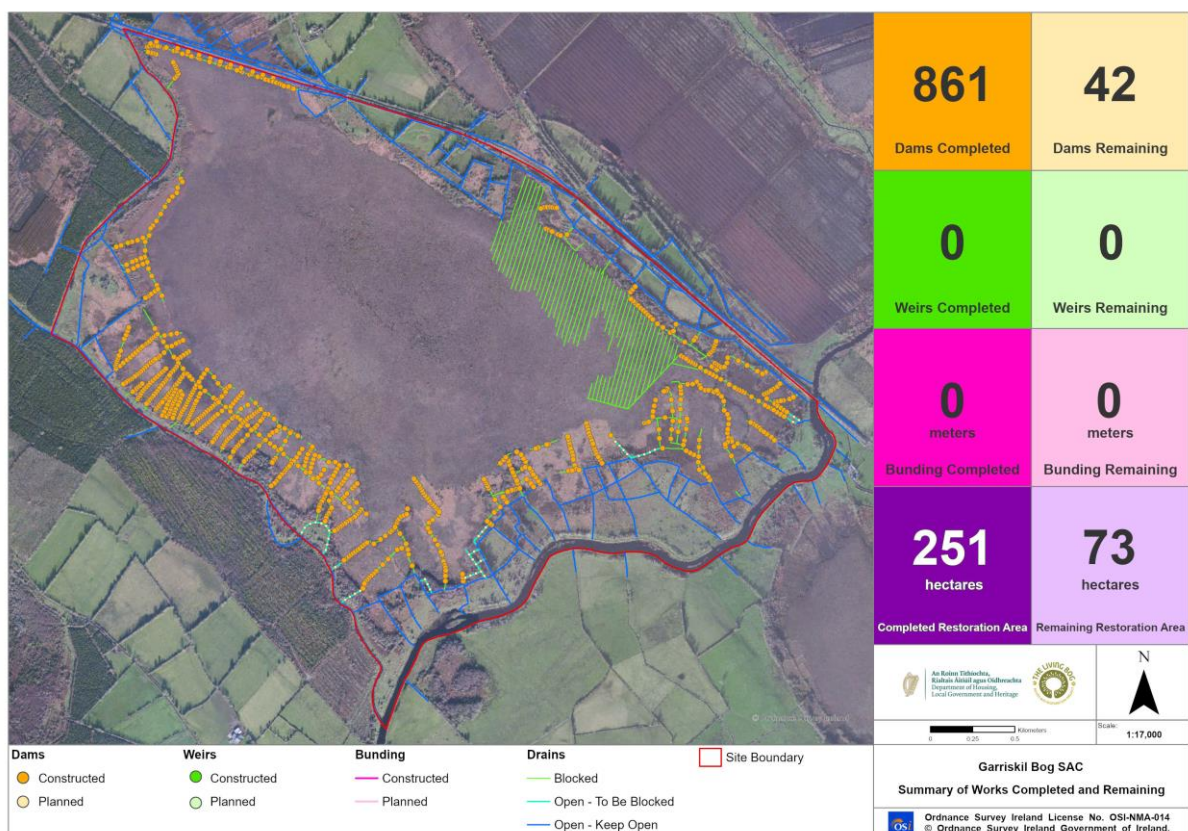
Figure 5.8 Summary of Works completed to date

Post-Works inspections have been completed and an as-built drawing was prepared by Bord na Móna on behalf of the Living Bog Project (summarised in Figure 5.8). This included detailed aerial surveys of the bog to collect high-resolution ortho-imagery and to ensure a detailed as-built drawing could be prepared.
