National Parks & Wildlife Service

Knockacoller Bog SAC (Site code 002333)

Raised Bog Restoration Plan (Report)

October 2022

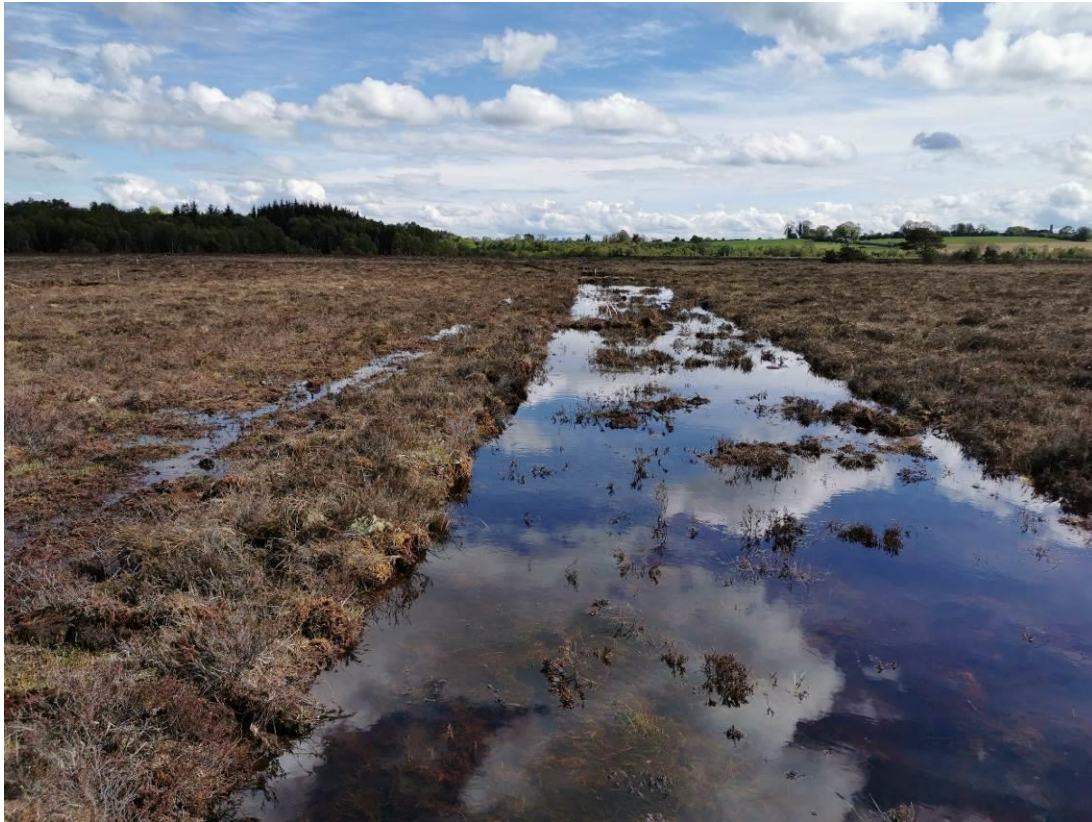
Figure 2.3 Contour bund constructed at Knockacoller Bog SAC, Co. Laois

Contour bunds on the high bog aims to reduce the rate of lateral flow through the upper layers of the peat. In contrast to some other bunding techniques, contour bunding is not intended as a means of impounding surface water. This method involves excavating a trench 1.5-2.0m deep, re-compacting peat into the trench and building a slightly raised bund 25-30cm above the current

ground surface. In addition, these bunds have 5m long ‘finger bunds’ constructed using the same technique at approximately 25m spacing to prevent flow along the bund which may lead to erosion. After 1-2 years it is anticipated that the bund will have subsided close to current ground level and therefore will not appear as a prominent feature on the bog surface.

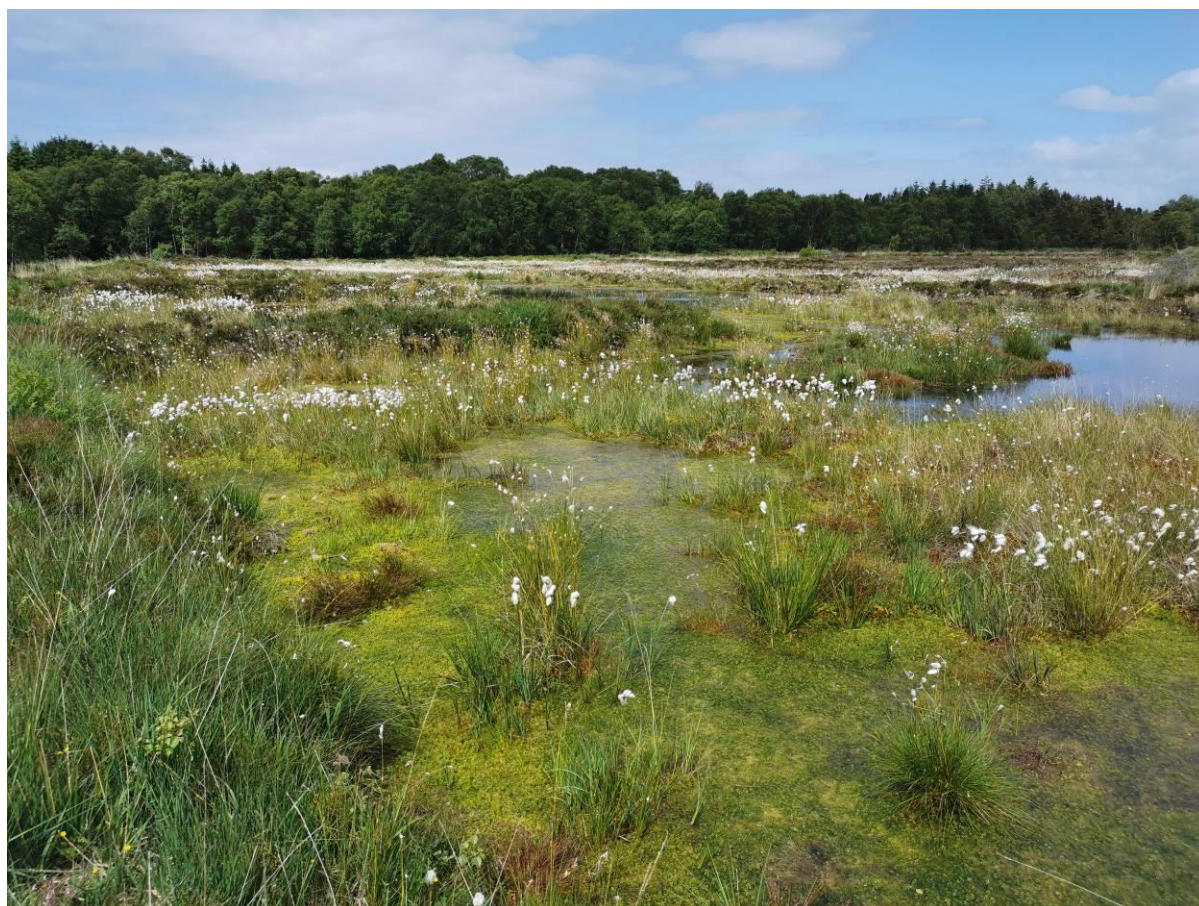
Figure 2.4 Example of existing cell bund constructed at Cloncrow Bog NHA (the vegetation in this photo has developed in the 2 years since cell construction)

Cell bunds are typically constructed by excavating a trench 1.0-1.5m deep, recompacting the excavated peat into the trench and constructing a bund 0.5-0.6m high above the ground surface (Figure 2.3). Water level control structures (pipes or overflow weirs) are incorporated into these cells as a means to regulate water levels and evenly distribute water across the site.

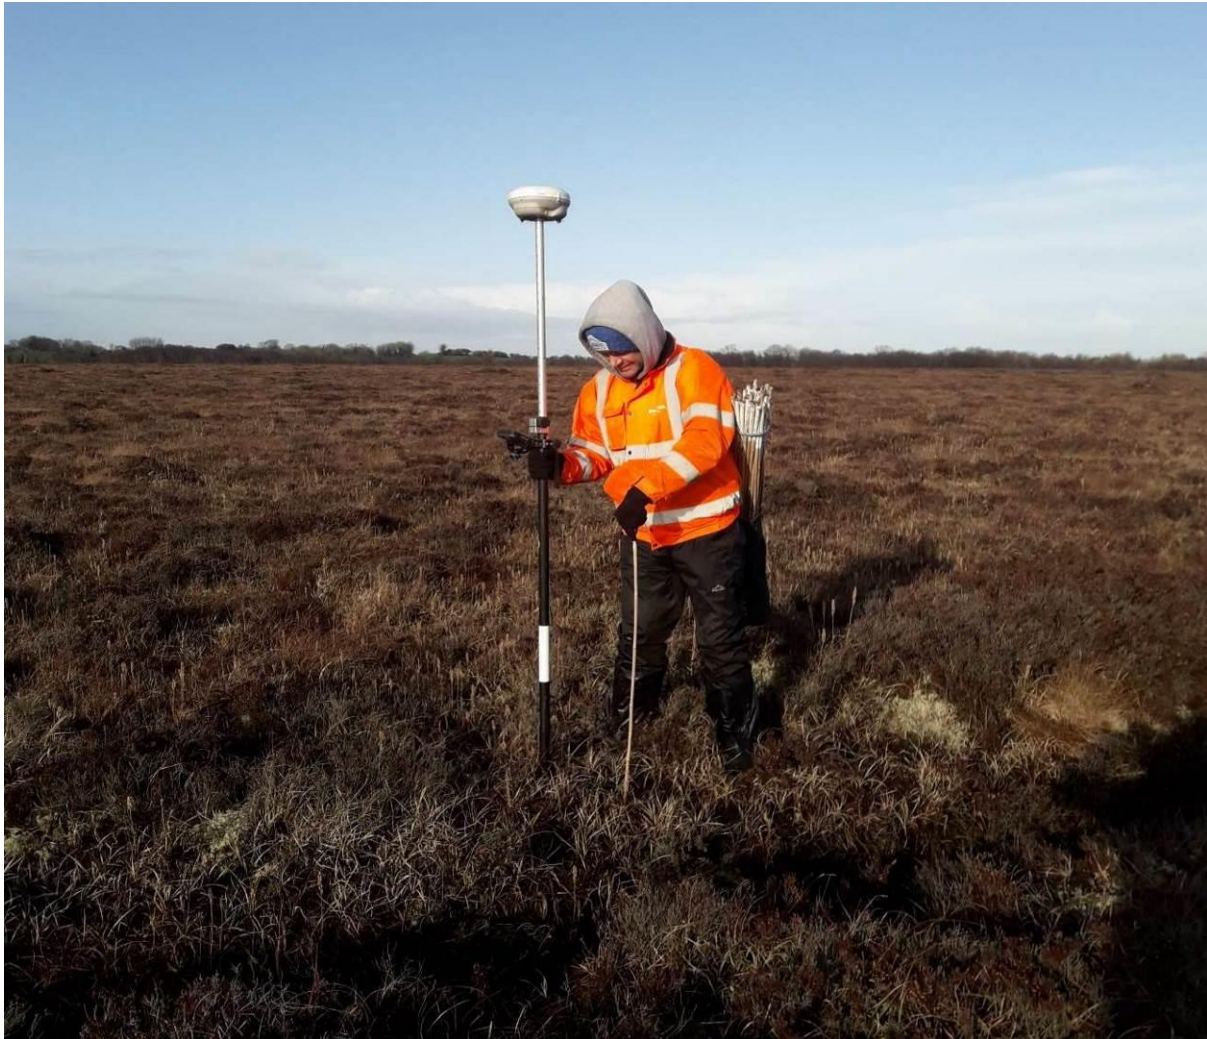
Figure 5.3 Example of setting out dams on an area of high bog

The surveying and staking out of drains and dams can be difficult due to the nature of the bog environment. Vegetation and soft ground conditions can make identification of features and surveying of same difficult and potentially dangerous. The setting out of the Works is generally done using bamboo stakes to mark the locations of the restoration measures that are to be constructed such as the dams or bunds. All Works proposed during phase 1 of the restoration plan were set out as required. This activity provides an additional opportunity to review the restoration measures in detail on the ground and where necessary minor modifications can be made (e.g., adjusting the placement of particular dams due to dense vegetation coverage or alignment of bunds due to ground conditions). This ensure that the risk of damage to the raised bog is minimized as inadequate planning can increase the risk of machines entering unsuitable areas.

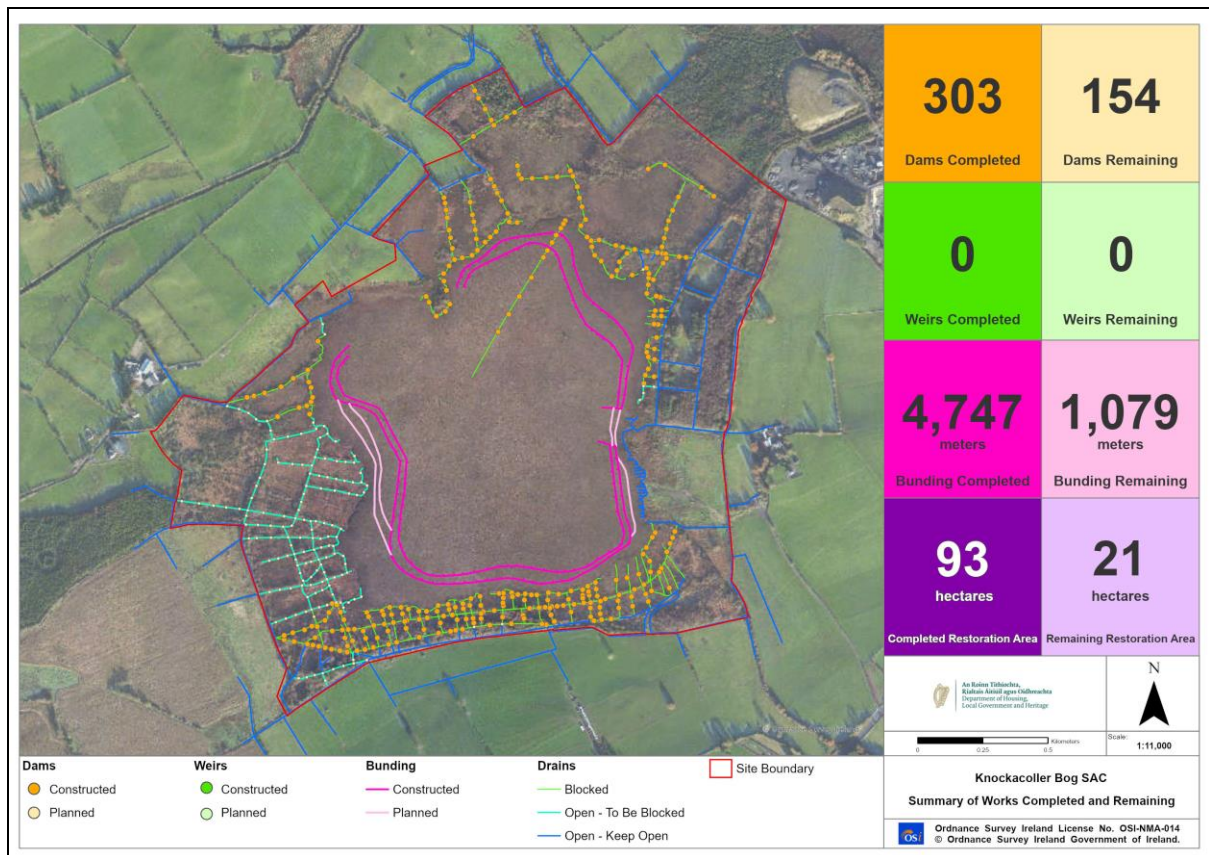
Figure 5.4 Summary of Works completed to date and Works remaining

A significant proportion of the restoration Works at Knockacoller Bog SAC have been completed with c. 93ha of a planned restoration area of 114ha being completed (82%). This includes construction of 303 peat dams and 4.75km of contour bunding. In total, 154 more dams are planned to be installed.

Post-Works inspections have been completed and an as-built drawing prepared (summaries in Figure 5.4). This has included detailed aerial surveys of the bog to collect high-resolution ortho-imagery and oblique images to ensure a detailed as-built drawing could be prepared.

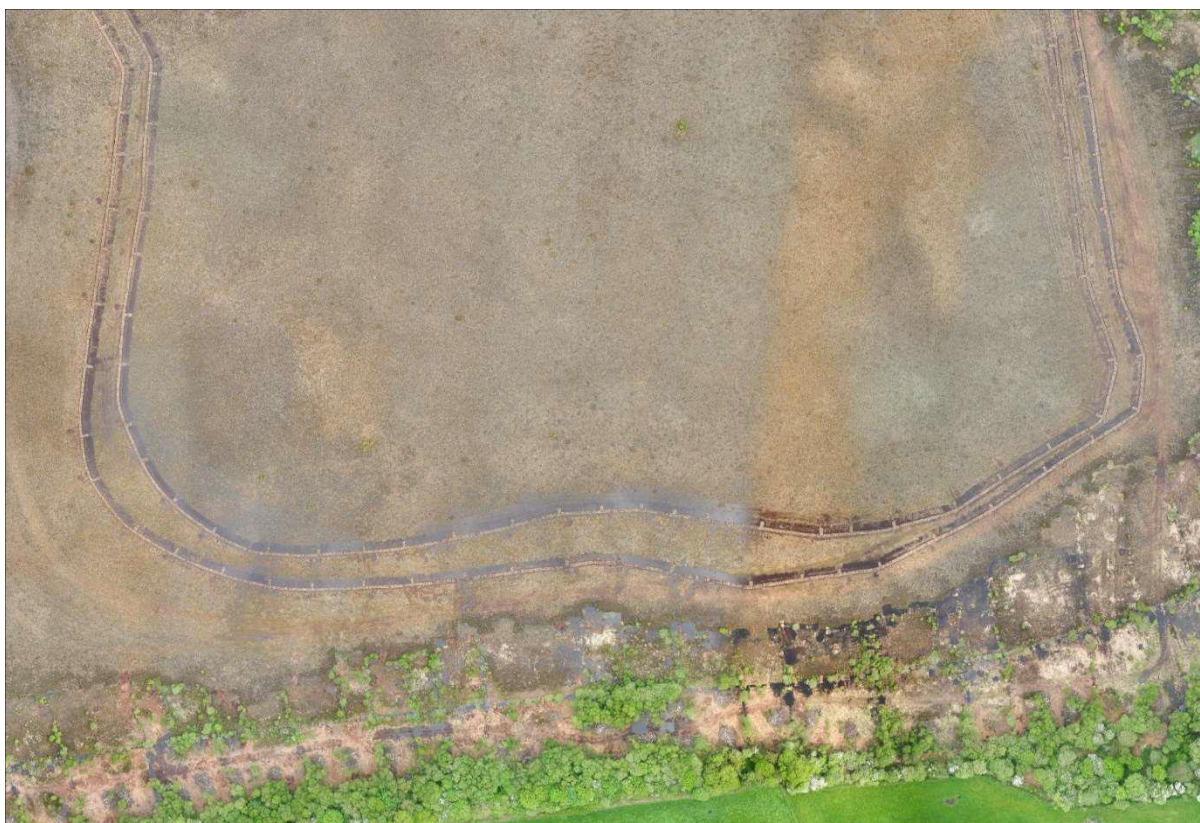
Figure 5.5 Example of high-resolution ortho-imagery illustrating contour bunding on the high bog

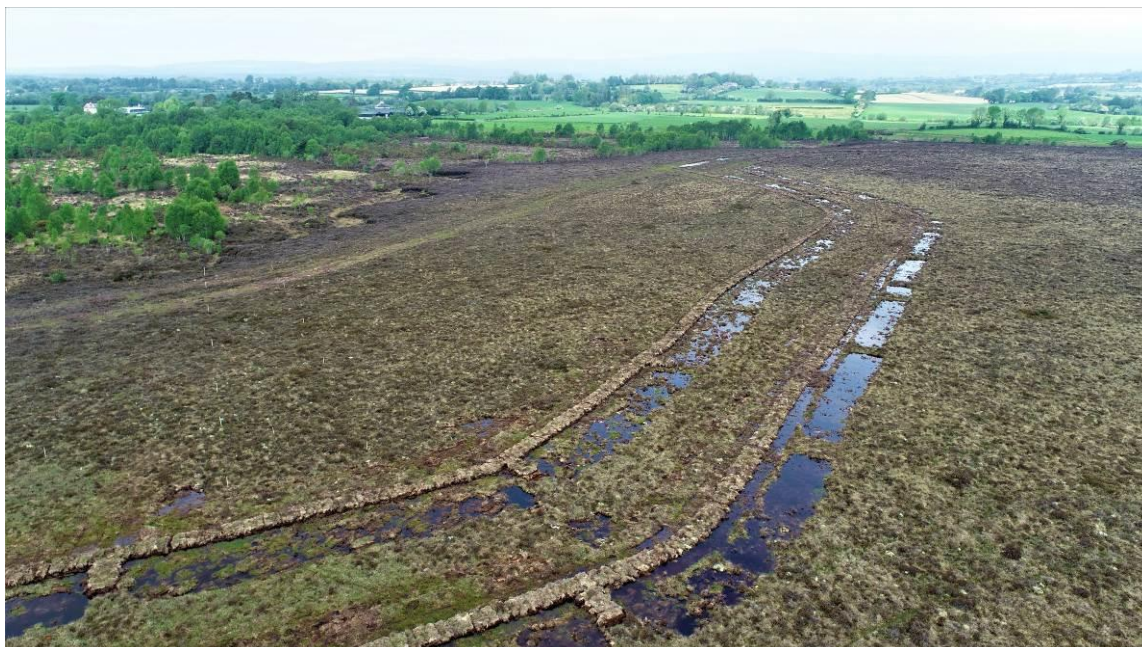
Figure 5.6 Example of contour bunding on the high bog illustrating finger bunds extending perpendicular to the main bund

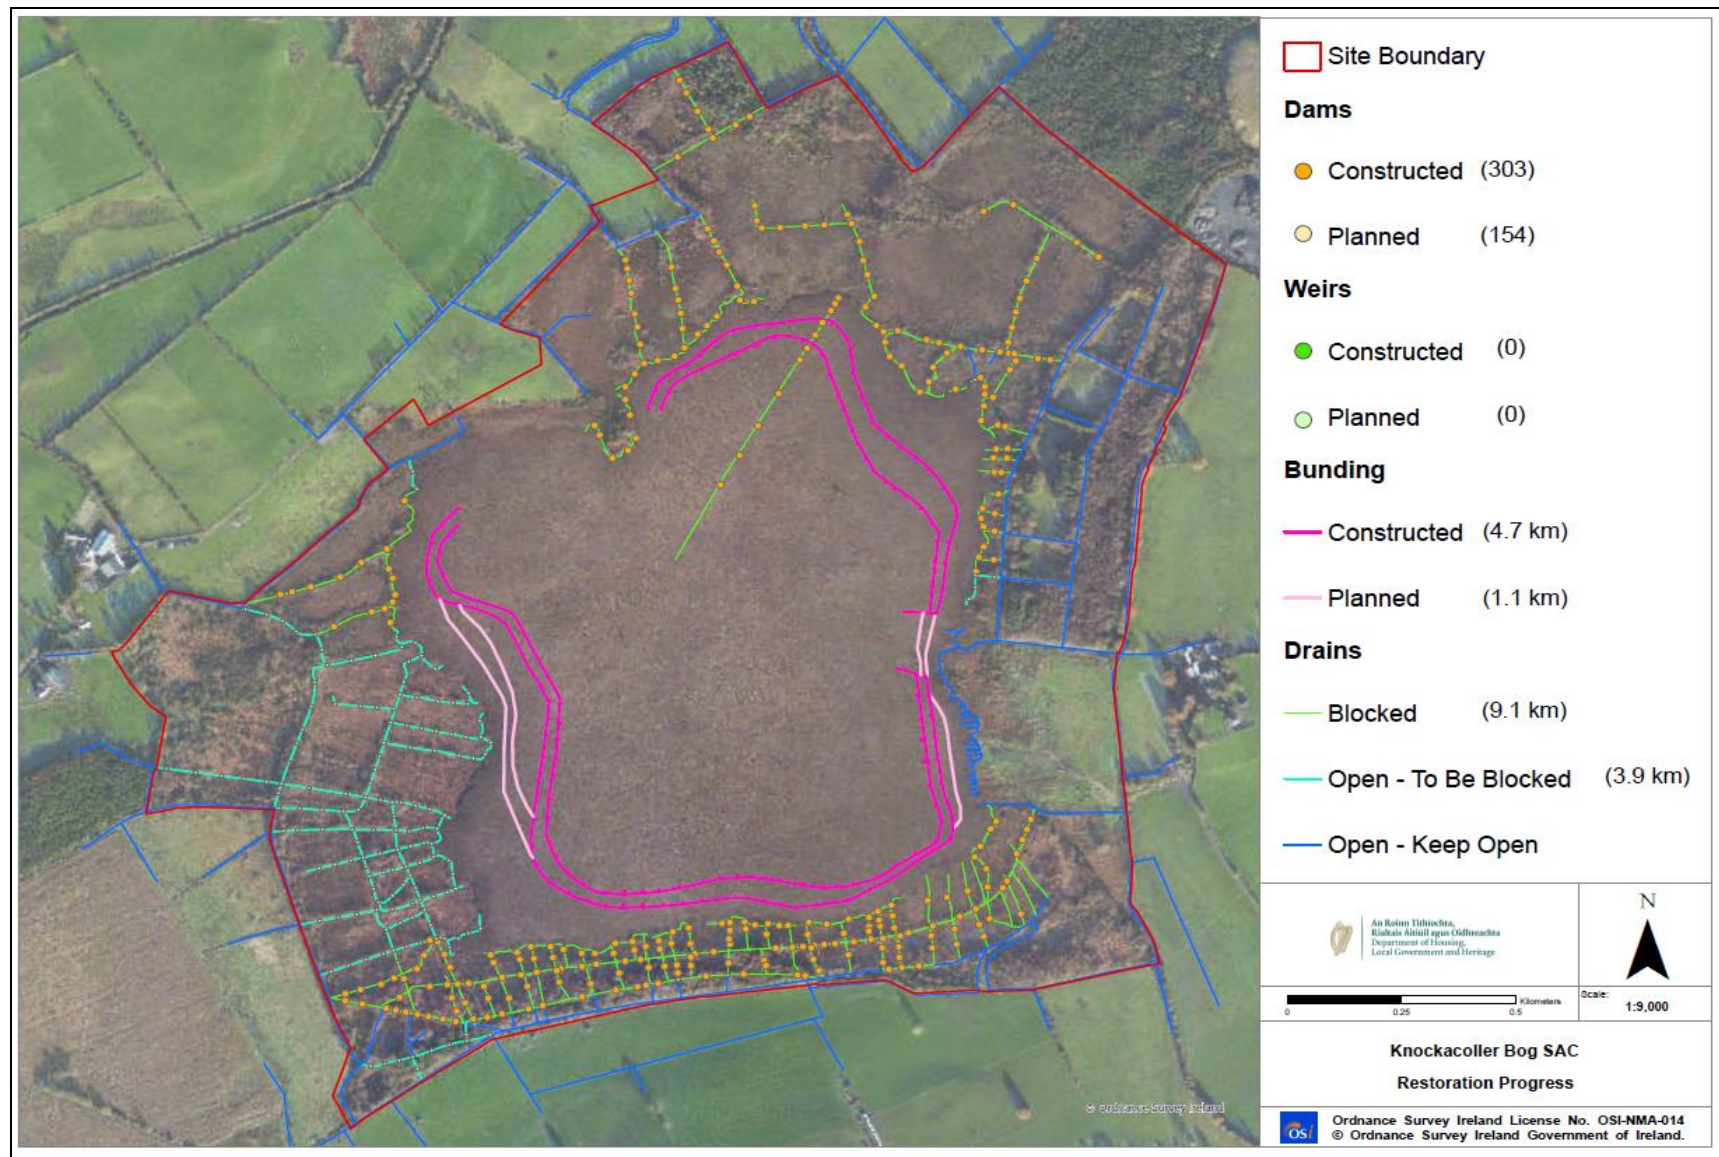
Map 2 - Knockacoller Bog SAC Restoration Proposals

Map 1 outlines the location and extent of Knockacoller Bog SAC and Map 2 illustrates the restoration measures that have been implemented to date as well as any proposed/outstanding restoration measures to be implemented at Knockacoller Bog.

All high bog drains have been blocked on Knockacoller Bog. However, ongoing monitoring of the drain blocking activity is required to ensure dams do not fail over time. Details of the locations of blocked drains on the high bog can be found in Map 2.

Many cutover drains have already been blocked on Knockacoller Bog. However, ongoing monitoring of the drain blocking activity is required to ensure dams do not fail over time. In addition, there are several remaining drains to be blocked. Blocking of cutover drains may reduce ongoing subsidence of the high bog and in some areas will also lead to the development of peat forming habitats. It is proposed that these drains are blocked, primarily with peat dams, with some plastic reinforcements where necessary to prevent erosion. The required conditions are for the water table to be maintained at or close to the surface, therefore large areas of standing water or deep pools are not desired. Details of the locations on the cutover where it is proposed to block drains can be found in Map 2.

It is proposed to construct 1.1km of contour bunding at Knockacoller Bog SAC. In addition, 4.75 km of contour bunding has already been constructed. Details of the locations on the high bog where existing contour bunding is located and whether further contour bunding is proposed can be found in Map 2. The impact of the contour bund will be monitored over time to determine how effective this measure has been and determine the cost/benefit of implementing this measure.
