National Parks & Wildlife Service

Raheenmore Bog SAC (Site code 000582)

Raised Bog Restoration Plan (Report)

October 2022

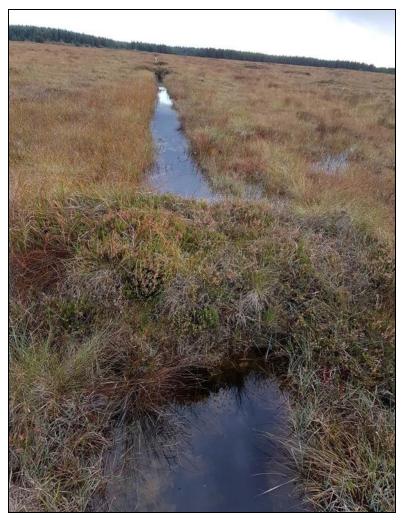
Figure 2.1 Example of a peat dam to block a typical high bog drain

Blocking high bog drains slows the flow of water off the surface of the bog and increases the water table in the peat. Drain blocking is a proven and effective restoration measure on Irish raised bogs with minimal maintenance requirements. The approach has been demonstrated at a number of raised bogs in Ireland with very positive results evident in less than 10 years (**Figure 2.1**) as outlined by Fernandez *et al.* (2014a).

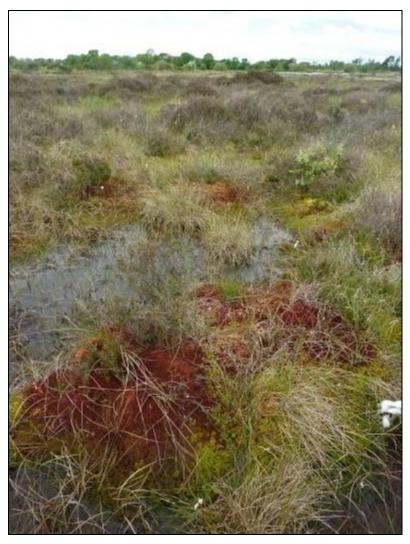
Figure 2.2 Water table at the surface of cutover bog following successful drain blocking resulting in *Sphagnum* development less than 10 years after drain blocking (this was previously an area of bare peat)

Blocking of cutover drains slows the flow of water off the cutover areas and increases the water table in the surrounding peat. This can help to reduce the rate of infiltration through the high bog and can lead to conditions that allow peat to form on the cutover (**Figure 2.2**).

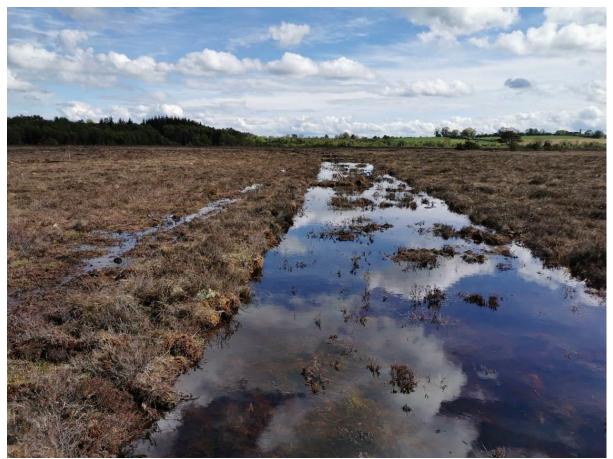
Figure 2.3 Example of a contour bund constructed at Knockacoller Bog SAC, Co Laois

Contour bunds on the high bog aims to reduce the rate of lateral flow through the upper layers of the peat. In contrast to some other bunding techniques, contour bunding is not intended as a means of impounding surface water. This method involves excavating a trench 1.5-2.0m deep, re-

compacting peat into the trench and building a slightly raised bund 25-30cm above the current ground surface. In addition, these bunds have 5m long 'finger bunds' constructed using the same technique at approximately 25m spacing to prevent flow along the bund which may lead to erosion. After 1-2 years it is anticipated that the bund will have subsided close to current ground level and therefore will not appear as a prominent feature on the bog surface.

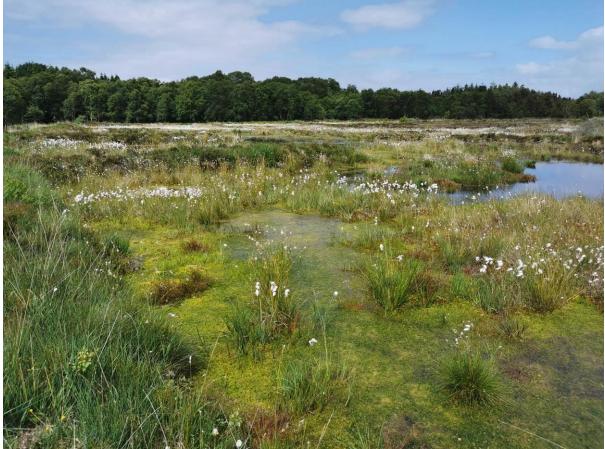
Figure 2.4 Example of existing cell bund constructed at Cloncrow Bog NHA (the vegetation in this photo has developed in the 2 years since cell construction)

Cell bunds are typically constucted by excavating a trench 1.0-1.5m deep, recompacting the excavated peat into the trench and constucting a bund 0.5-0.6m high above the ground surface (Figure 2.3). Water level control structures (pipes or overflow weirs) are incorporated into these cells as a means to regulate water levels and evenly distribute water across the site.

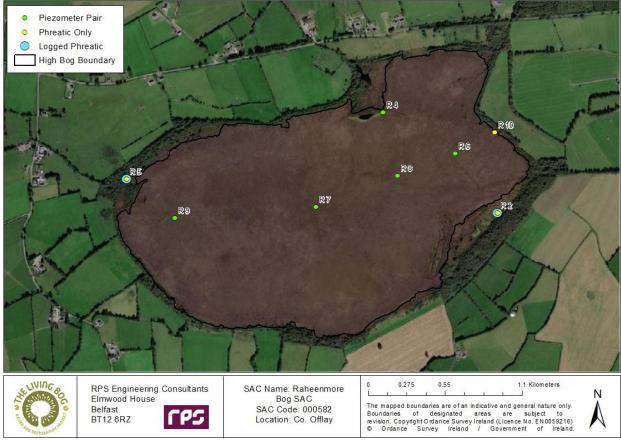
Figure 5.1 Location of hydrological monitoring network at Raheenmore Bog SAC

Detailed hydrological characterisation of Raheenmore Bog SAC has been completed. This comprised detailed surveys of the high bog and cutover carried out as part of the Living Bog Project to collect data to enable the restoration plan to be refined. This was supported by a significant amount of research completed on the bog since the early 1990s. A hydrological monitoring network was established in 2018, comprising piezometer nests at eight locations across the bog (high bog and cutover). These were monitored at frequent intervals to assess the hydrological impact of restoration measures and this information is used as a feedback mechanism in reviewing the restoration plan.

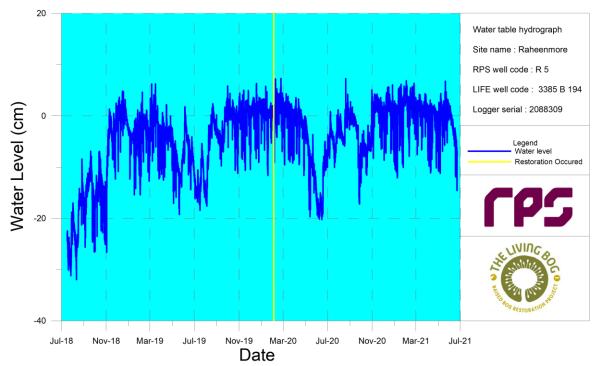
Figure 5.2 Example of hydrological monitoring at Raheenmore Bog SAC illustrating response to drain blocking on cutover with the water table rising from 30cm below ground surface to remaining within 20cm of ground surface at all times.

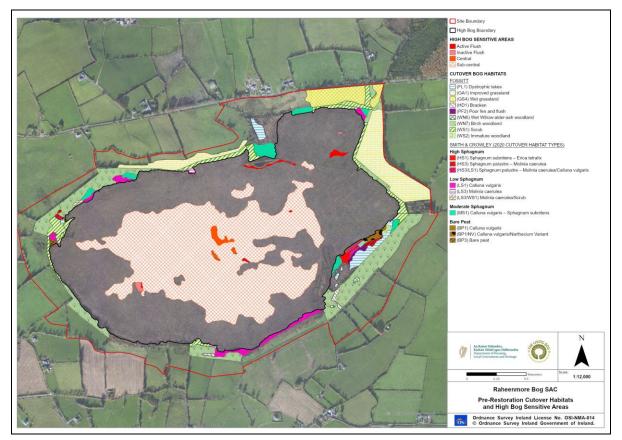
Figure 5.3 Ecological monitoring results (Pre-Restoration)at Raheenmore Bog SAC illustrating high bog and cutover vegetation types

The most recent ecotope survey of Raheenmore Bog SAC was completed in 2016, prior to restoration measures being implemented. This survey determined that active raised bog (7110) covered 45.8ha of the high bog in 2016 (Crowley & Smith, 2022) which compares to 52.31ha of ARB mapped during the previous ecotope survey in 2013 (Fernandez et al. 2014). These surveys show that the active raised bog is decreasing prior to restoration measures being implemented. Five of the twelve Living Bog sites were surveyed in 2021 post restoration and all five sites shown an increase in active raised bog area. This would suggest that restoration measures are working across the bogs although until another survey is completed it cannot be sure. Future monitoring will be completed by NPWS when the vegetation has had more time to respond to restoration measures, with a full analysis of the increase in extent of ARB scheduled to be carried out by the NPWS raised bog monitoring programme 2022-24.

128 'The Habitats of Cutover Raised Bog' (Smith & Crowley, 2020). A cutover survey carried out in accordance with this methodology was completed at Raheenmore which identified that there are already 0.2ha of high *Sphagnum* areas throughout the cutover area, although the cutover was found to be dominated by Low *Sphagnum* types. No significant increase in the area of high Sphagnum vegetation types is expected following rewetting measures (Crowley & Smith, 2022). The high bog and cutover surveys completed as part of the Living Bog Project provides a baseline status that can be used to monitor the results of restoration measures in future.

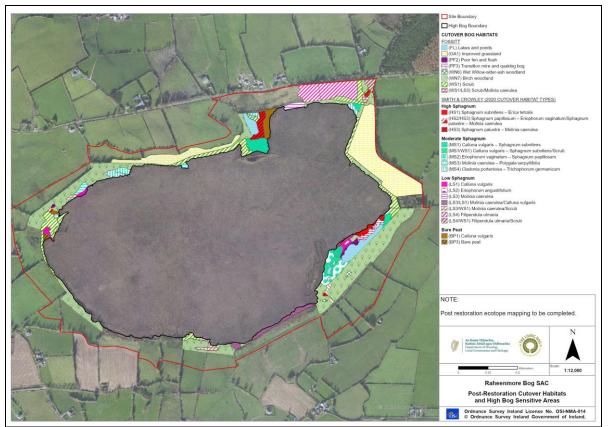
Figure 5.4 Ecological monitoring results (Post Restoration)at Raheenmore Bog SAC illustrating high bog and cutover vegetation types

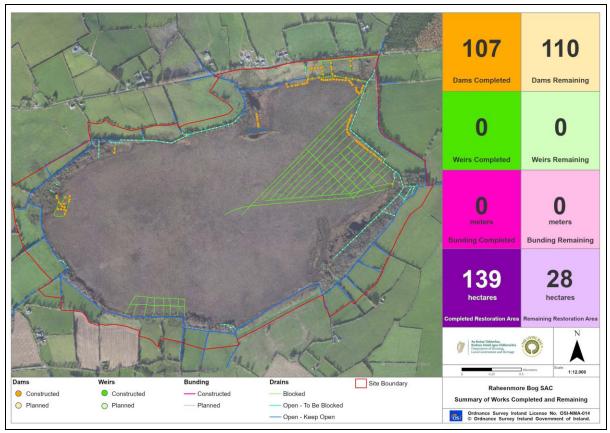
Figure 5.4 Summary of works completed to date

All of the proposed measures as part of the Living Bog Project were completed as required at Raheenmore Bog SAC. This includes construction of 217 dams, which were all constructed from peat.

Post-works inspections have been completed and an as-built drawing was prepared by Bord na Móna on behalf of the Living Bog Project (summarised in Figure 5.4). This included detailed aerial surveys of the bog to collect high-resolution ortho-imagery and to ensure a detailed as-built drawing could be prepared.

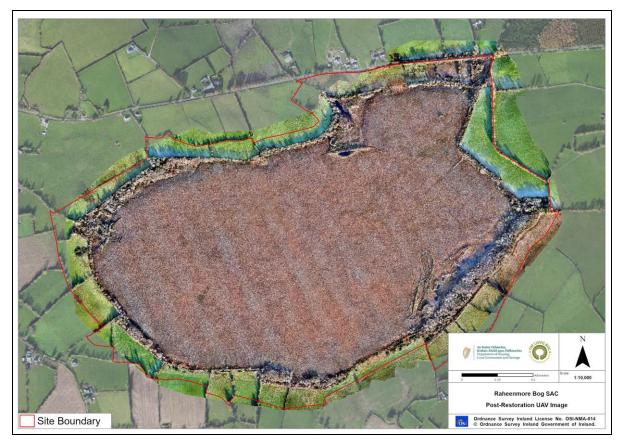
Figure 5.5 High resolution post-works ortho imagery from UAV survey

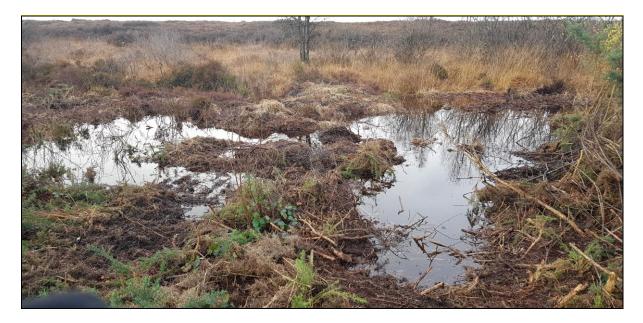
Figure 5.6 Example of rewetting on the margins of Raheenmore Bog SAC from drain blocking carried out through the Living Bog Project

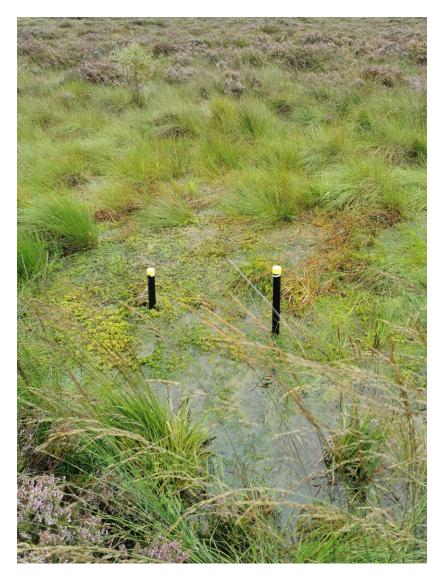
Figure 5.7 Example of rewetting on the margins of Raheenmore Bog SAC from drain blocking in the 1990s

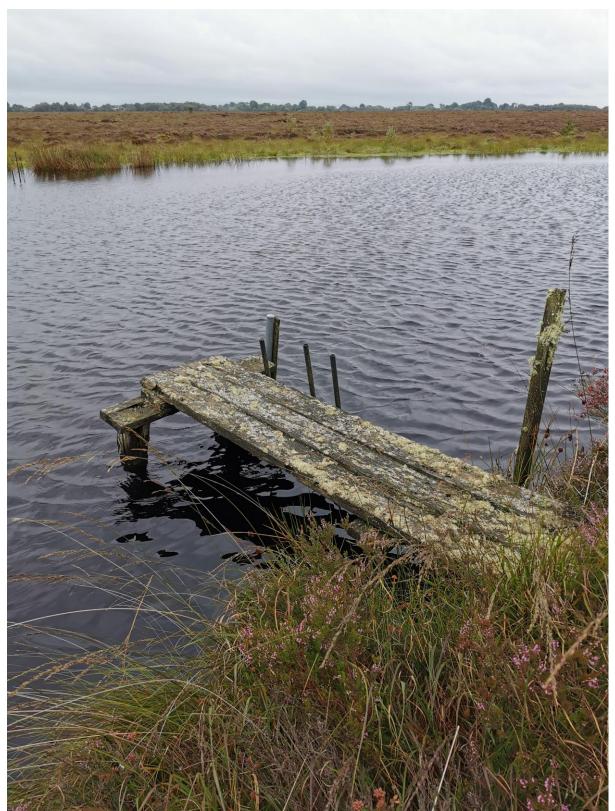
Figure 5.8 Example large marginal bund constructed at the edge of the high bog at Raheenmore Bog SAC in the 1990s

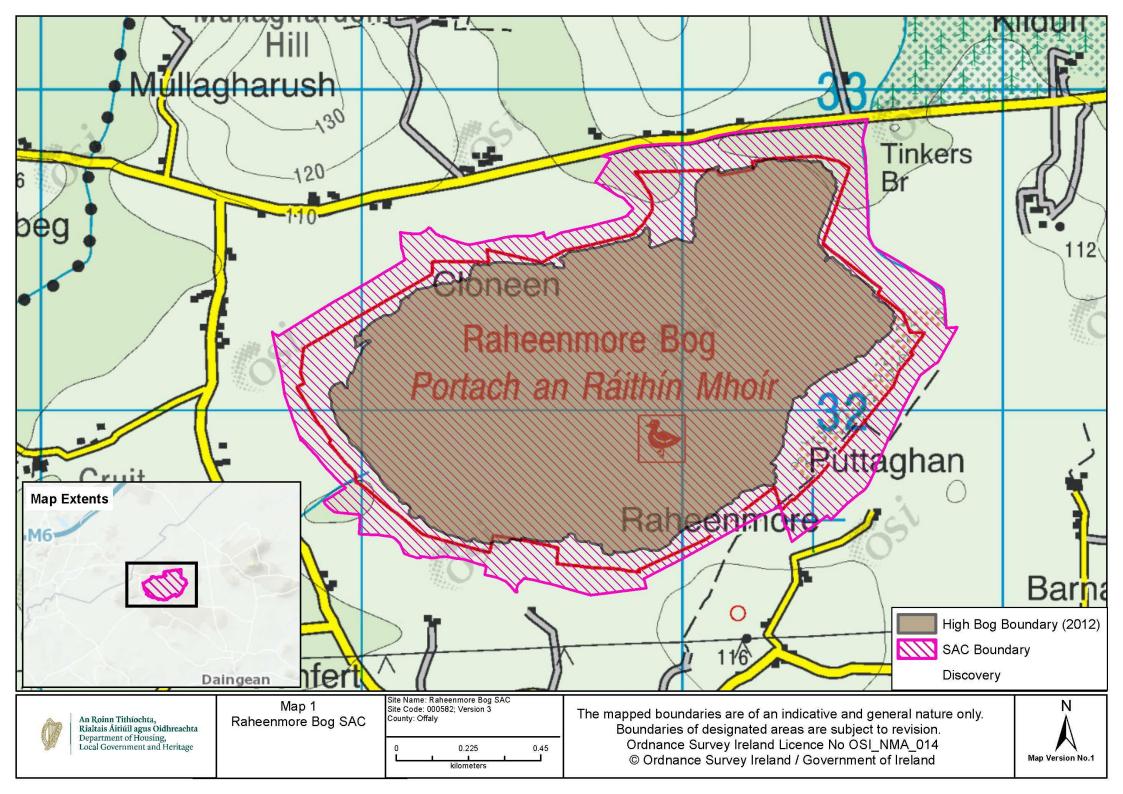
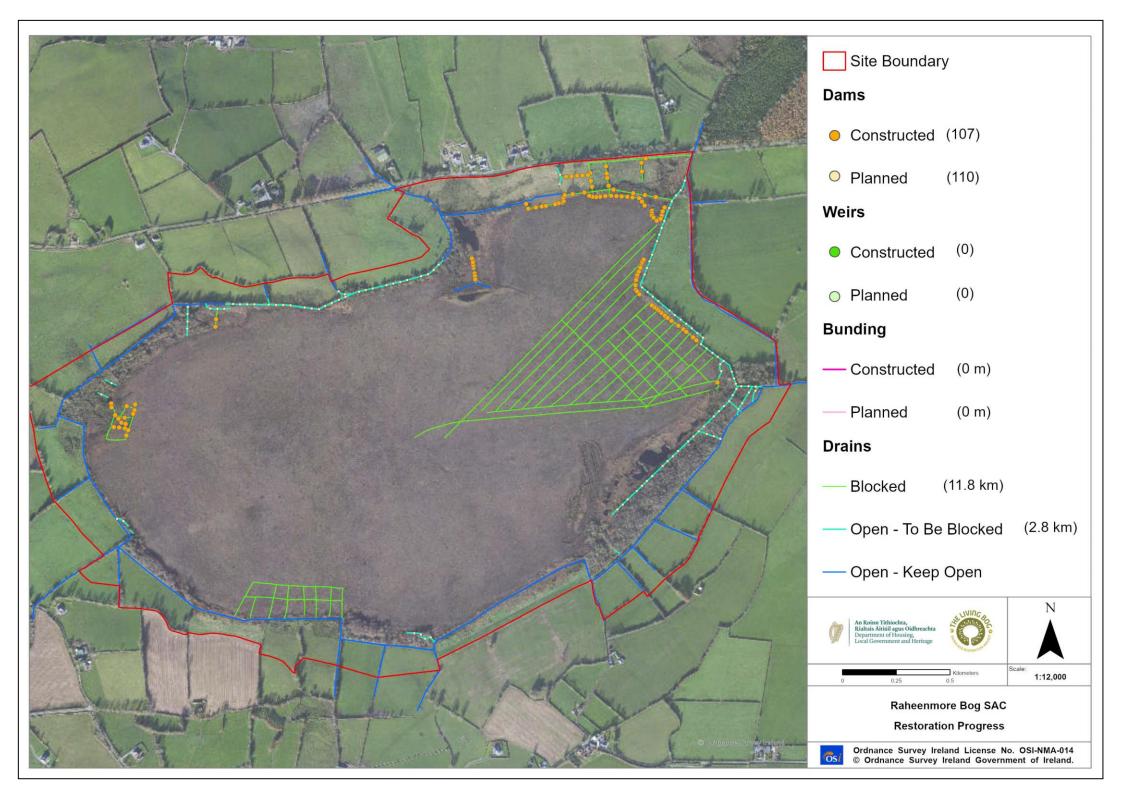
Map 1 outlines the location and extent of Raheenmore Bog SAC. Map 2 illustrates the restoration measures that have been implemented to date as well as any proposed/outstanding restoration measures to be implemented at Raheenmore Bog.

Map 1 - Raheenmore Bog SAC Boundary	
Map 2 - Raheenmore Bog SAC Restoration Measures	21
