National Parks & Wildlife Service

Derrinlough Bog NHA (Site code 001254)

Raised Bog Restoration Plan (Report)

October 2022

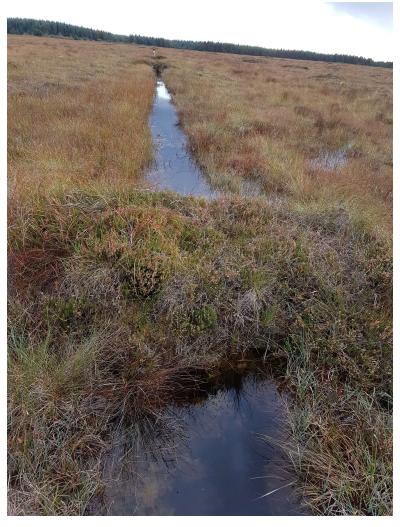
Figure 2.1 Overgrown peat dams showing water table at the ground surface

Blocking high bog drains slows the flow of water off the surface of the bog and increases the water table in the peat. Drain blocking is a proven and effective restoration measure on Irish raised bogs with minimal maintenance requirements. The approach has been demonstrated at a number of raised bogs in Ireland with very positive results evident in less than 10 years (**Figure 2.1**) as outlined by Fernandez *et al.* (2014).

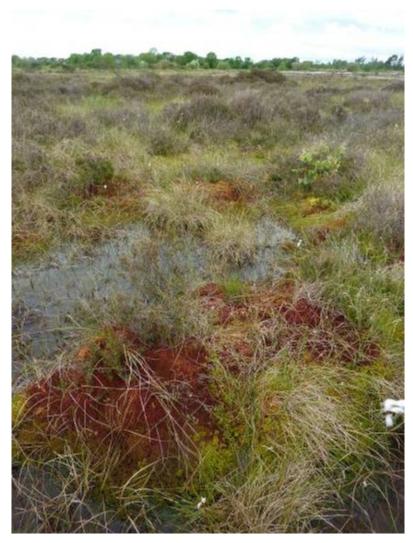
Figure 2.2 Water table at the surface of cutover bog following successful drain blocking resulting in *Sphagnum* development less than 10 years after drain blocking (this was previously an area of bare peat)

Blocking of cutover drains slows the flow of water off the cutover areas and increases the water table in the surrounding peat. This can help to reduce the rate of infiltration through the high bog and can lead to conditions that allow peat to form on the cutover (**Figure 2.2**).

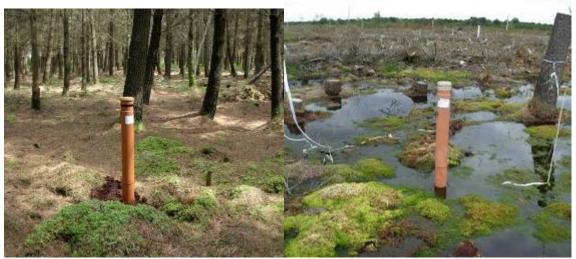
a) Bog surface prior to forestry removal and drain blocking

Figure 2.3 Example of the impact of felling forestry on a raised bog to restore more natural hydrological conditions

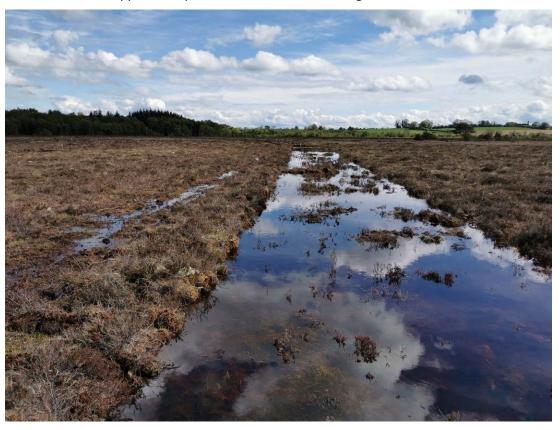
Figure 2.4 Example of typical contour bund constructed at Knockacoller Bog SAC, Co. Laois

Contour bunds on the high bog aims to reduce the rate of lateral flow through the upper layers of the peat. In contrast to some other bunding techniques, contour bunding is not intended as a means of impounding surface water. This method involves excavating a trench 1.5-2.0m deep, recompacting peat into the trench and building a slightly raised bund 25-30cm above the current ground surface. In addition, these bunds have 5m long 'finger bunds' constructed using the same technique at approximately 25m spacing to prevent flow along the bund which may lead to erosion. After 1-2 years it is anticipated that the bund will have subsided close to current ground level and

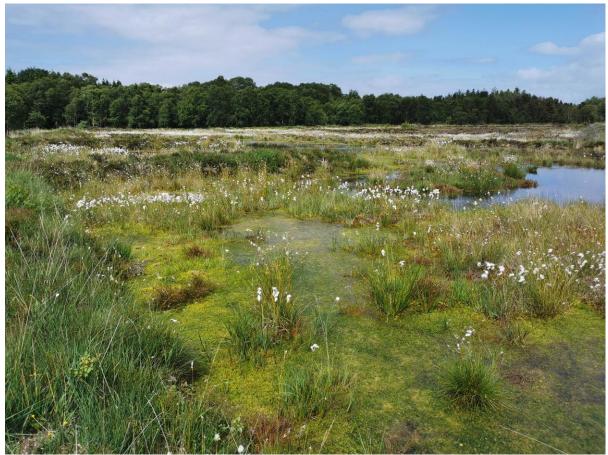
Figure 2.5 Example of existing cell bund constructed at Cloncrow Bog NHA (the vegetation in this photo has developed in the 2 years since cell construction)

Cell bunds are typically constucted by excavating a trench 1.0-1.5m deep, recompacting the excavated peat into the trench and constucting a bund 0.5-0.6m high above the ground surface (Figure 2.3). Water level control structures (pipes or overflow weirs) are incorporated into these cells as a means to regulate water levels and evenly distribute water across the site.

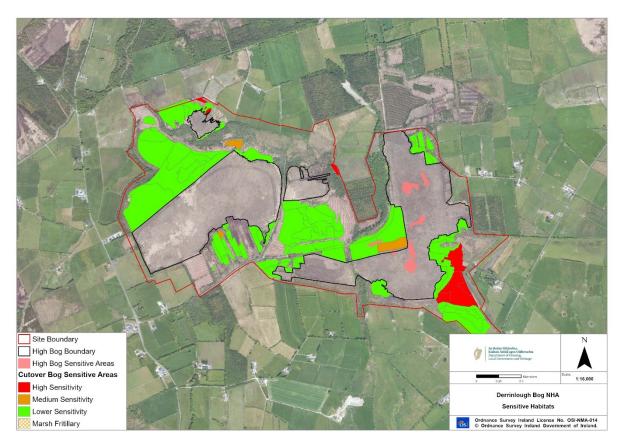
Figure 5.1 Sensitive habitats mapped at Derrinlough Bog

In addition to the high bog survey, a cutover habitat survey was carried out in 2022 in accordance with Irish Wildlife Manual No. 128 'The Habitats of Cutover Raised Bog' (Smith & Crowley, 2020). This survey involved detailed mapping of the various vegetation communities occurring on the cutover bog and also classified these in terms of sensitivity to damage from restoration activities. Most areas were found to be of negligible or lower sensitivity; however, there were several areas of medium and high sensitivity including an area of transition mire (7140) to the east of the bog. This mapping together with mapping of the high bog ensures the restoration plan takes into account the existing sensitive habitats present on site to minimize potential impacts and also establishes a baseline status that can be used to monitor the results of measures.

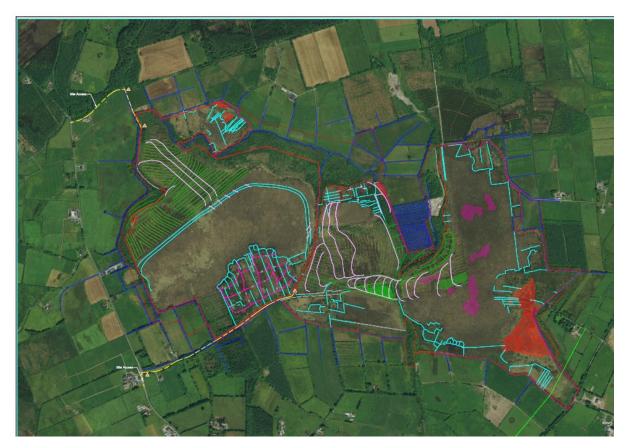
Figure 5.2 Contract Drawing showing the Restoration Works to be Constructed in Phase 1

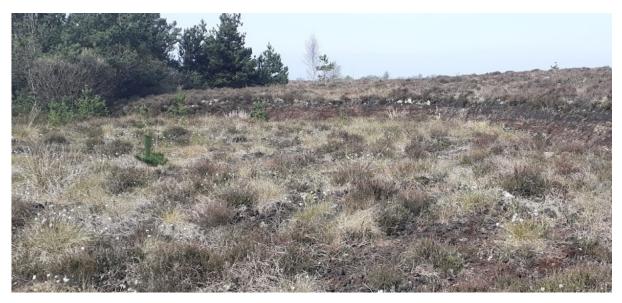
Figure 5.3 Proposed cell-bunding area in southwest o bog

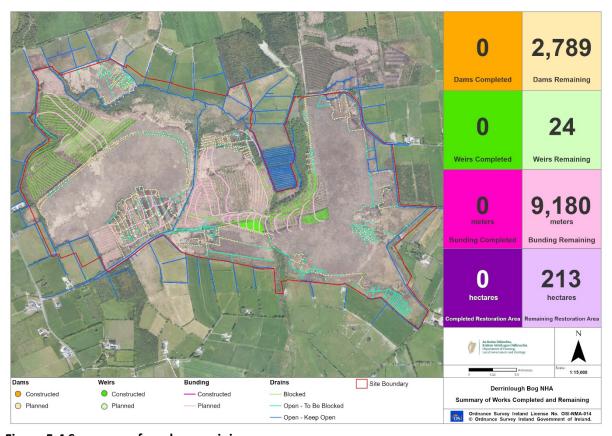
Figure 5.4 Summary of works remaining

It is envisaged that the construction phase of the proposed restoration measures will commence in 2023. It is envisaged that over 6km of contour bunding and over 2km of trench bunding will be installed with almost 3,000 peat dams to be constructed.
