National Parks & Wildlife Service

Brown Bog SAC
(Site code 002346)

Raised Bog Restoration Plan (Report)

Version 2a

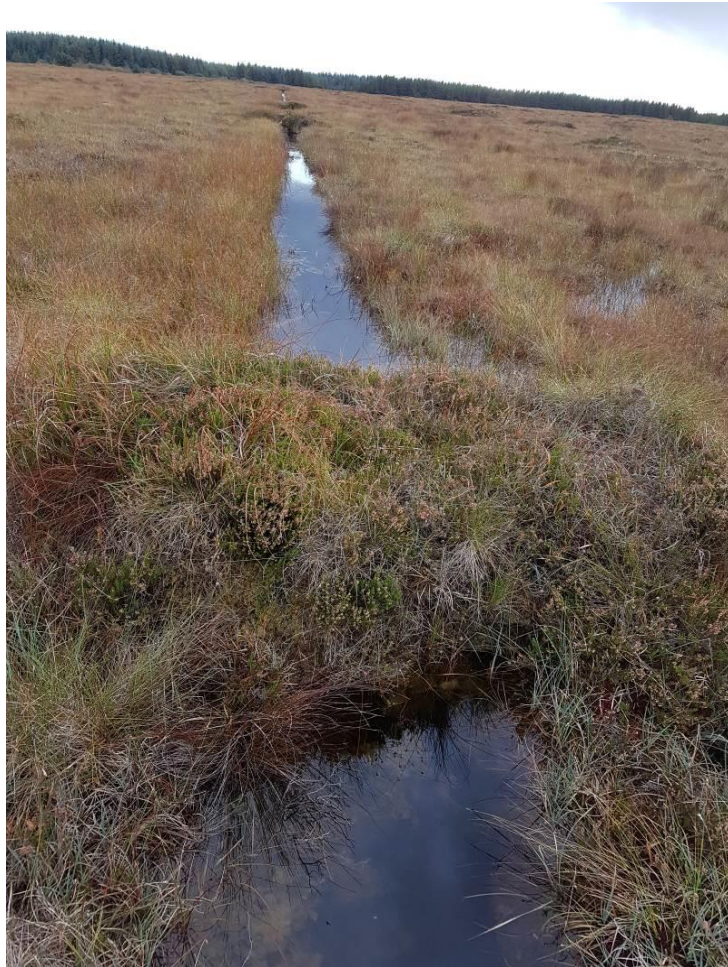
Figure 2.1 Example of a peat dam to block a typical high bog drain

Blocking high bog drains slows the flow of water off the surface of the bog and increases the water table in the peat. Drain blocking is a proven and effective restoration measure on Irish raised bogs with minimal maintenance requirements. The approach has been demonstrated at a number of raised bogs in Ireland with very positive results evident in less than 10 years (**Figure 2.1**) as outlined by Fernandez *et al.* (2014).

There are very few drains on the high bog drains of Brown Bog. It is proposed that all unblocked drains on the high bog are blocked with peat dams. Details of the locations of unblocked drains on the high bog can be found in Map 2.

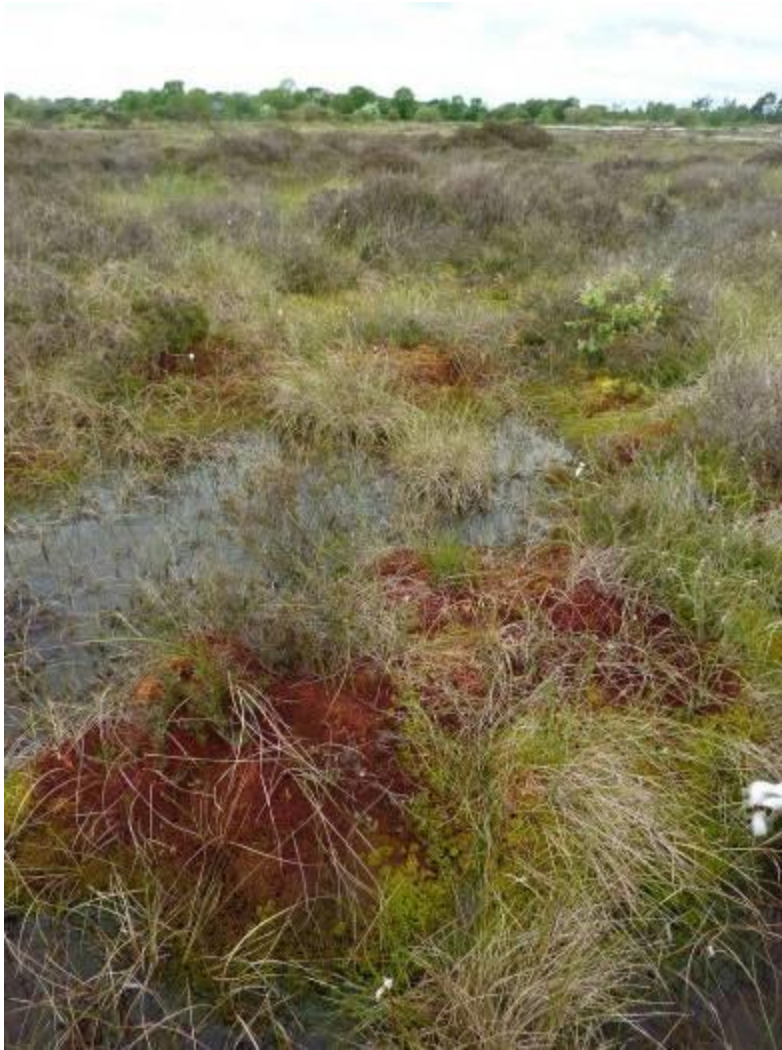
Figure 2.2 Water table at the surface of cutover bog following successful drain blocking resulting in *Sphagnum* development less than 10 years after drain blocking (this was previously an area of bare peat)

Blocking of cutover drains slows the flow of water off the cutover areas and increases the water table in the surrounding peat. This can help to reduce the rate of infiltration through the high bog and can lead to conditions that allow peat to form on the cutover (**Figure 2.2**).

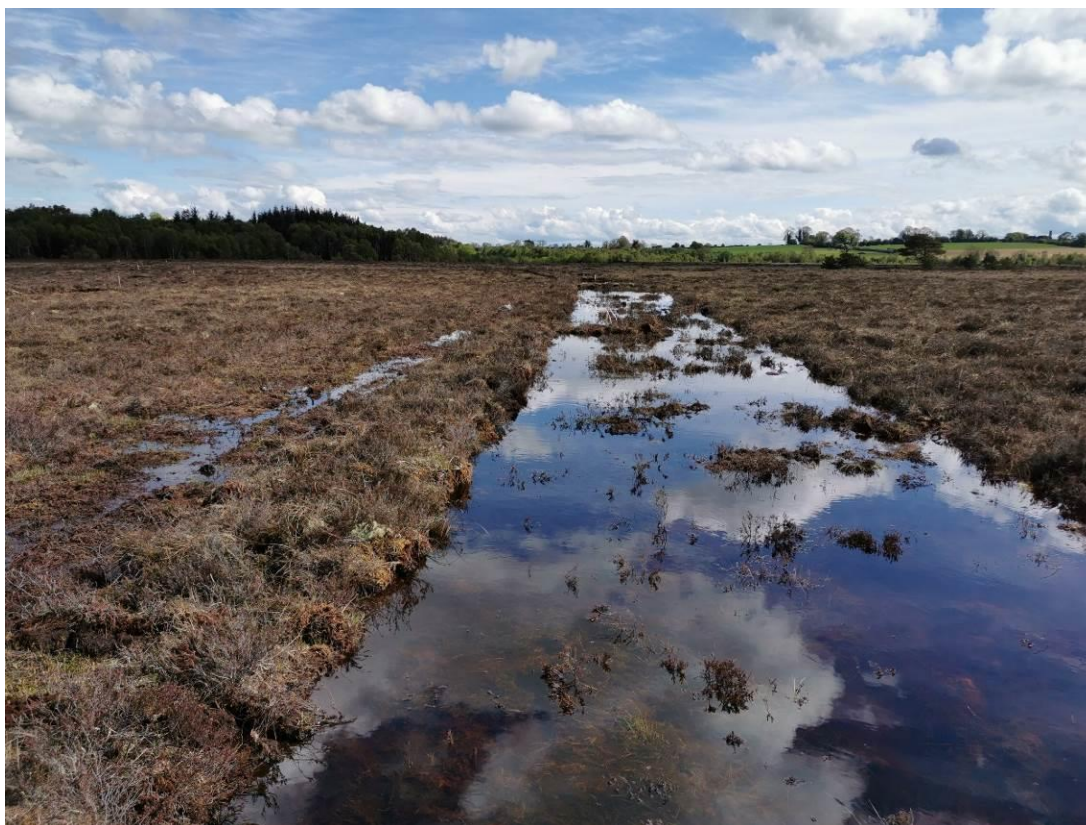
Figure 2.3 Example of contour bund constructed at Knockacoller Bog SAC, Co. Laois

Contour bunds on the high bog aims to reduce the rate of lateral flow through the upper layers of the peat. In contrast to some other bunding techniques, contour bunding is not intended as a means of impounding surface water. This method involves excavating a trench 1.5-2.0m deep, re-compacting peat into the trench and building a slightly raised bund 25-30cm above the current ground surface. In addition, these bunds have 5m long ‘finger bunds’ constructed using the same technique at approximately 25m spacing to prevent flow along the bund which may lead to erosion.

After 1-2 years it is anticipated that the bund will have subsided close to current ground level and therefore will not appear as a prominent feature on the bog surface.

Contour bunds are most effective where there is cracking or slumping in the upper layers of the peat as the re-compacted trench assists in sealing up these cracks and slows the flow rate through the peat, supporting a higher water table behind the bund. The key issue with this technique is that the extent of the impact extending back into the bog depends on the hydraulic gradient (which is closely correlated to surface slope). As a result, the extent of impact from such bunds is likely to be extremely limited where the surface slope at the margins is steep. This method is best suited to sites with a relatively gentle slope towards the margins or as a means of effectively blocking a dense network of shallow surface drains on the high bog. Ground conditions will play an important factor in whether the bund can be constructed in such circumstances, therefore this method is most effective on drier sites where machines can operate safely and effectively.

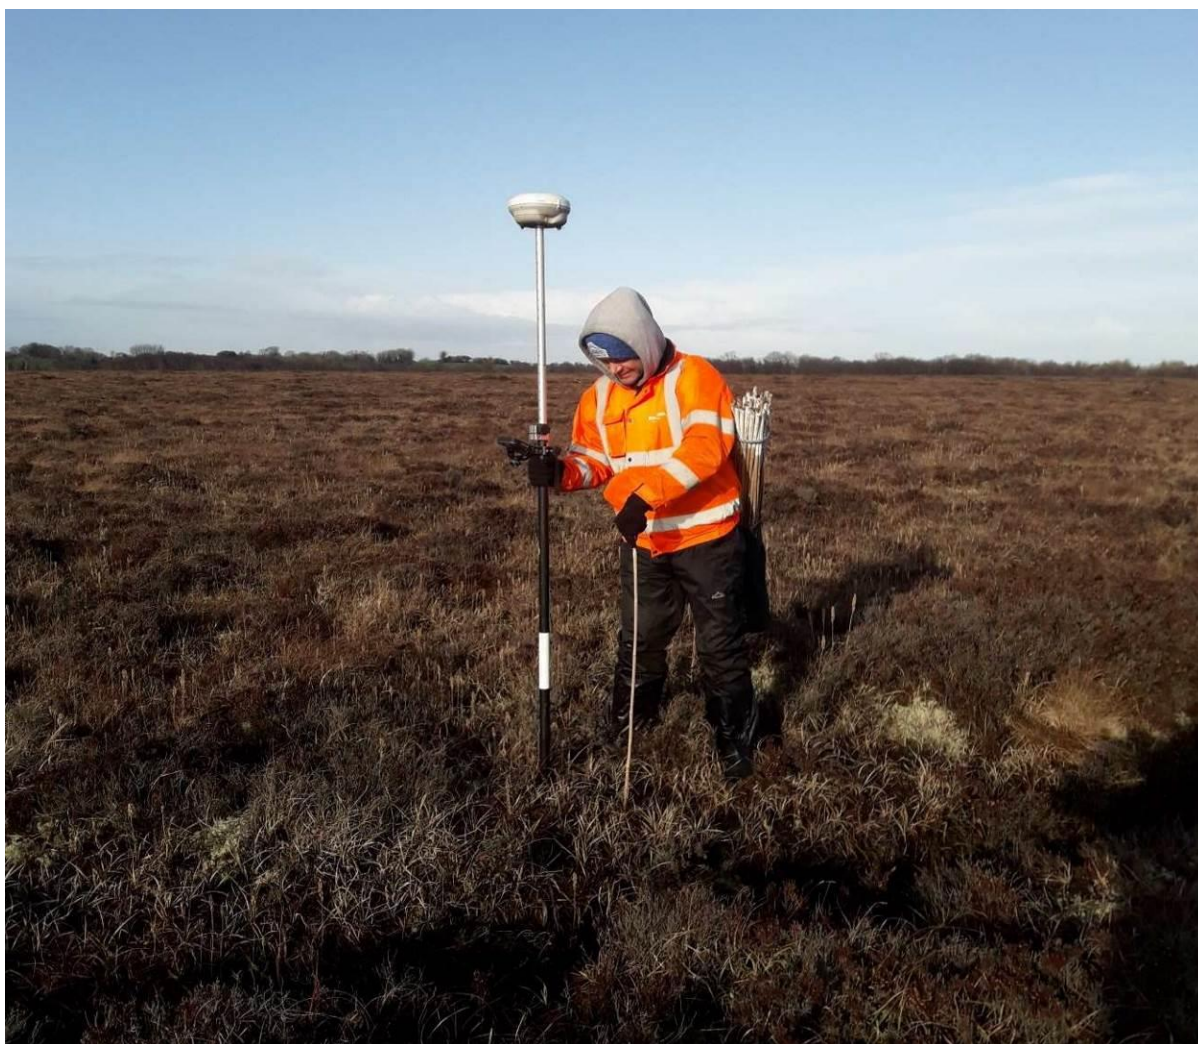
Figure 5.2 Example of setting out dams on an area of high bog

The surveying and staking out of drains and dams can be difficult due to the nature of the bog environment. Vegetation and soft ground conditions can make identification of features and surveying of same difficult and potentially dangerous. The setting out of the works is generally done using bamboo stakes to mark the locations of the restoration measures that are to be constructed such as the dams or bunds. This activity provides an additional opportunity to review the restoration measures in detail on the ground and where necessary minor modifications can be made (e.g., adjusting the placement of particular dams due to dense vegetation coverage or alignment of bunds due to ground conditions). This ensure that the risk of damage to the raised bog is minimized as inadequate planning can increase the risk of machines entering unsuitable areas.

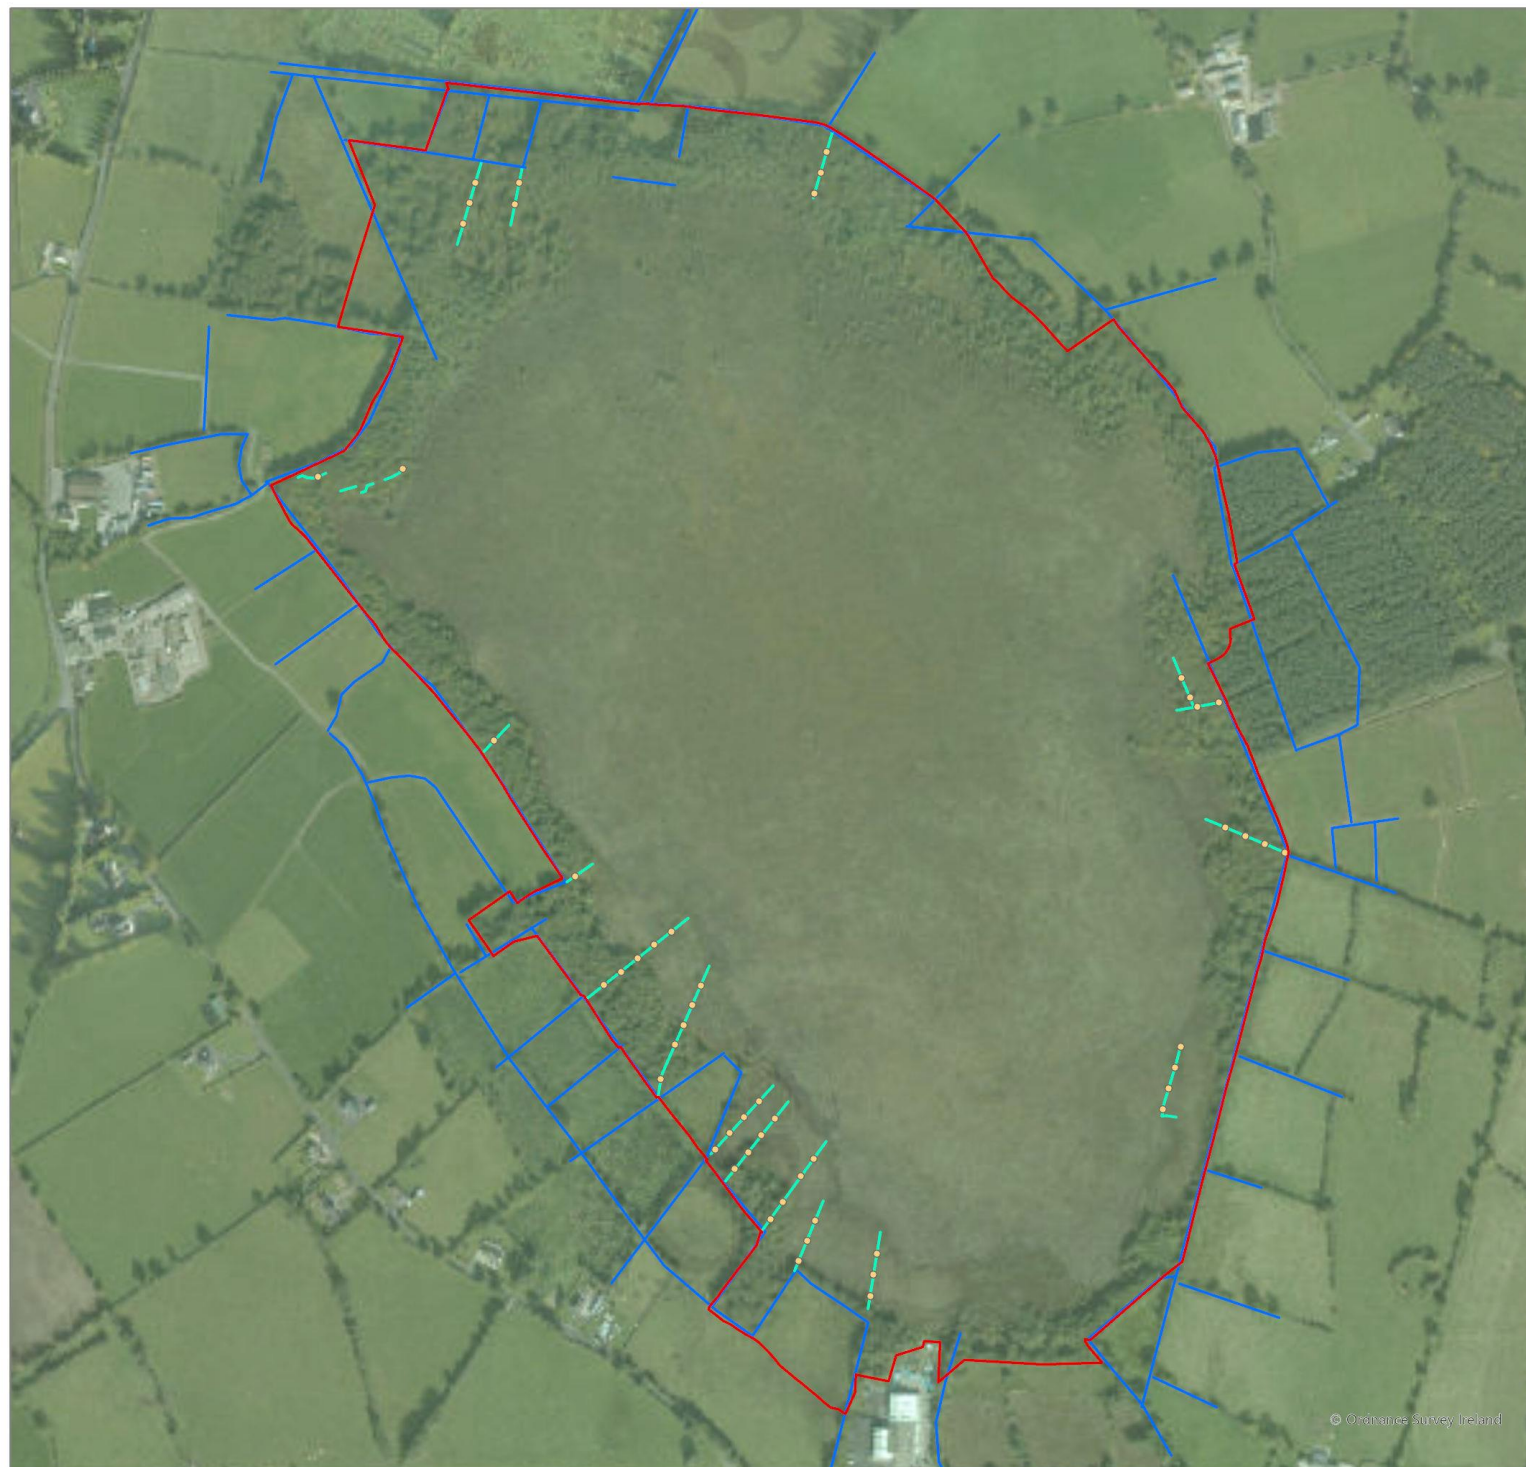
Dams

Dams (52)

Open - To Be Blocked (1.3 km)

Map 1 outlines the location and extent of Brown Bog SAC. Map 2 illustrates the restoration measures that have been implemented to date as well as any proposed/outstanding restoration measures to be implemented at Brown Bog.

There are relatively few drains on the cutover surrounding Brown Bog. However, these should be blocked to reduce the risk of ongoing subsidence of the high bog. In some areas this will also lead to the development of peat forming habitats. It is proposed that these drains are blocked, primarily with peat dams, with some plastic reinforcements where necessary to prevent erosion. The required conditions are for the water table to be maintained at or close to the surface, therefore large areas of standing water or deep pools are not desired. Details of the locations on the cutover where it is proposed to block drains can be found in Map 2.
