National Parks & Wildlife Service

Tullaghanrock Bog SAC (Site code 002354)

Raised Bog Restoration Plan (Report)

March 2023

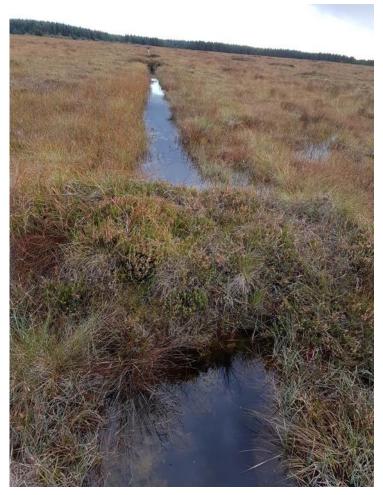
Figure 2.1 Example of a peat dam to block a typical high bog drain

Blocking high bog drains slows the flow of water off the surface of the bog and increases the water table in the peat. Drain blocking is a proven and effective restoration measure on Irish raised bogs with minimal maintenance requirements. The approach has been demonstrated at a number of raised bogs in Ireland with very positive results evident in less than 10 years (**Figure 2.1**) as outlined by Fernandez *et al.* (2014).

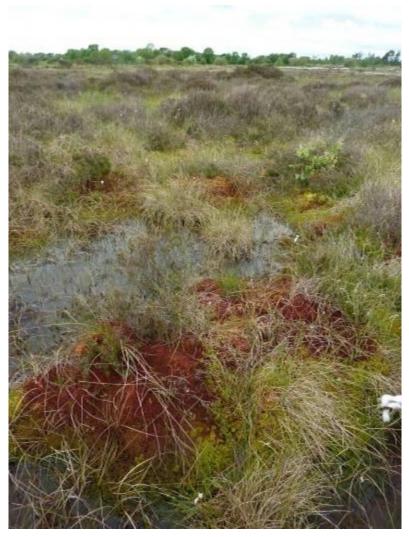
Figure 2.2 Water table at the surface of cutover bog following successful drain blocking resulting in *Sphagnum* development less than 10 years after drain blocking (this was previously an area of bare peat)

Blocking of cutover drains slows the flow of water off the cutover areas and increases the water table in the surrounding peat. This can help to reduce the rate of infiltration through the high bog and can lead to conditions that allow peat to form on the cutover (**Figure 2.2**).

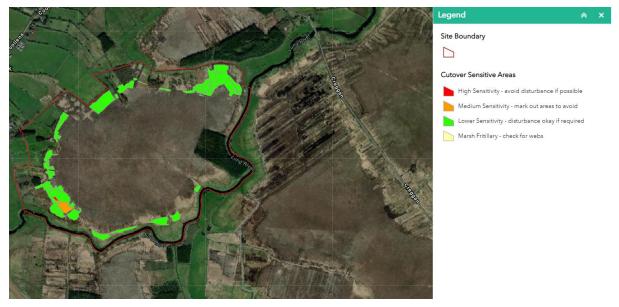
Figure 5.1 Sensitive habitats mapped at Tullaghanrock Bog SAC

In addition to the high bog survey, a cutover habitat survey was carried out in 2023 in accordance with Irish Wildlife Manual No. 128 'The Habitats of Cutover Raised Bog' (Smith & Crowley, 2020). This survey involved detailed mapping of the various vegetation communities occurring on the cutover bog and classified these in terms of sensitivity to damage from restoration activities. Although most areas were found to be of negligible or lower sensitivity, there were small pockets of medium and high sensitivity vegetation, particularly towards the north of the bog. This mapping together with mapping of the high bog ensures the restoration plan takes into account the existing sensitive habitats present on site to minimise potential impacts.

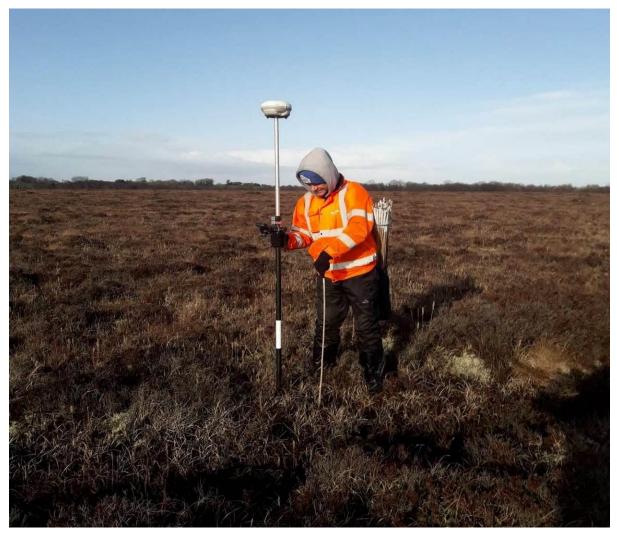
Figure 5.2 Example of setting out dams on an area of high bog

The surveying and staking out of drains and dams can be difficult due to the nature of the bog environment. Vegetation and soft ground conditions can make identification of features and surveying of same difficult and potentially dangerous. The setting out of the works is generally done using bamboo stakes to mark the locations of the restoration measures that are to be constructed such as the dams or bunds. This activity provides an additional opportunity to review the restoration
